Project CLEANs Public Meeting Ben McIntyre School, Uranium City April 29, 2010 1:00 pm

PROJECT CLEANS:
*Satellite Remediation Completed in
2009*

Project CLEANS Group 3 Satellite site Remediation Proposed for 2010

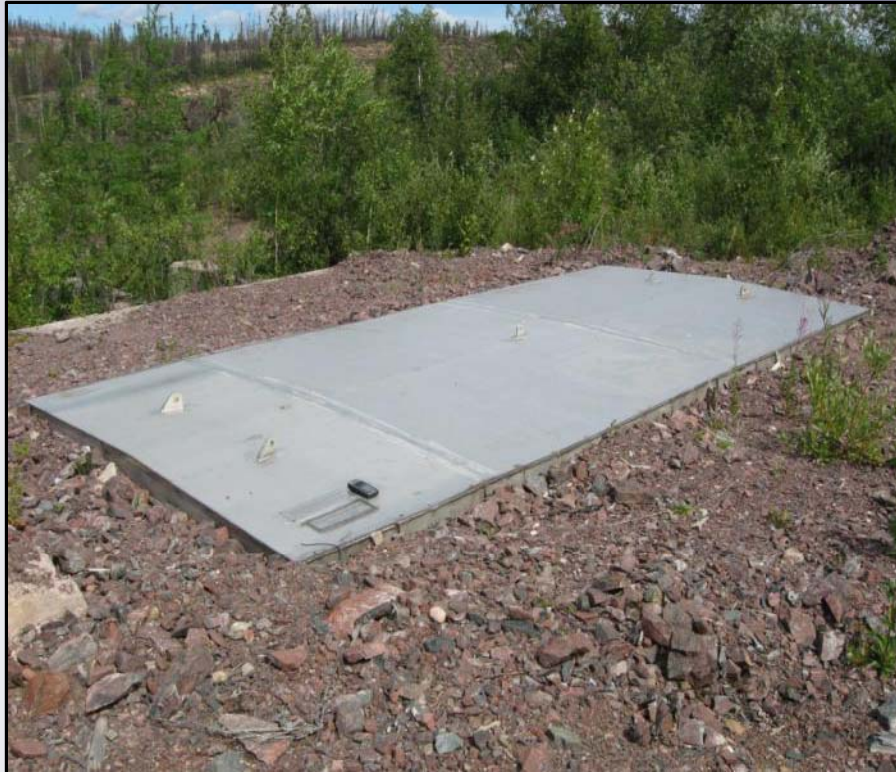
3 stainless steel caps were installed over the shaft openings

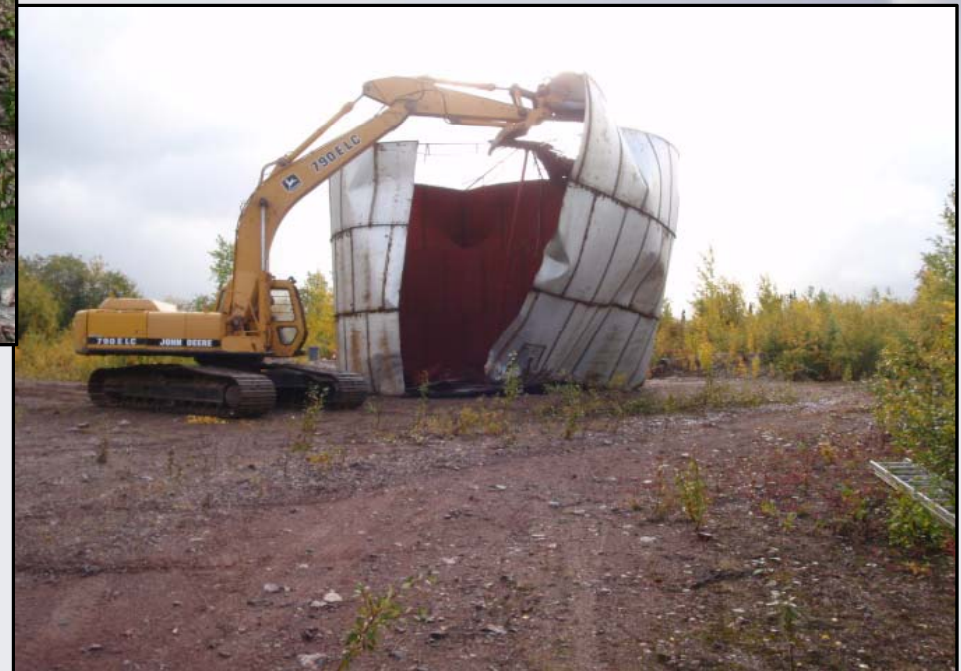
1 bulk water tank was dismantled

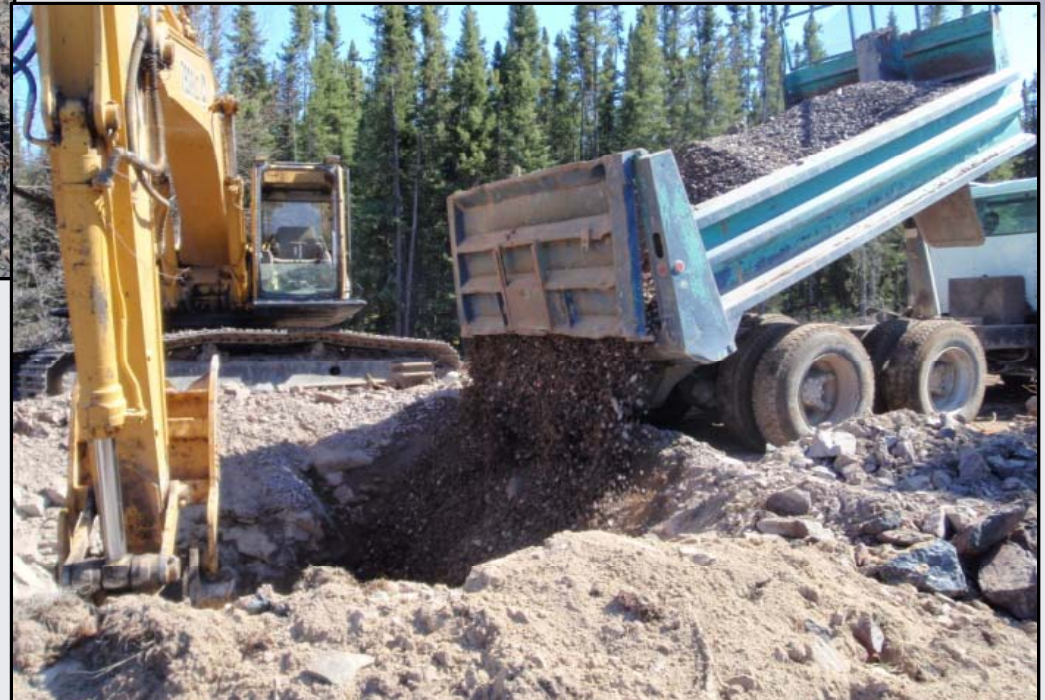
(Right) Backfilling of raise #1.
A second raise north of the
Crackingstone river was also
backfilled.

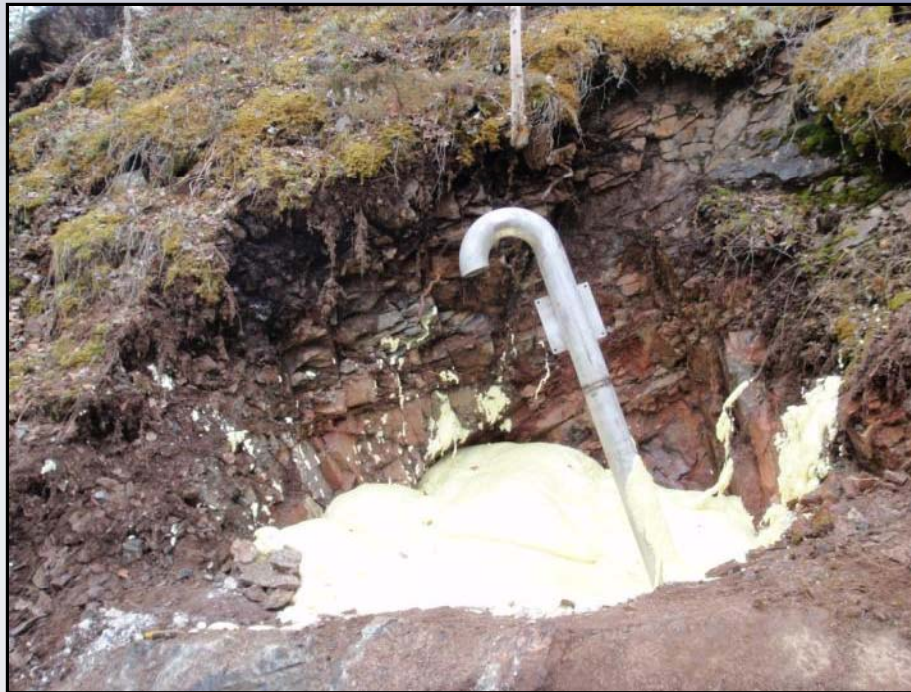
(left) Raise #3 was sealed using polyurethane foam (PUF)

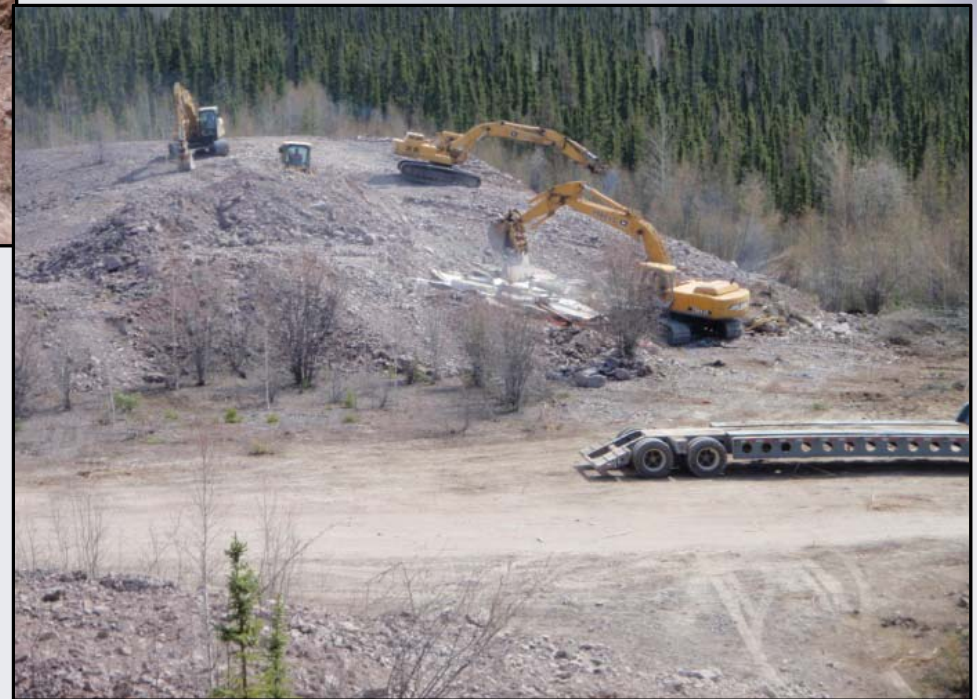
(right) Non hazardous material was buried onsite at the base of the waste rock pile

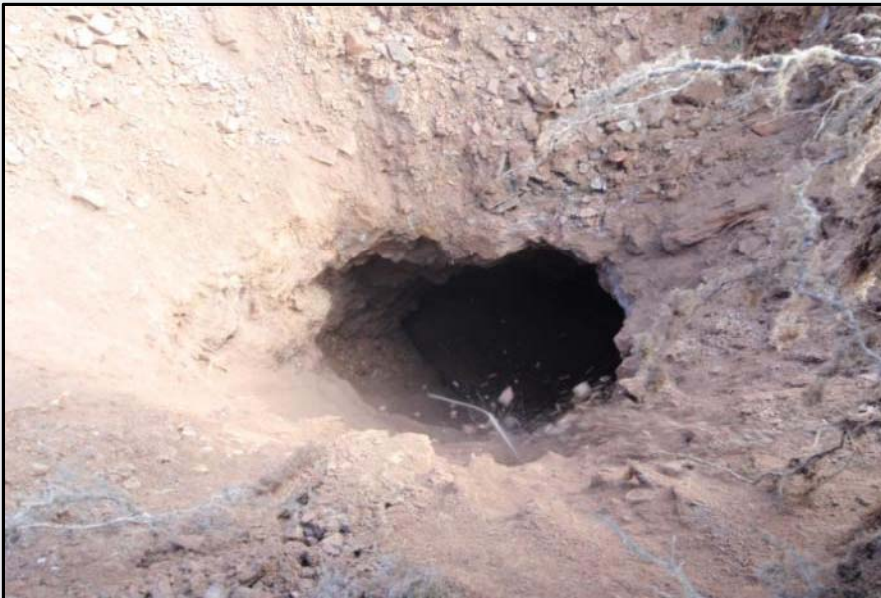
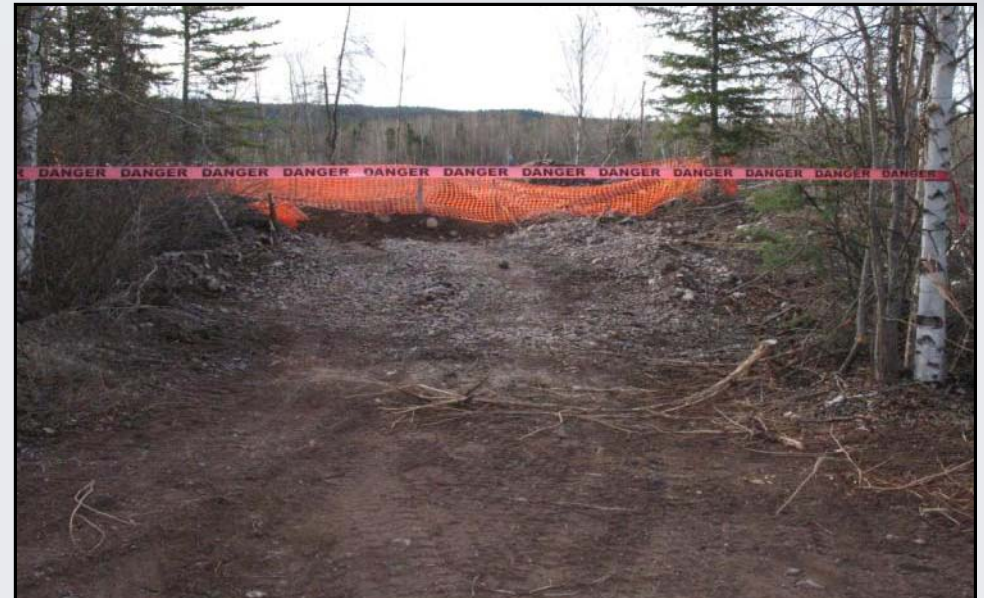
- The fourth raise, located on the north side of the Crackingstone river, could not be backfilled properly in 2009
- The area was fenced and temporary closure was put in place until a stainless steel cap could be fabricated.

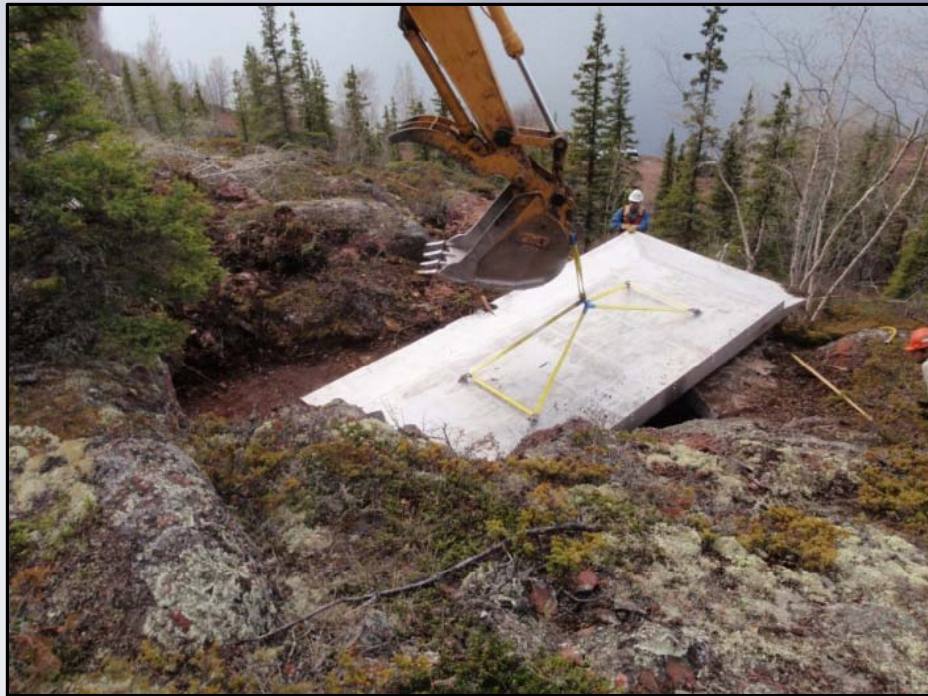
(left) Installation of a stainless steel cap on the shaft opening

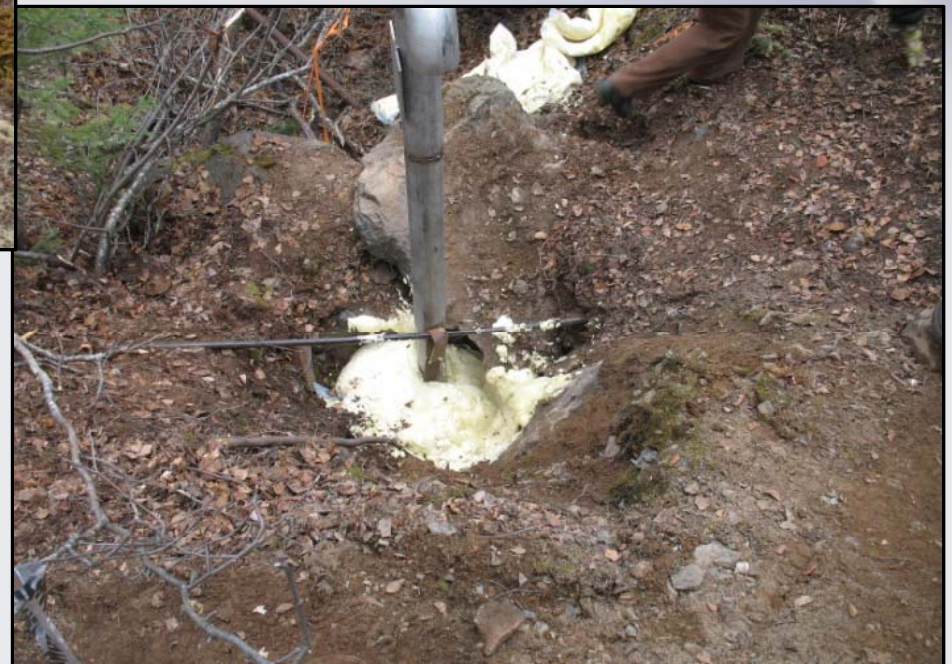
(right) raise foamed with PUF.

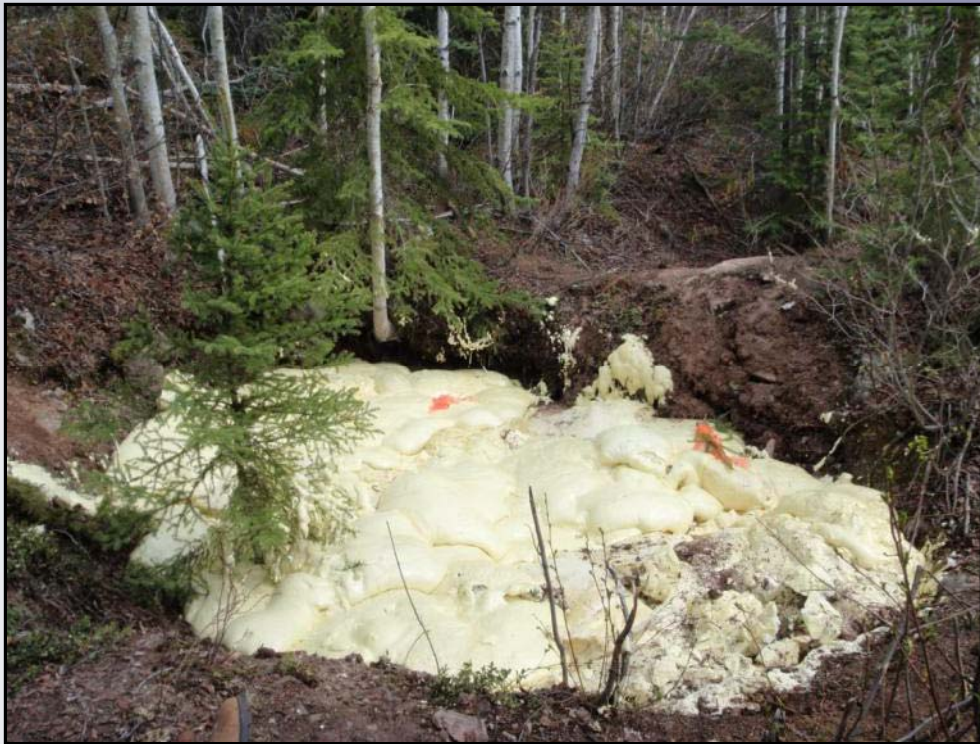
(right) PUF plug at raise #2

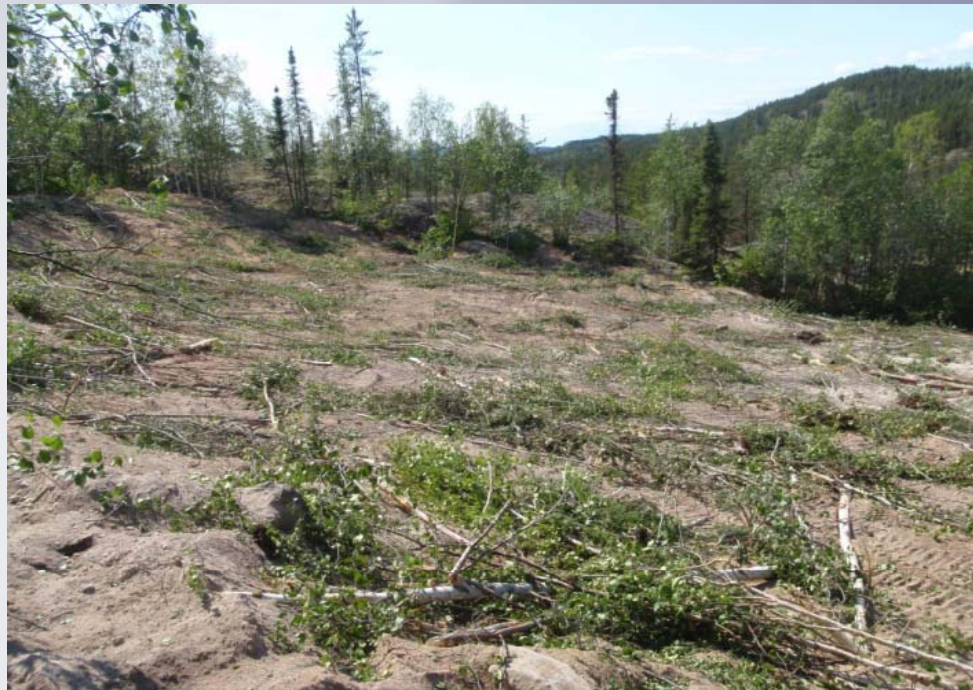
(left) Sand covered ore pad with slash placement

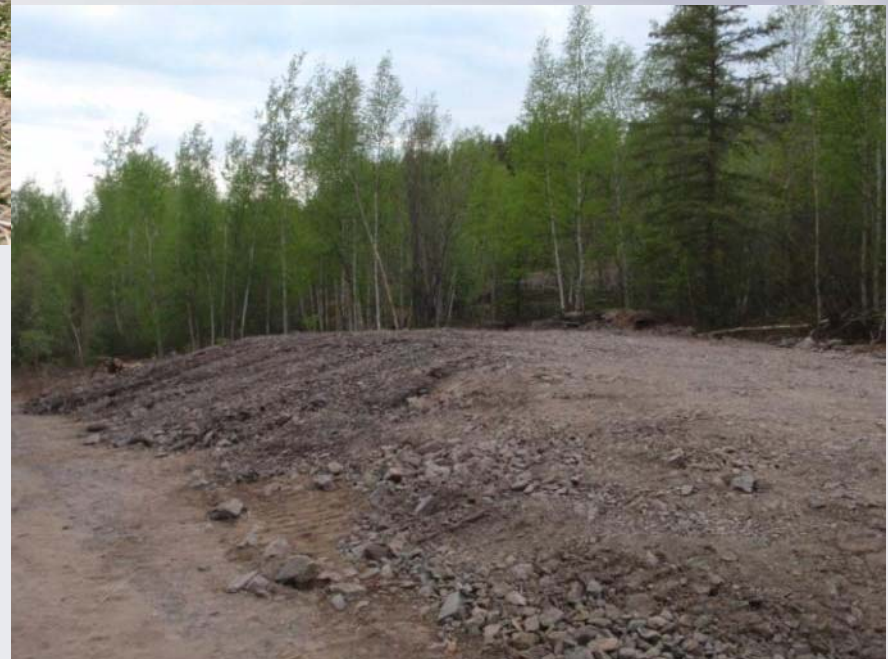
(right) landscaped terrain where concrete foundations existed

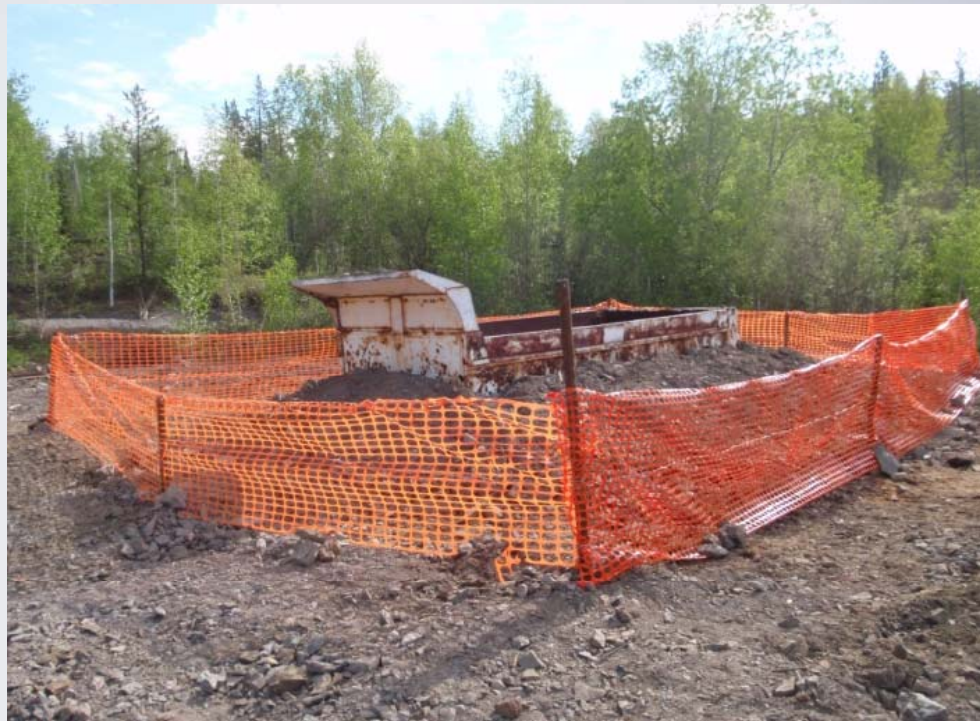
- The shaft opening still needs to be sealed properly
- The temporary closure will be removed and a stainless steel cap will be installed early in the 2010 field season.

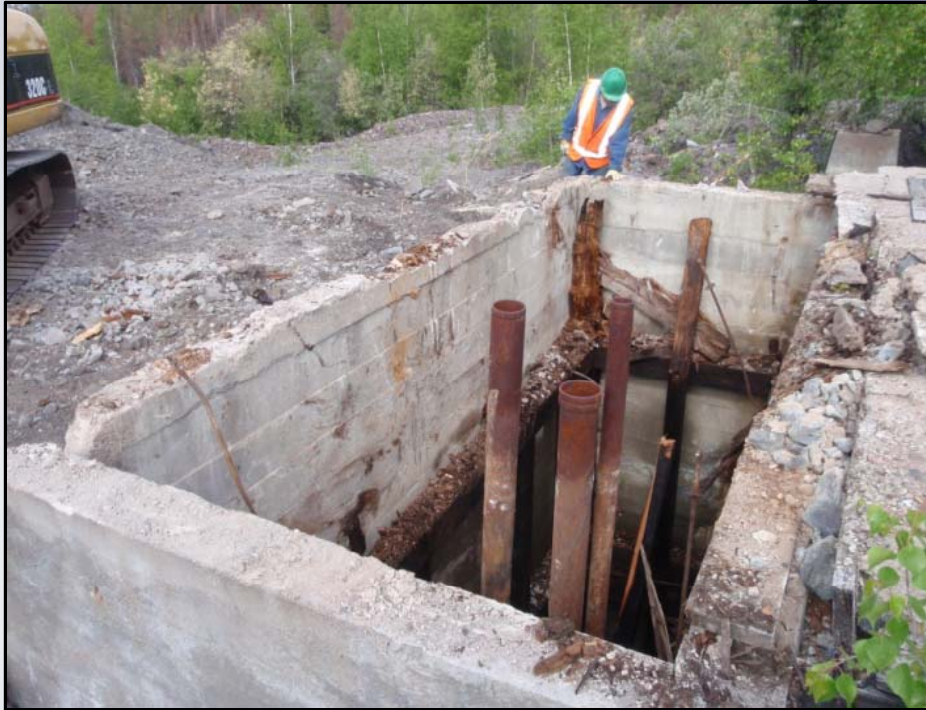
(left) Exposed shaft opening after failing concrete cap was removed

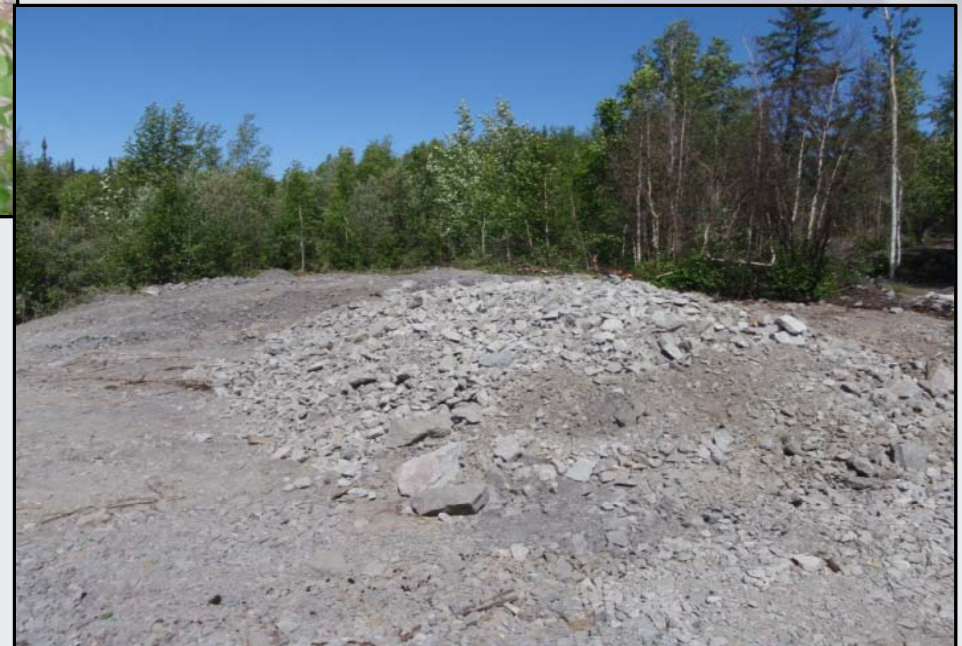
(right) The shaft once backfilling was completed.

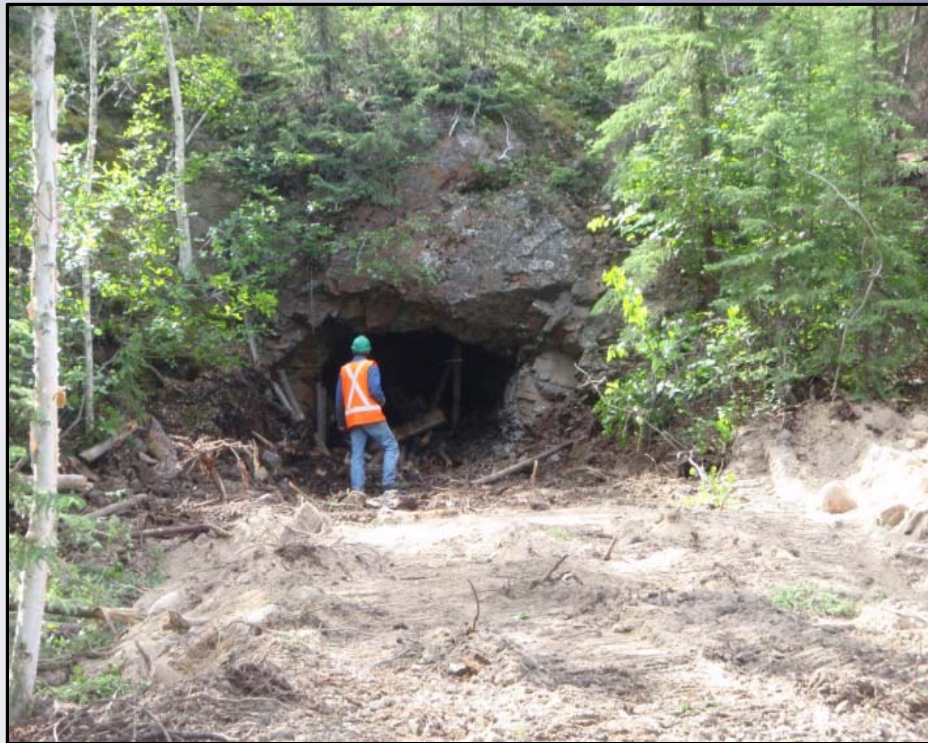
(left) Adit opening after failing steel grate was removed

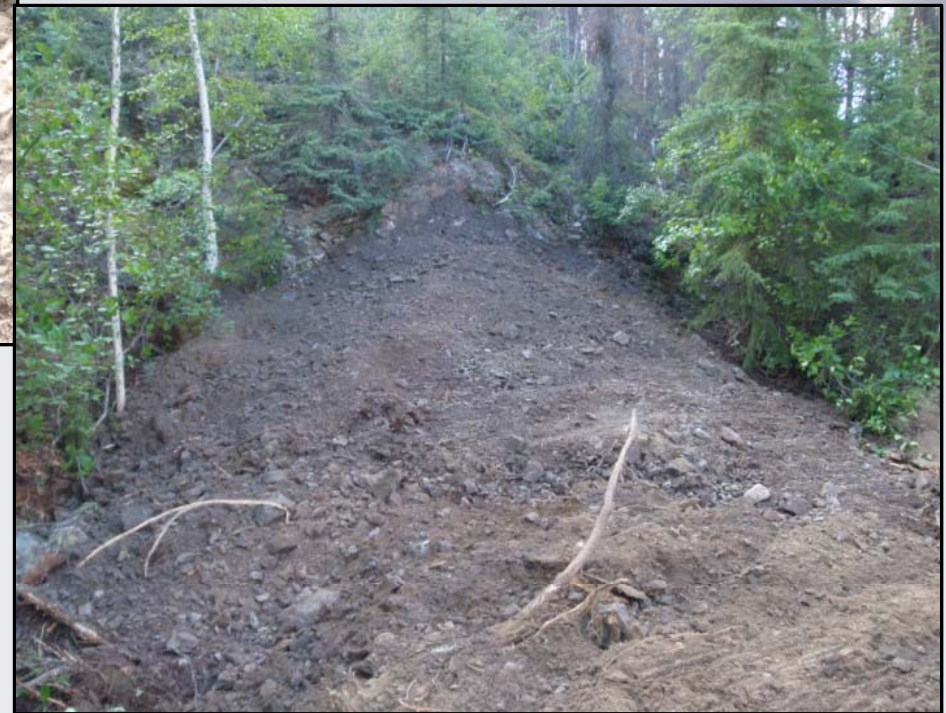
(right) completed backfill of the adit

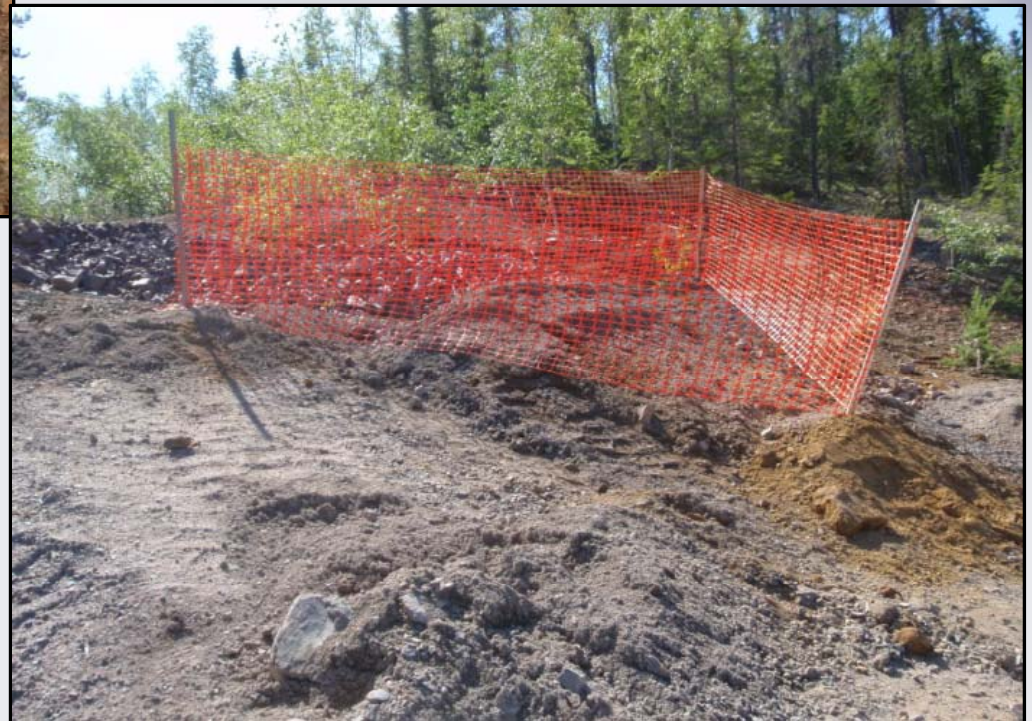
(right) fencing around slump

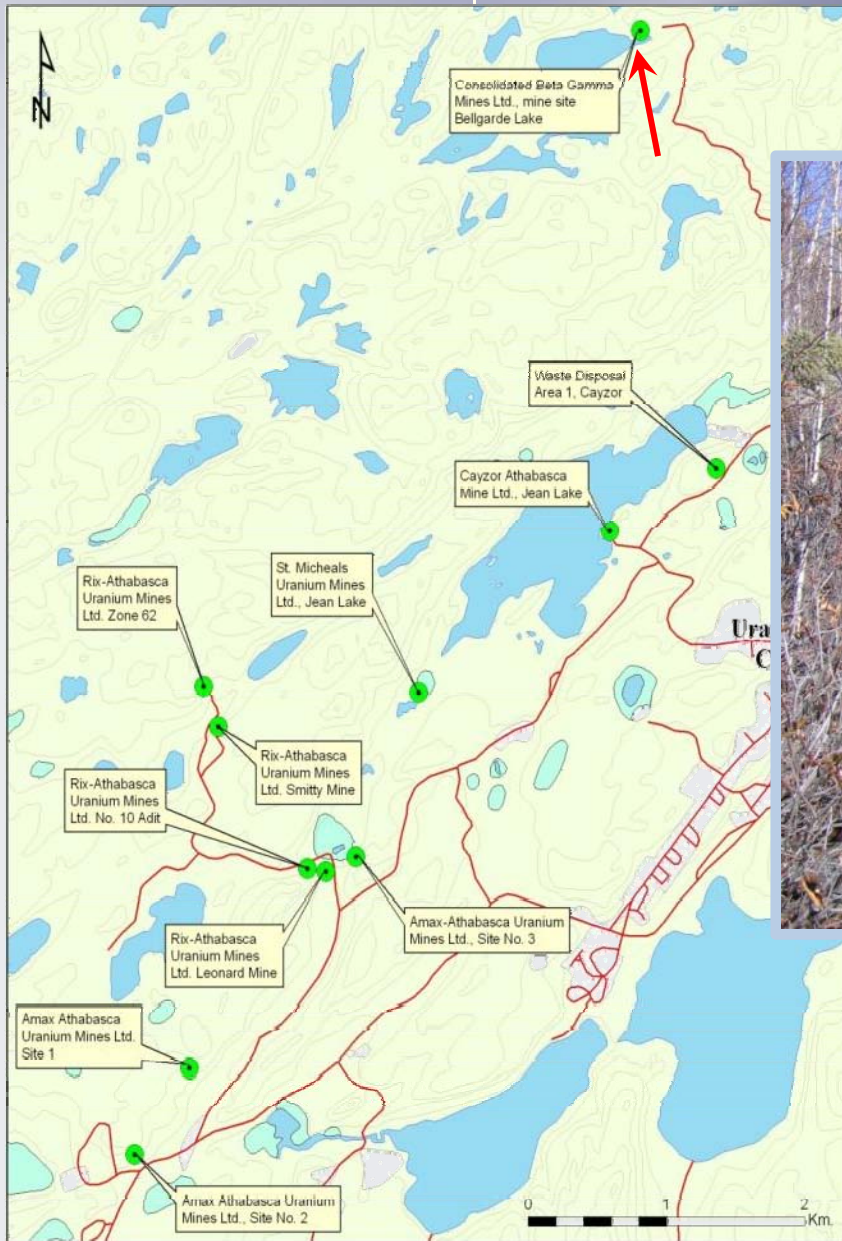
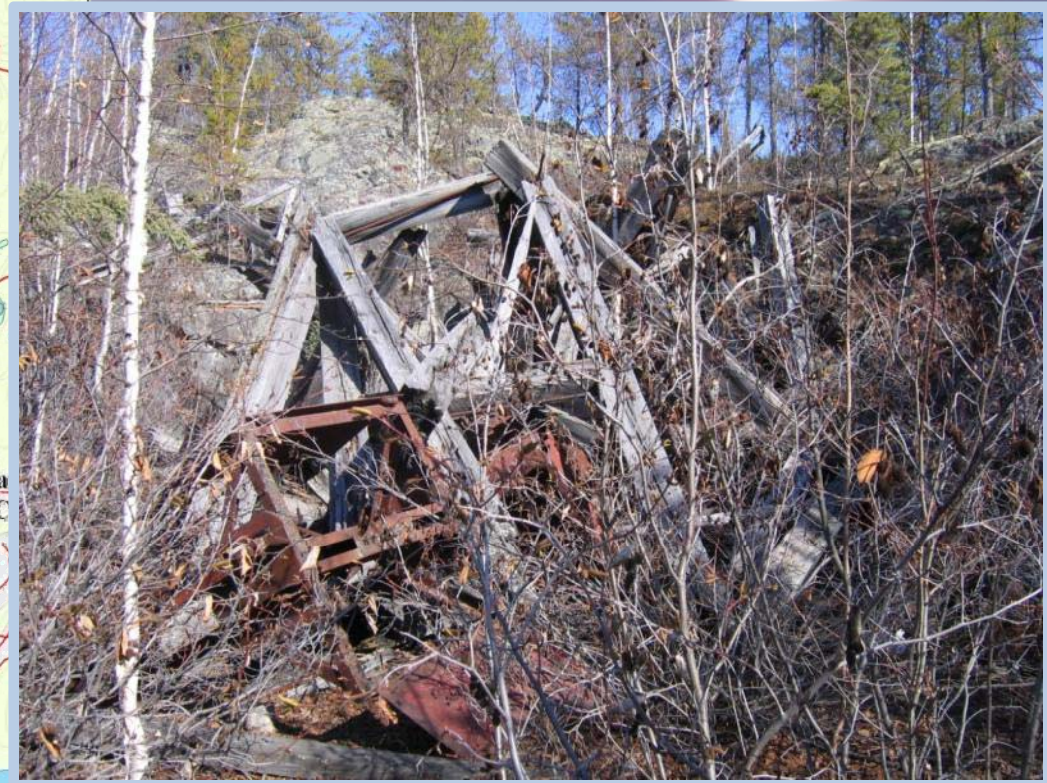
Consolidated Beta Gamma

- Headframe collapsed over open shaft, clear debris, assess cap options, secure opening until cap installed

Collect steel debris
Stockpile lumber for burn in fall
Waste rock pile
flatten slopes and bury steel on
site

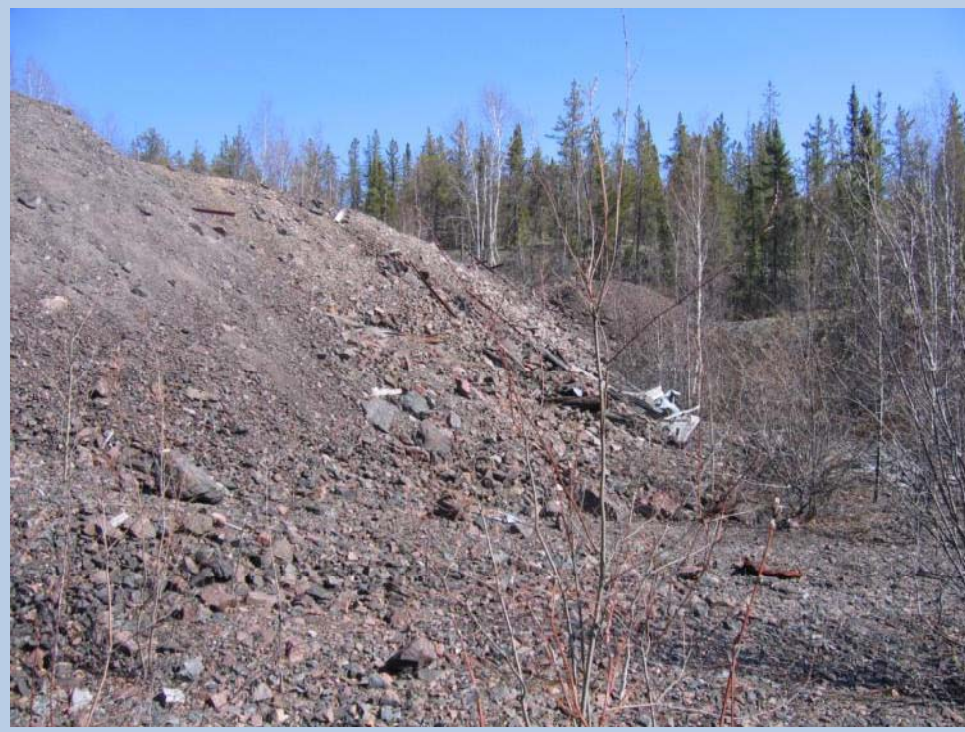
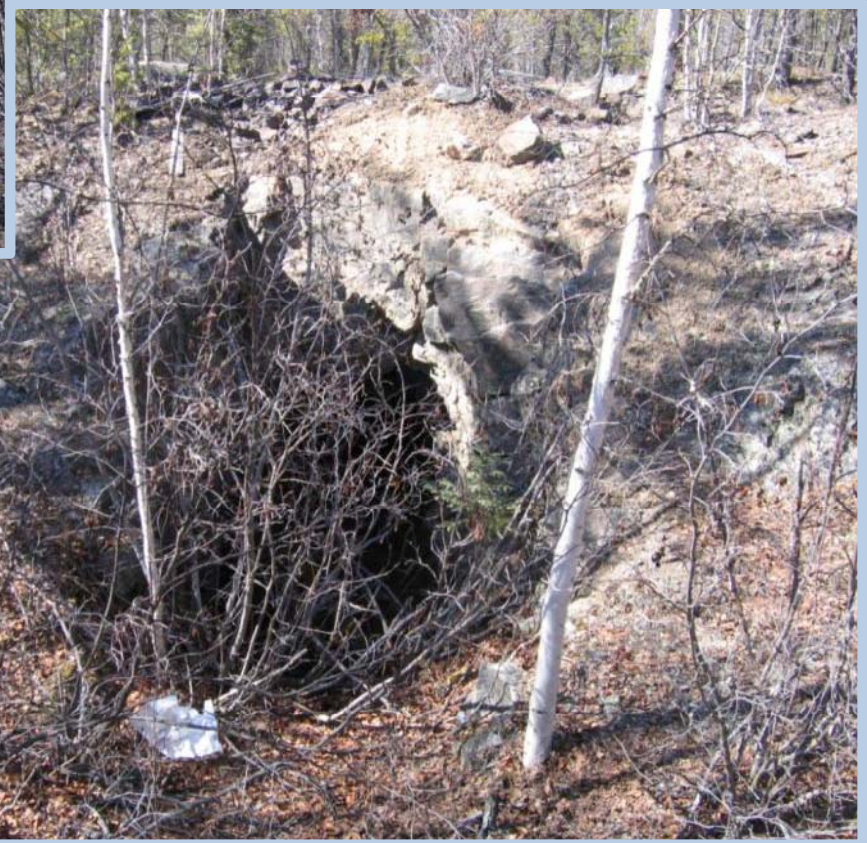
Open adit
Backfill with waste
rock
Gamma survey of
mine site area

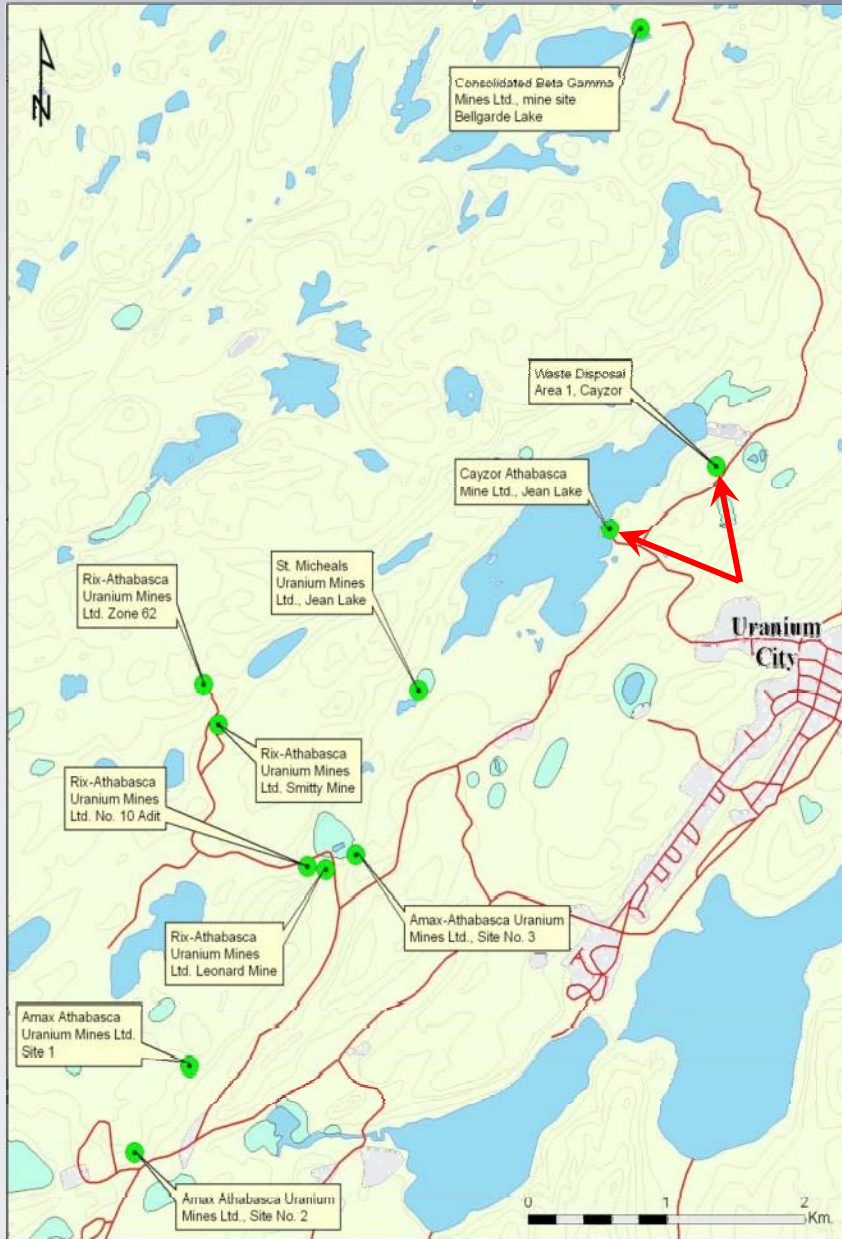
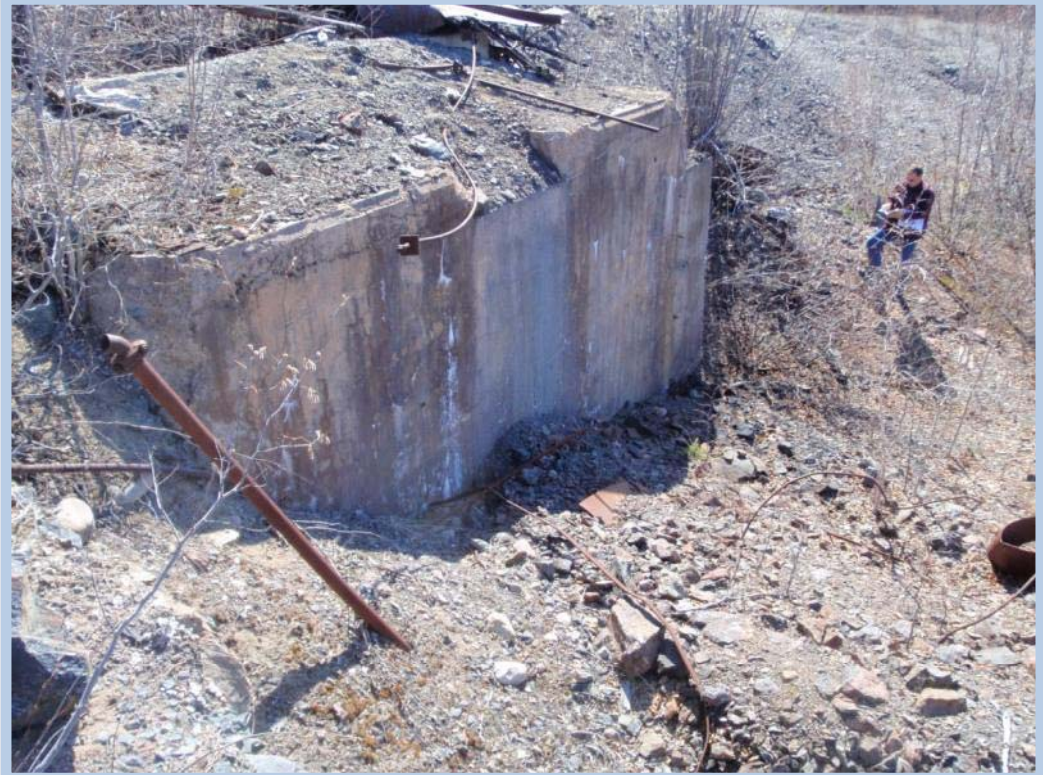
Cayzor mine and dump Jean Lake

Head frame shaft area,
expose and assess original
concrete shaft cap

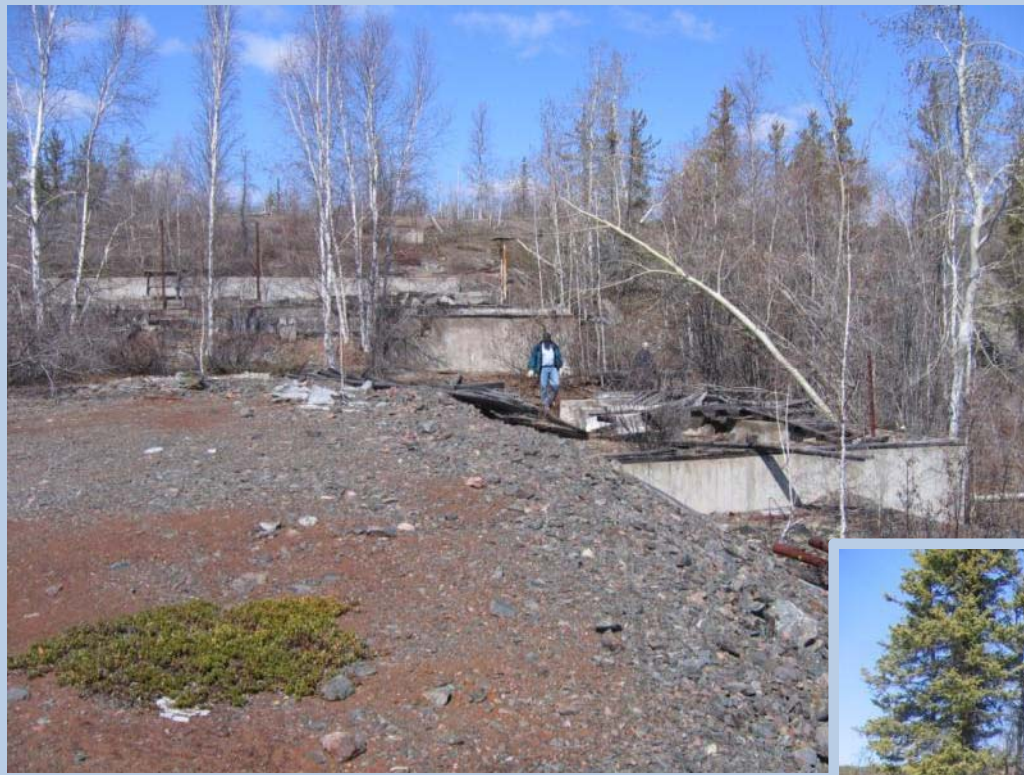
Concrete foundations
break up and/or bury

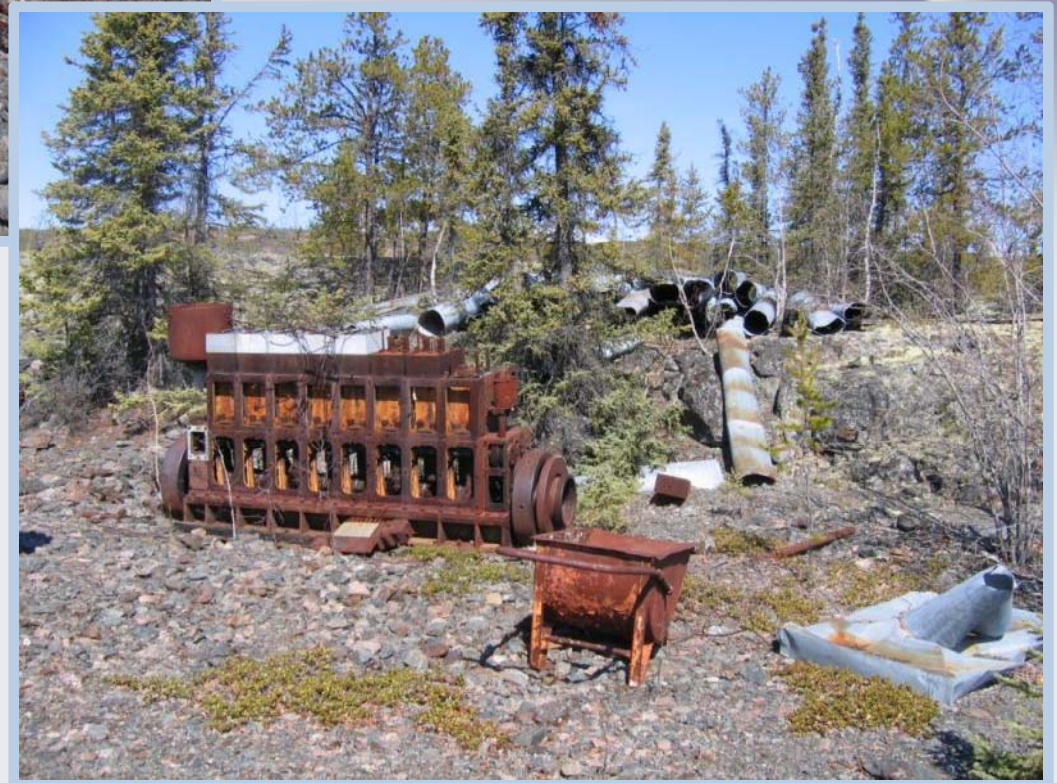
Steel debris
collect and bury on
site in waste rock

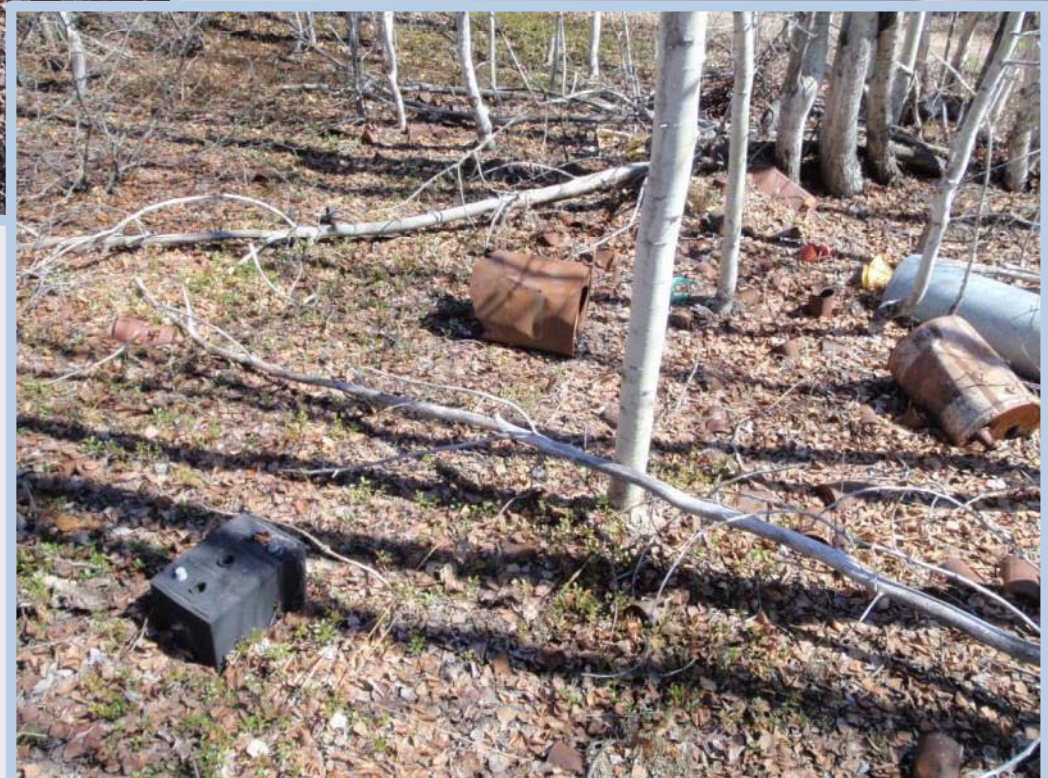
Steel debris, tires, 45 gal. drums, lead from batteries, bury steel in Cayzor waste rock
Remove batteries to waste storage site at Lorado
Gamma survey of site

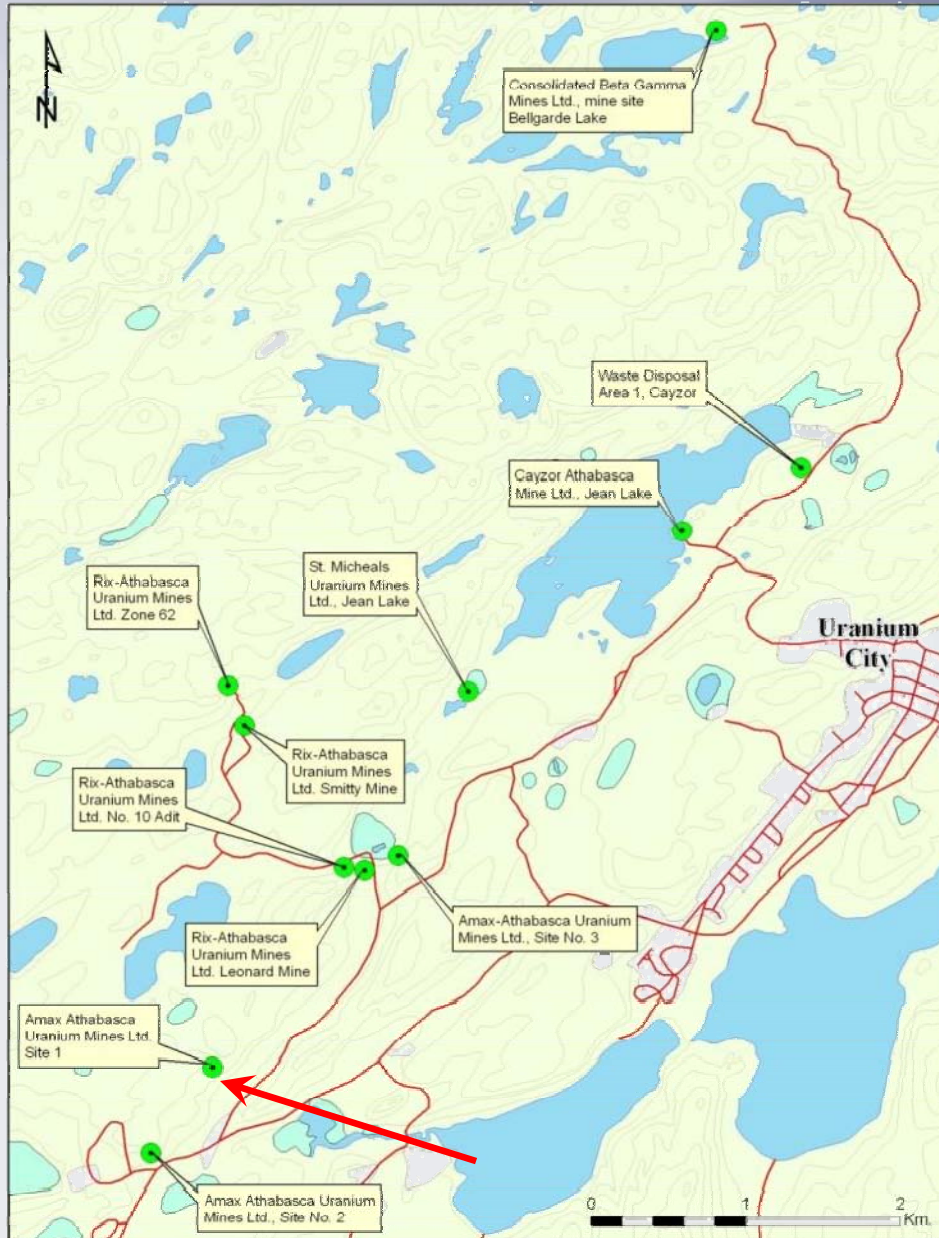
Rix Athabasca Site #1

- Adit backfilled at closure, may require repacking
- Steel debris (pipe, drill rod, rails) will be collected and taken to a nearby waste rock site for burial if onsite disposal is not possible
- Gamma survey of site

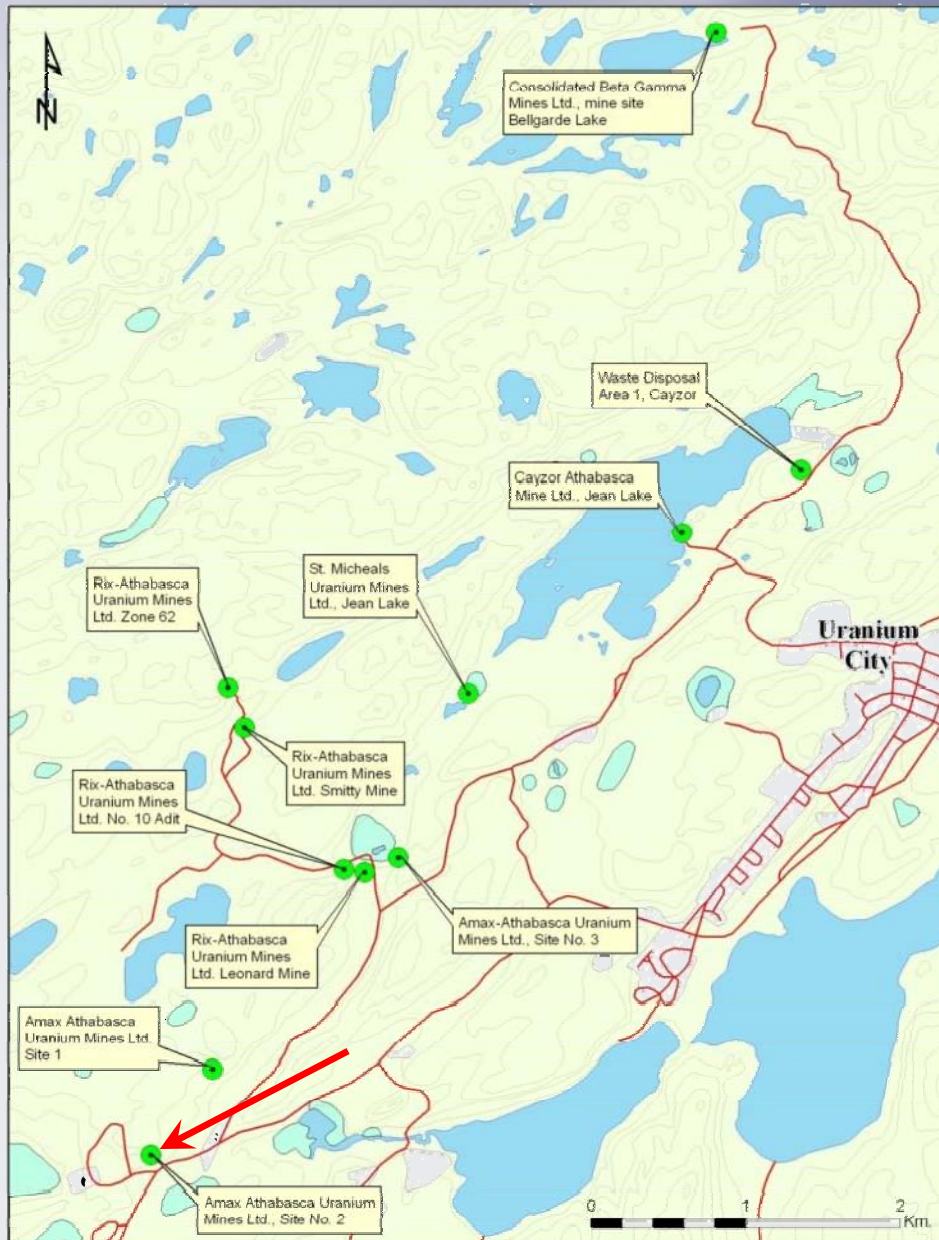
Amax Athabasca Site #2

- Scattered metal debris, 45 gal. drums, drill rods etc. collect and bury at St. Michaels
- No underground workings
- Gamma survey
