Project CLEANs Public Meeting Ben McIntyre School, Uranium City April 29, 2010 1:00 pm

PROJECT CLEANS:
*Satellite Remediation Completed in
2009*

Project CLEANS Group 3 Satellite site Remediation Proposed for 2010

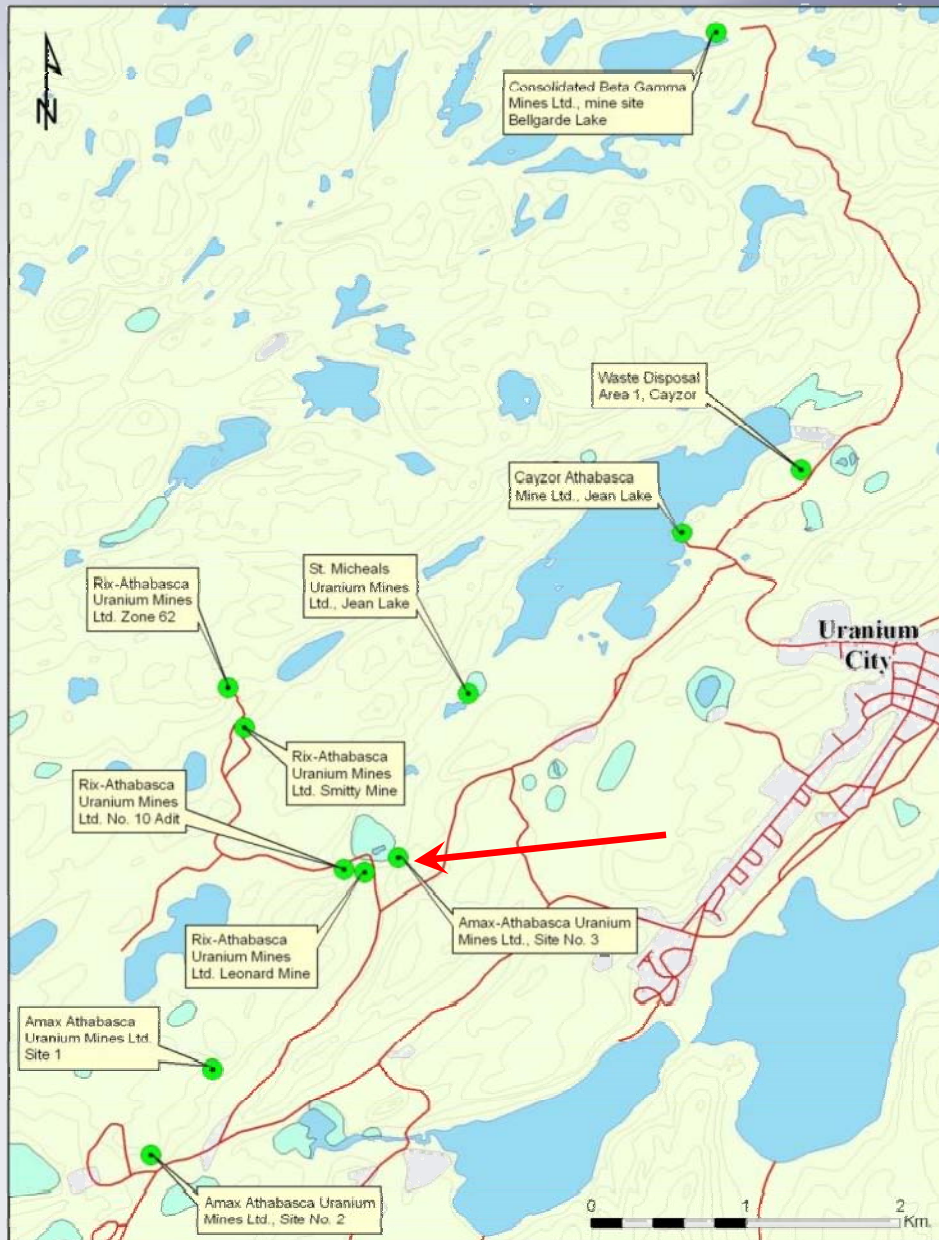
Amax Athabasca Site #3

- Scattered metal debris, drums, drill rods, rails etc. collect and bury in nearby waste rock pile
- No underground workings
- Some concrete building foundations to break up
- Gamma survey

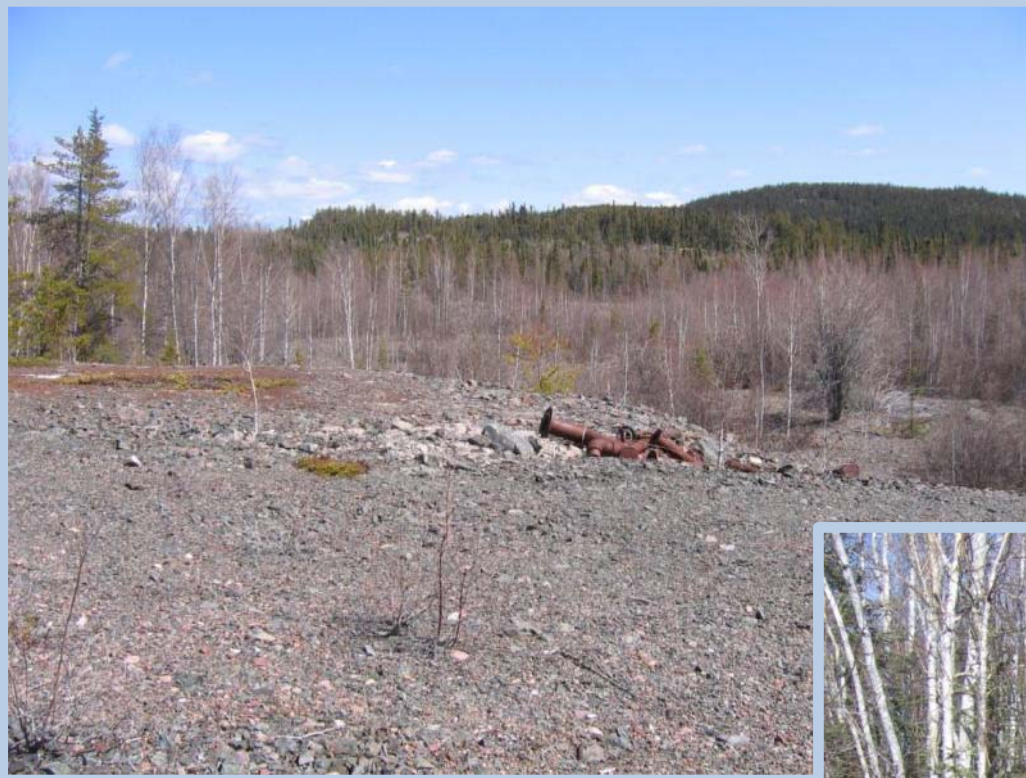
Some steel waste to be collected and buried in waste rock on site

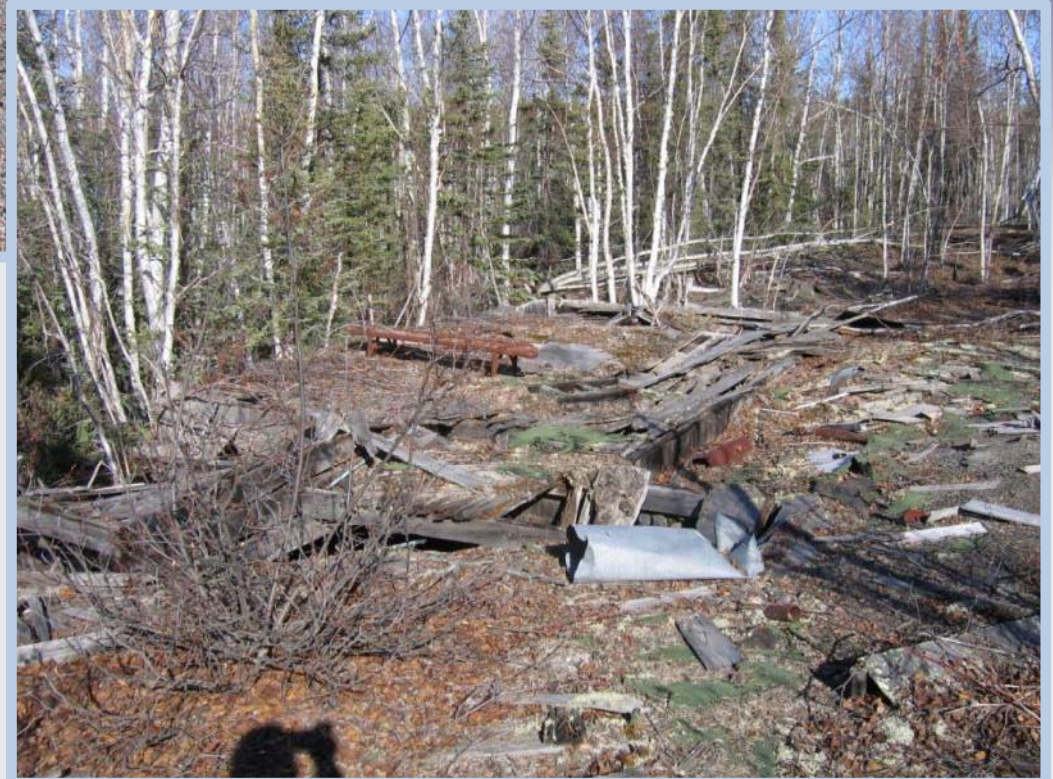
Partially vegetated waste rock pile with scrap steel, pipes and other mining steel debris to be collected and buried on site

Collapsed building debris lumber to be separated from other waste and stockpiled for later burn

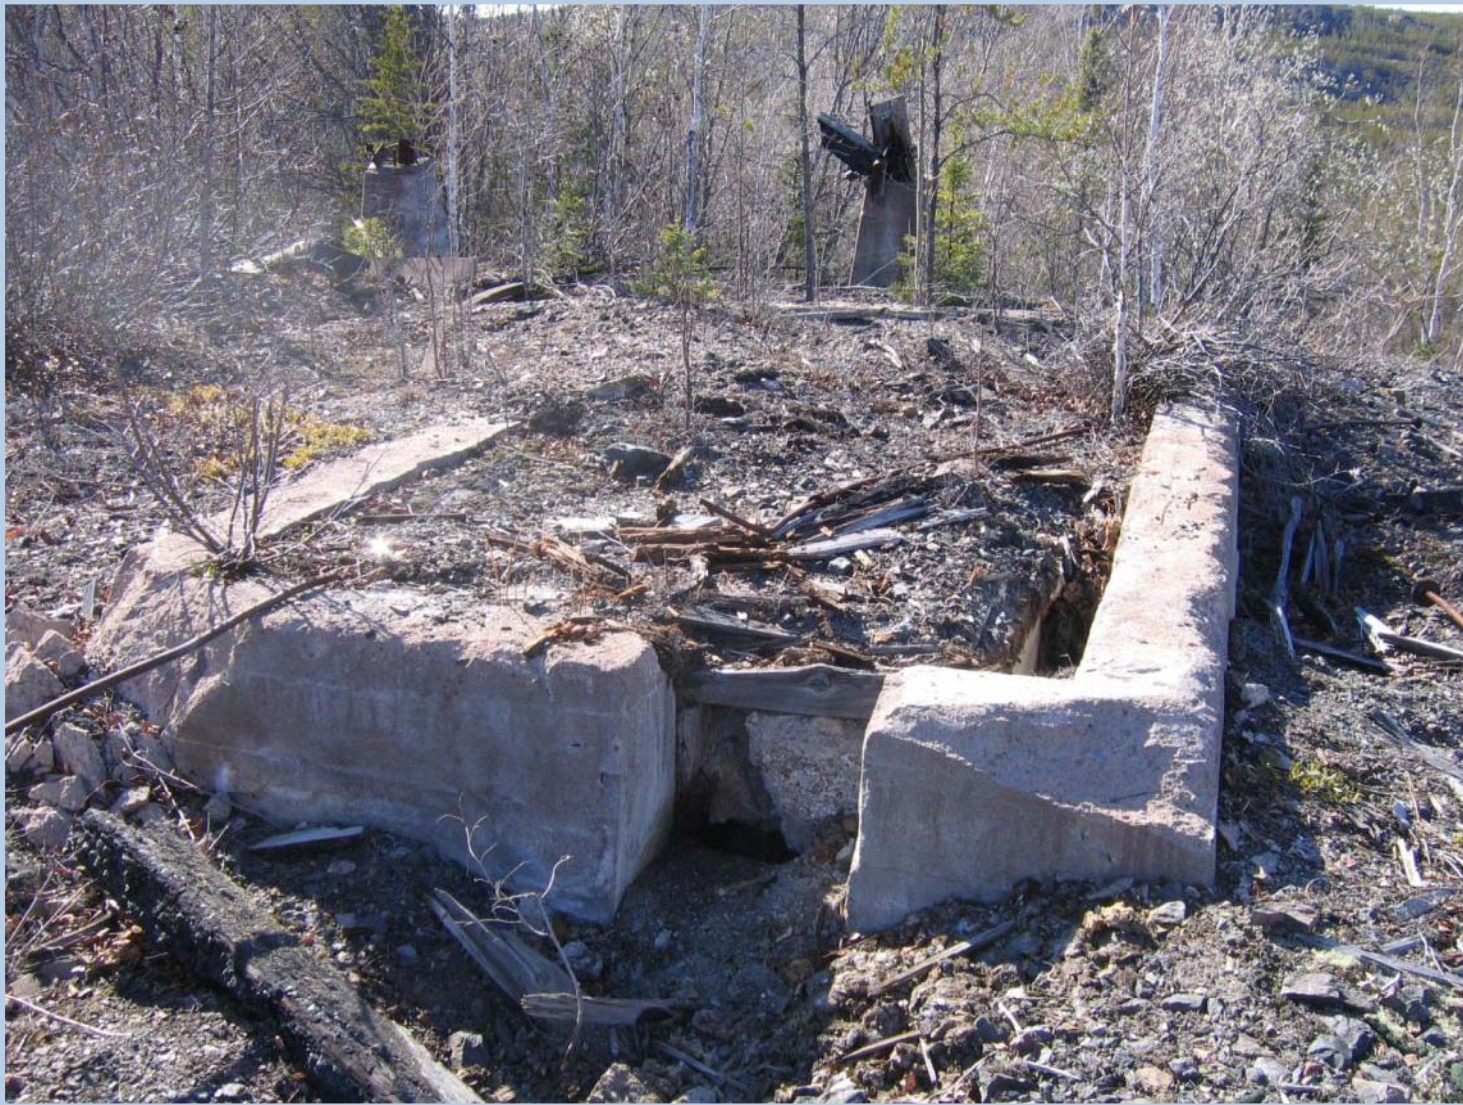
Concrete shaft at St Michaels, to be exposed, inspected and assessed for competence, may need replacement

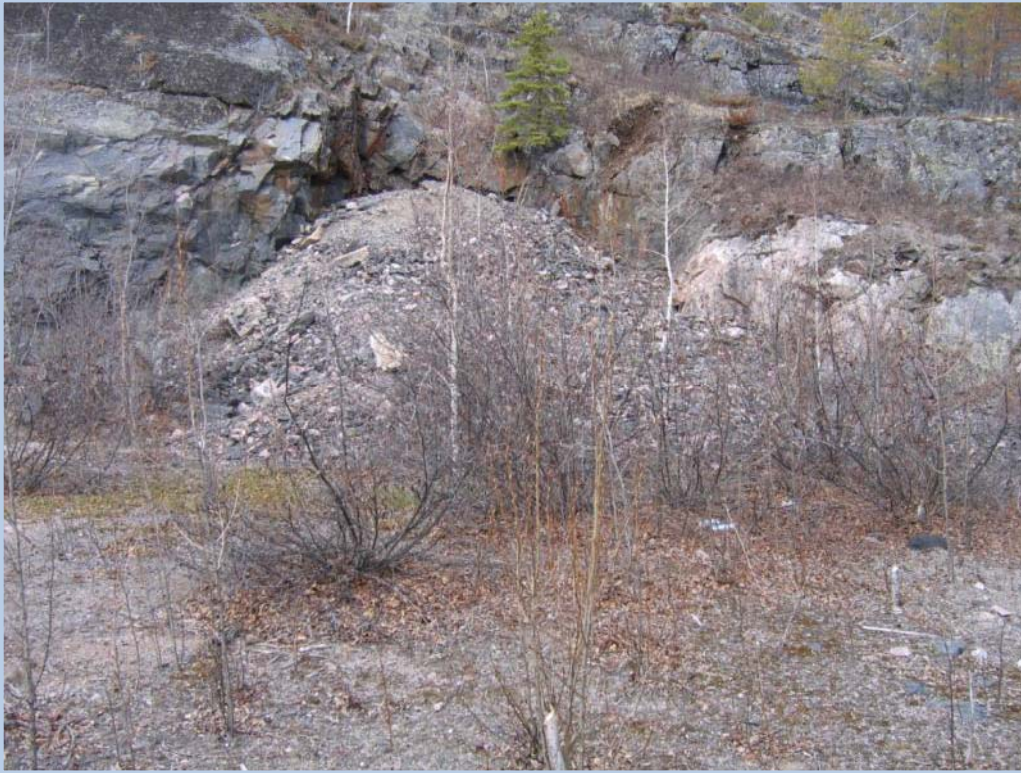
Adit showing signs of slumping, reopen and place backfill into adit as well as in front

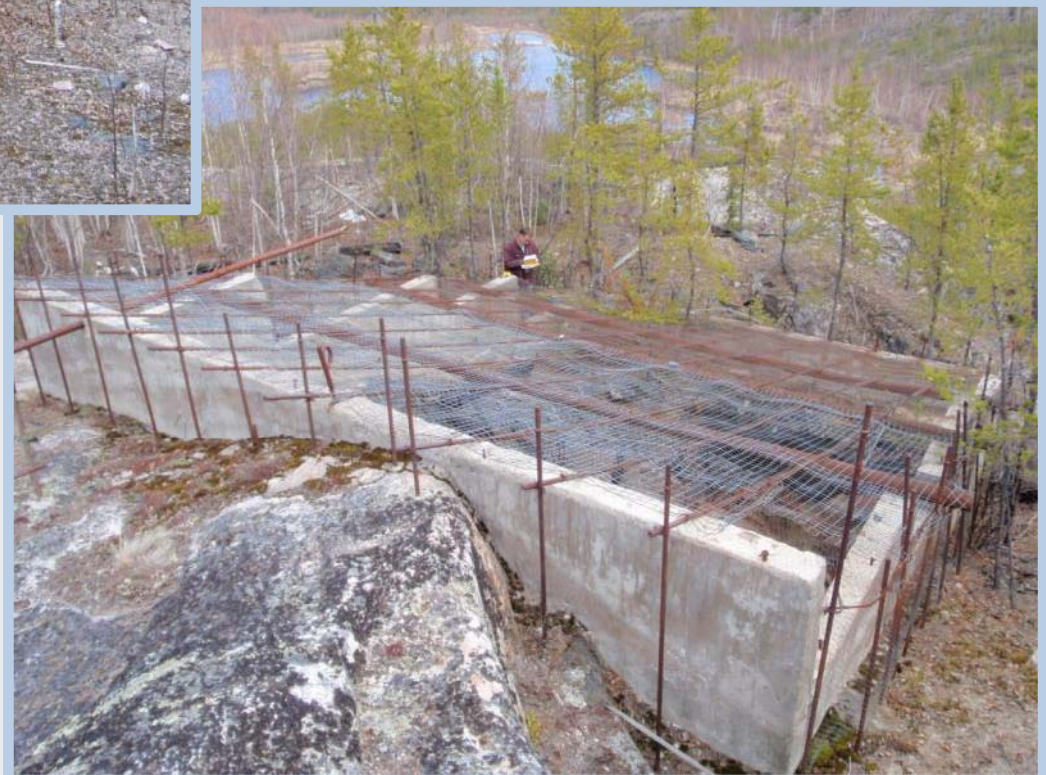
Large poorly covered raise at Leonard site, assess for alternative closure options
Gamma survey mine area

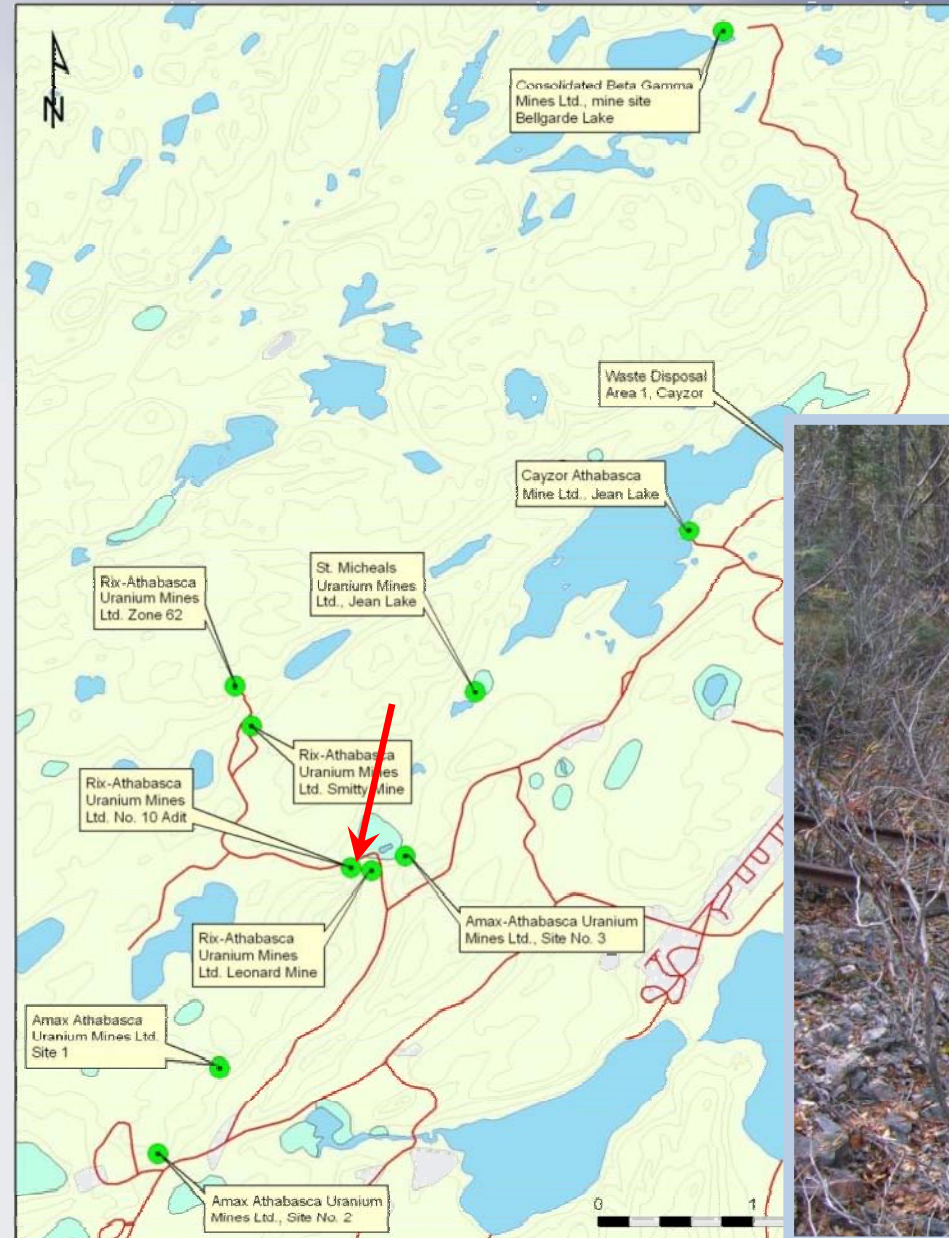
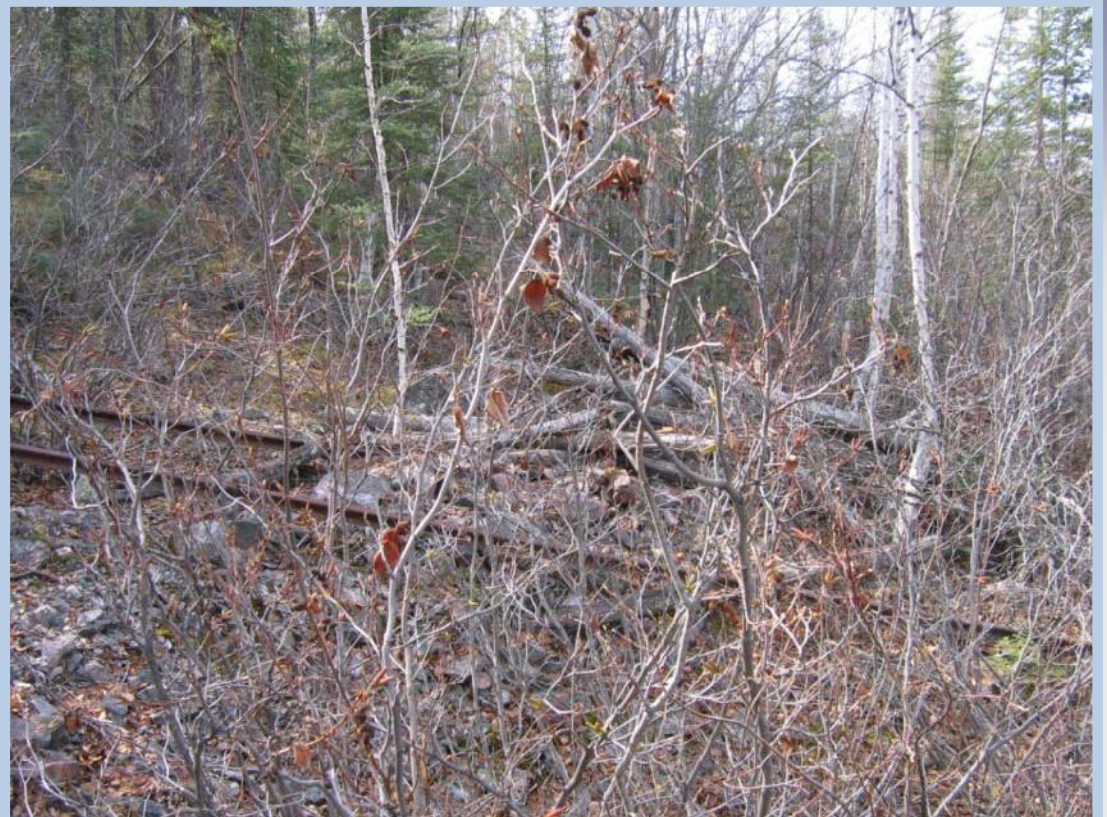
Rix-Athabasca Adit #10

- Collect steel and other debris found on site,
- Bury steel in waste rock
- Backfill adit with local waste rock
- Gamma survey

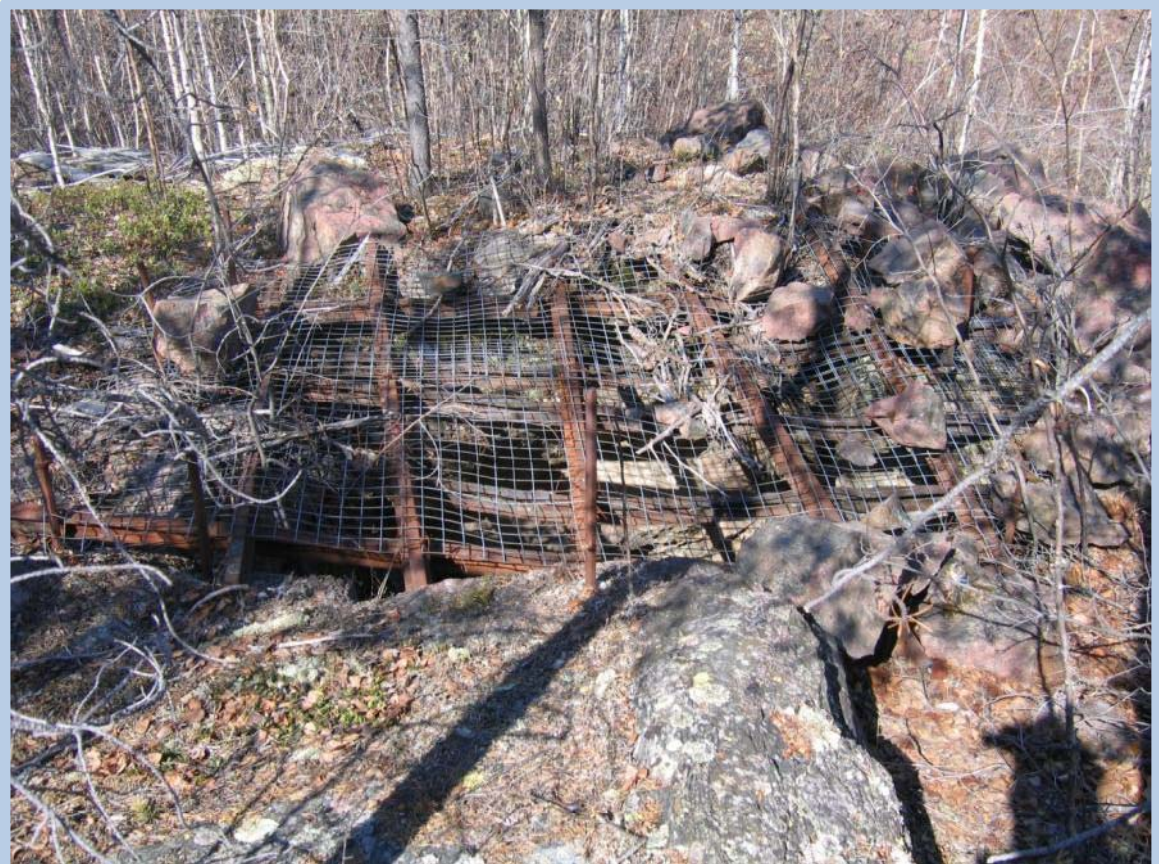
One of several openings in need of closure at Smitty mine

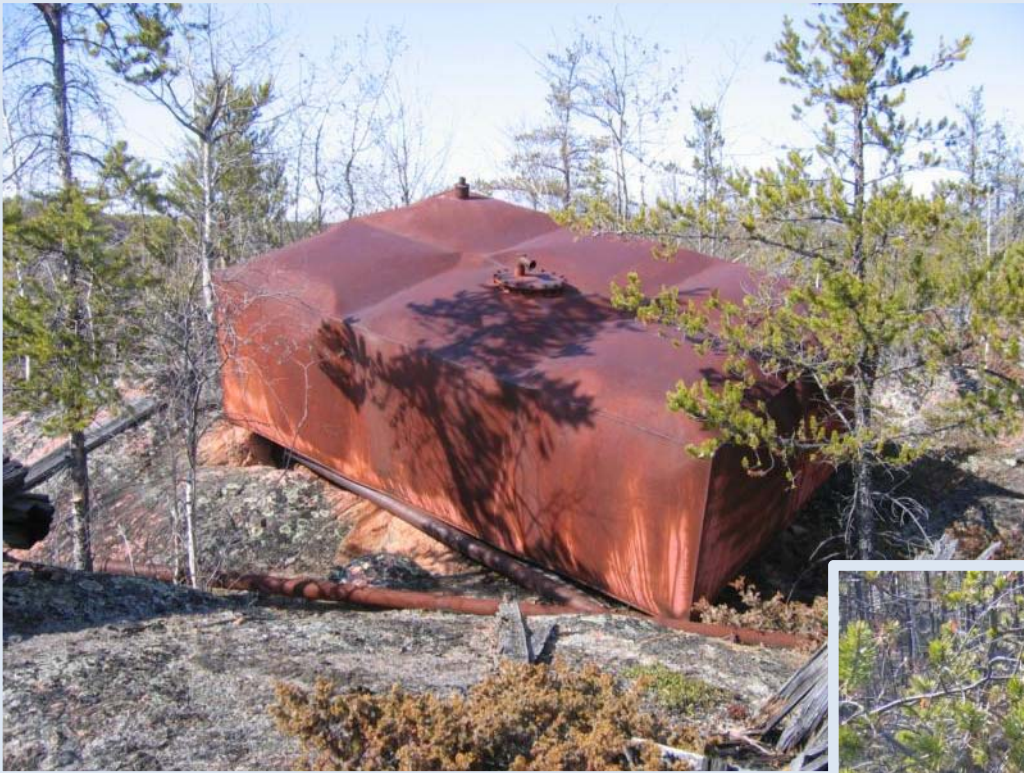
Large steel tank and steel debris scattered all over the Smitty site will be collected and buried in waste rock on site

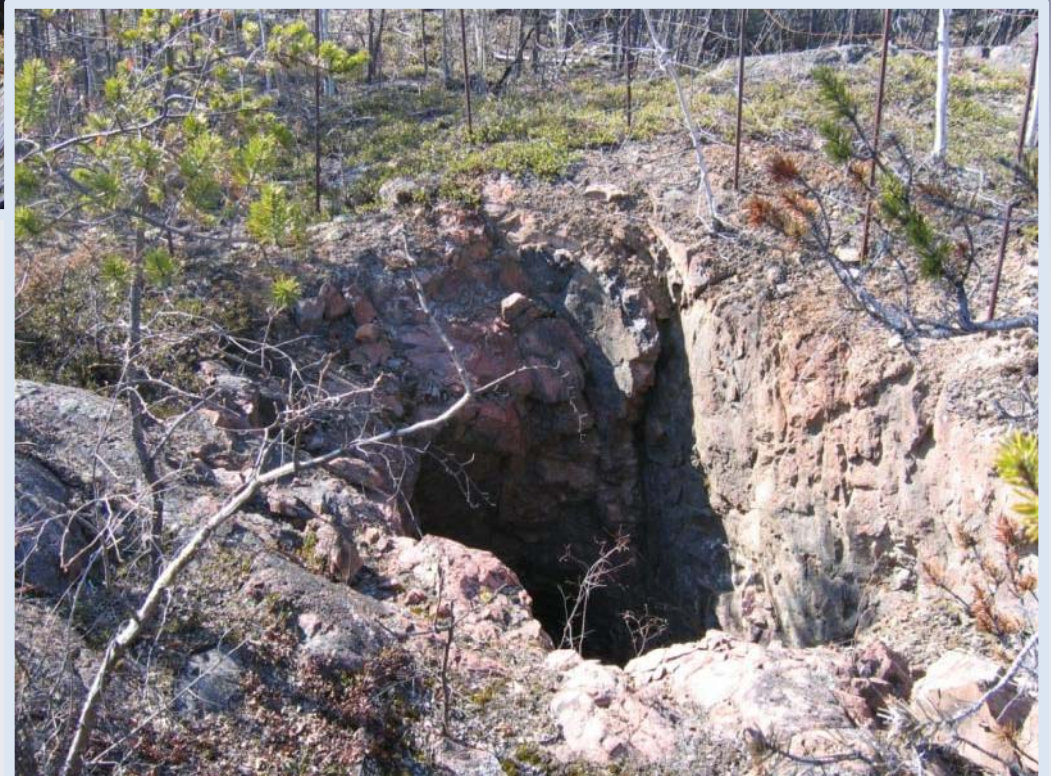
Open raise requires proper cover or plug to prevent entry
There are at least 3 similar openings on site that must be sealed
Complete gamma survey of mine site

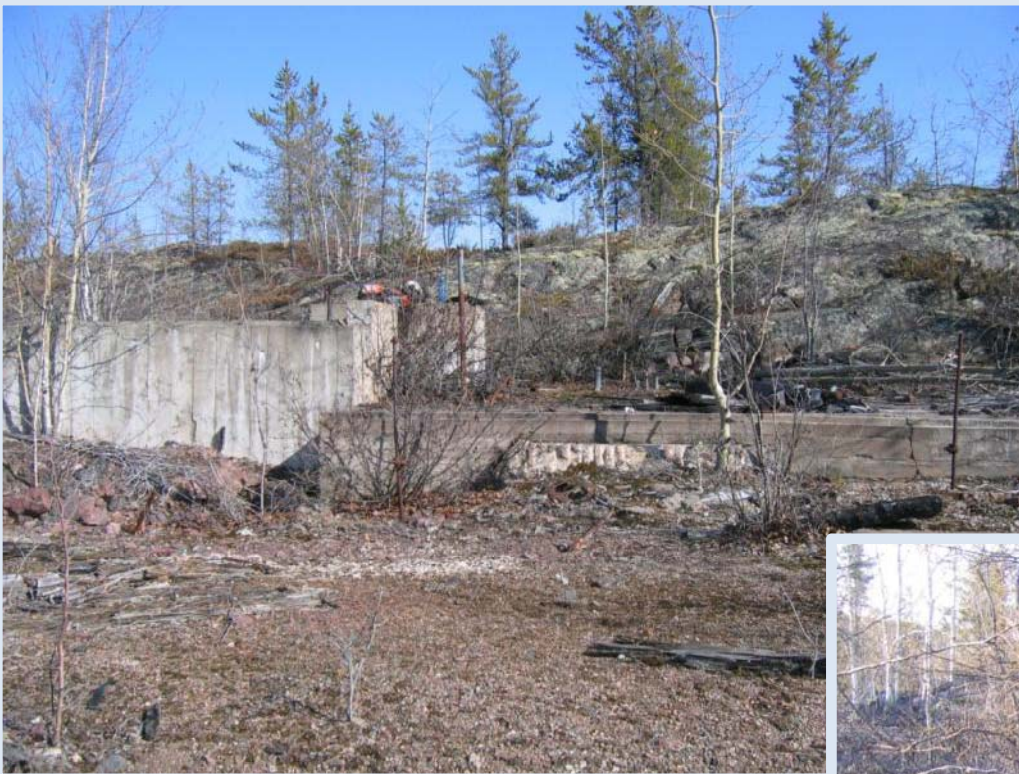
Concrete building foundations to be broken up and covered with waste rock

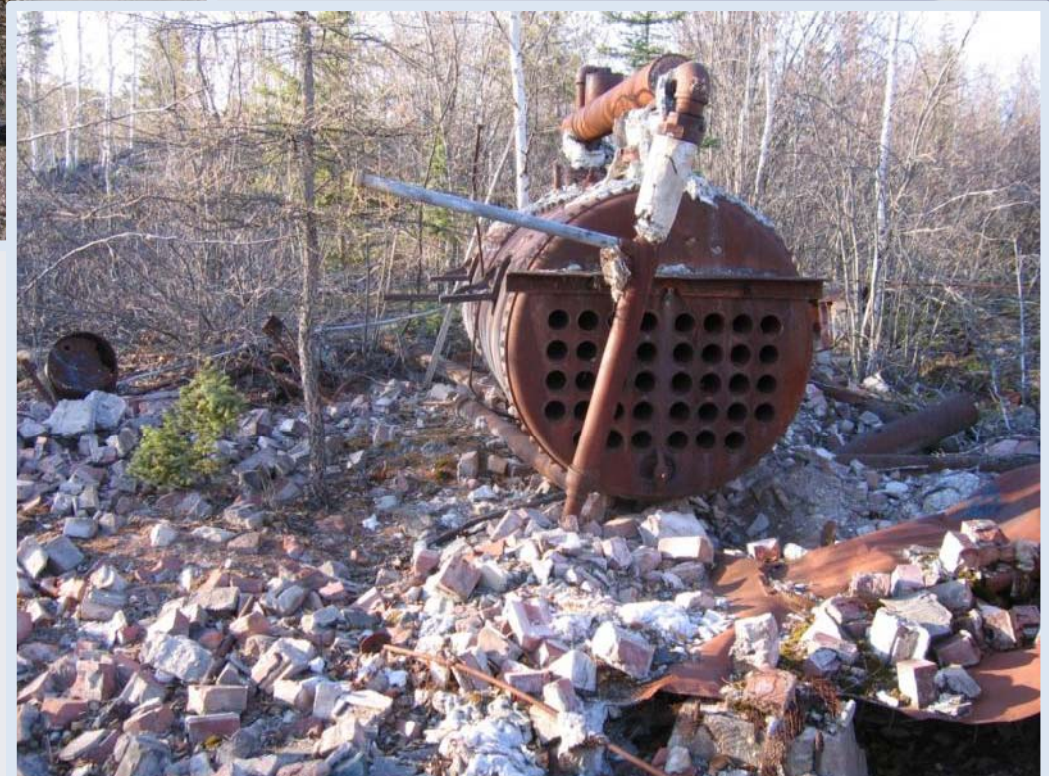
Steel boiler with asbestos wrapped pipes, asbestos to be removed, contained, and taken to the SRC fenced temporary waste storage site at Lorado pending final disposal

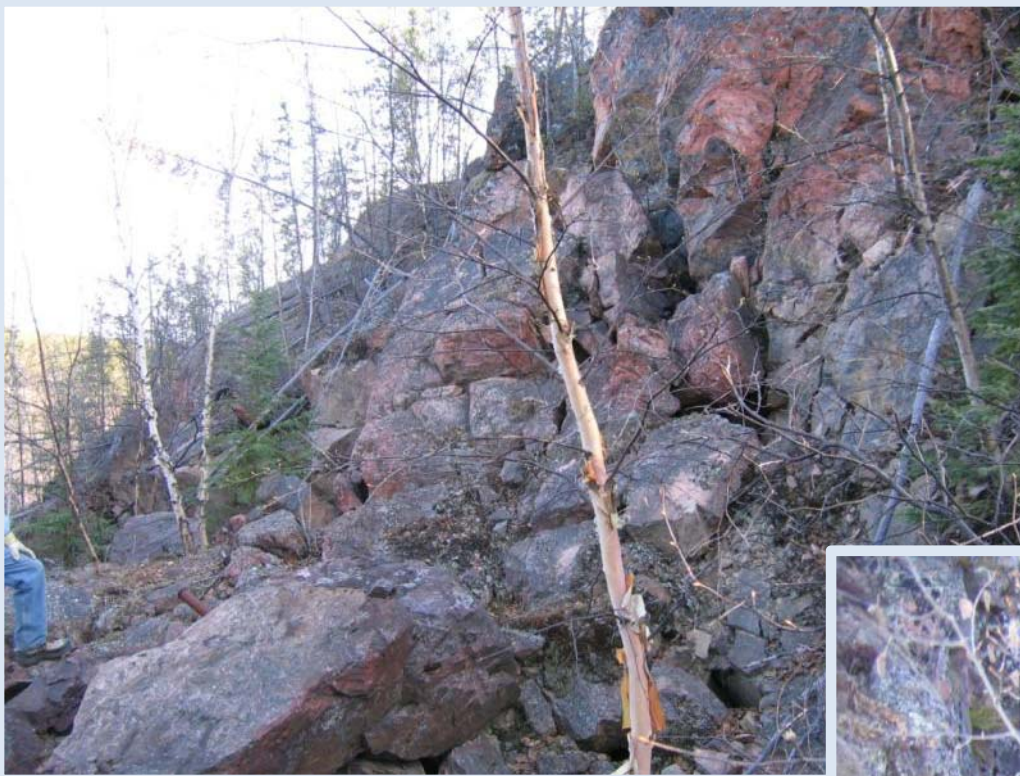
Unstable bedrock caused
by underground mining
near surface

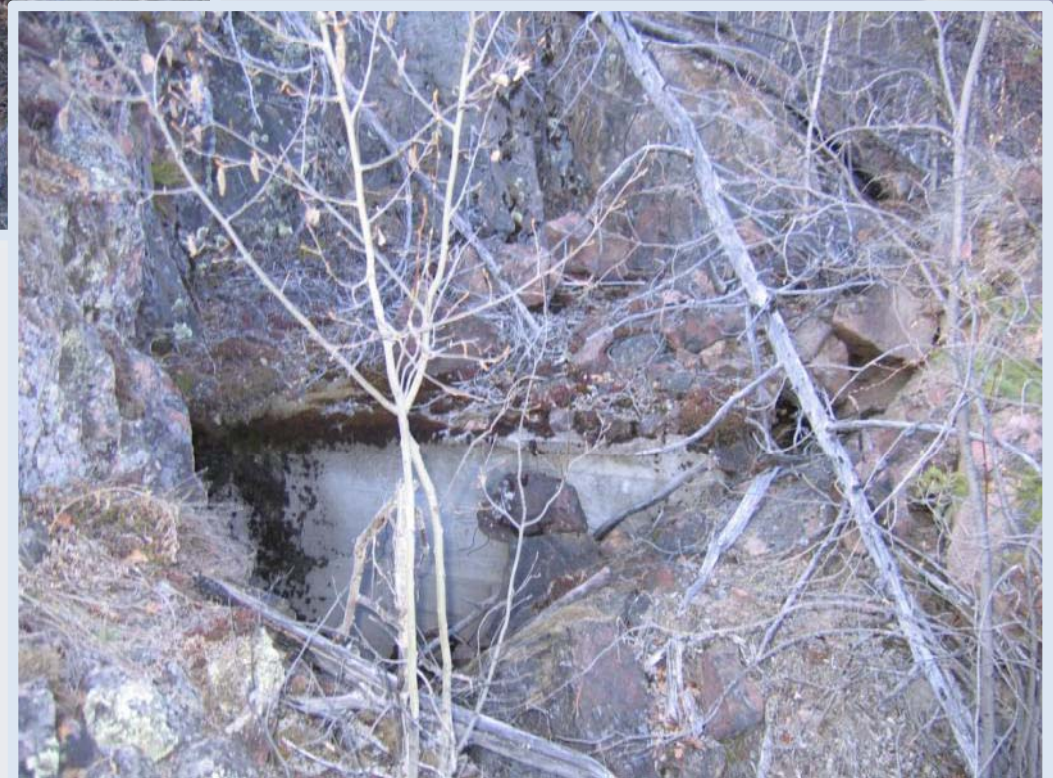
Concrete walls of adit covered by
falling bedrock, the adit is still
partially open and may require
backfilling
