Gunnar Uranium Mine Remediation – Northern Saskatchewan

**Environmental Quality
Committee (EQC)**

Project **CLEANS**

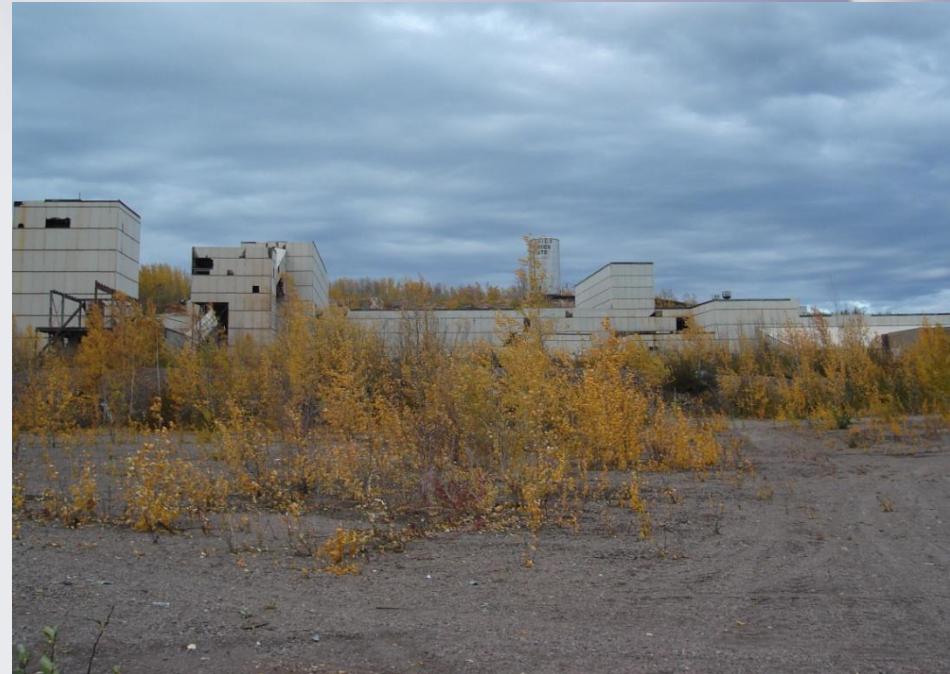
Salvaged shortly after shutdown

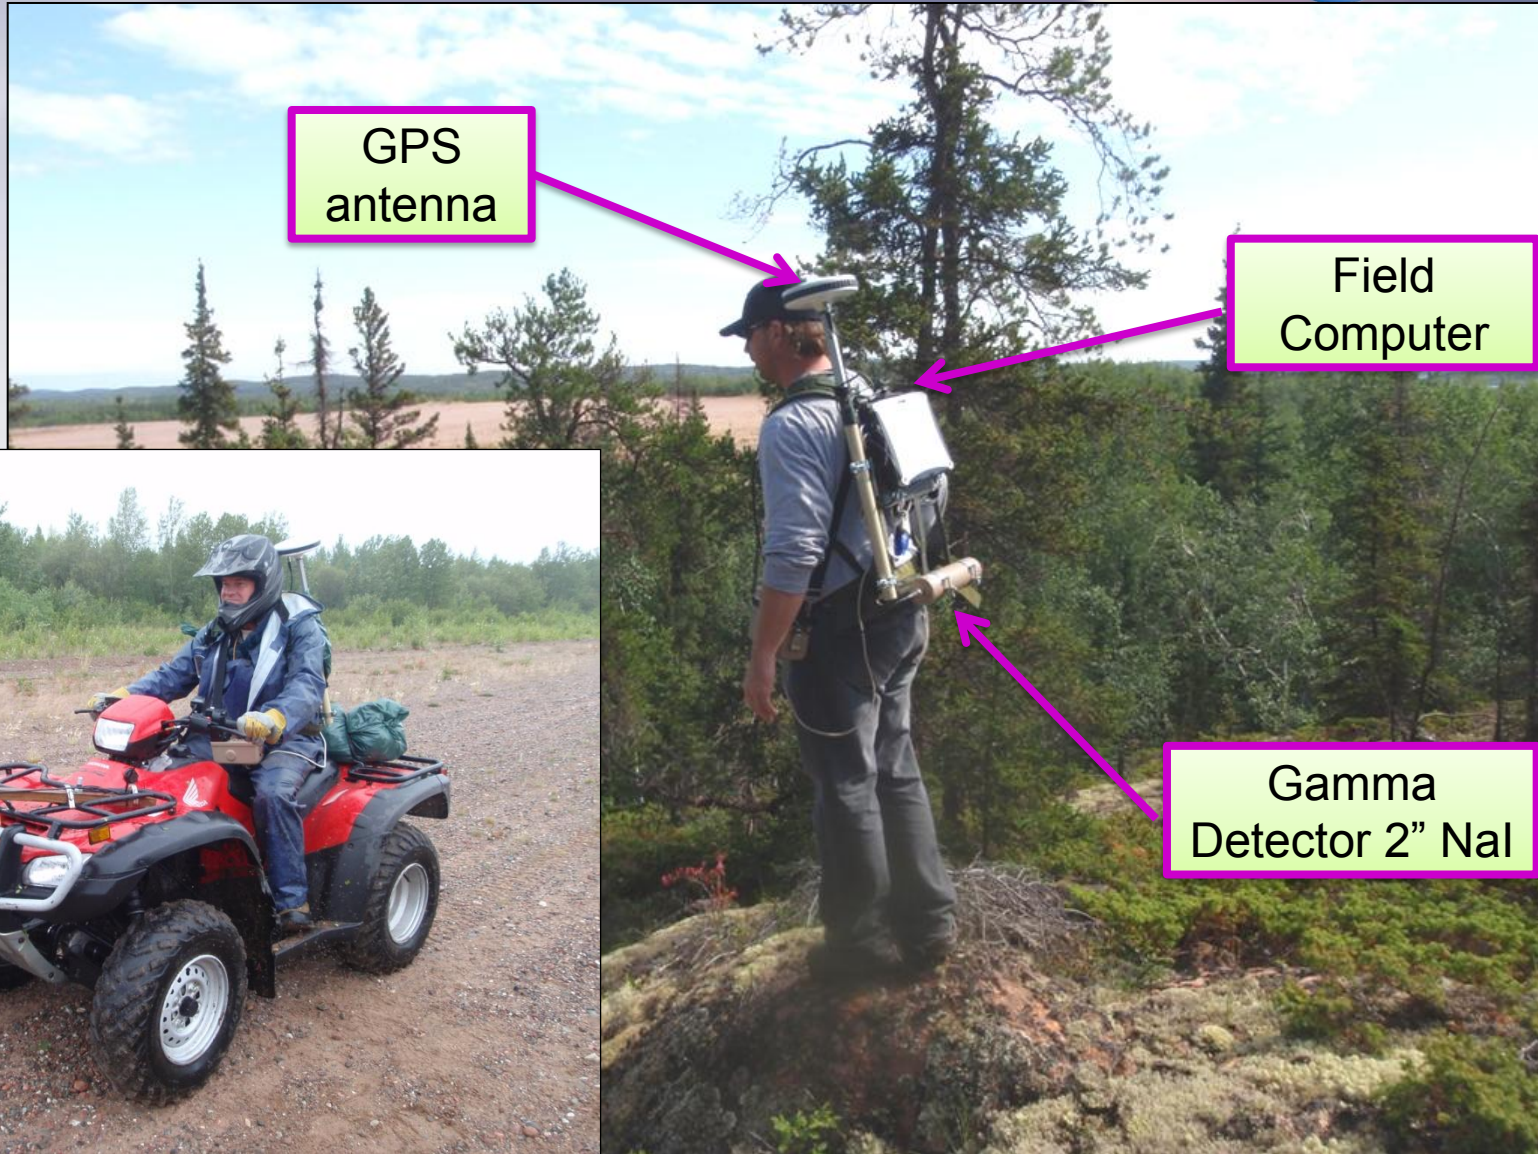
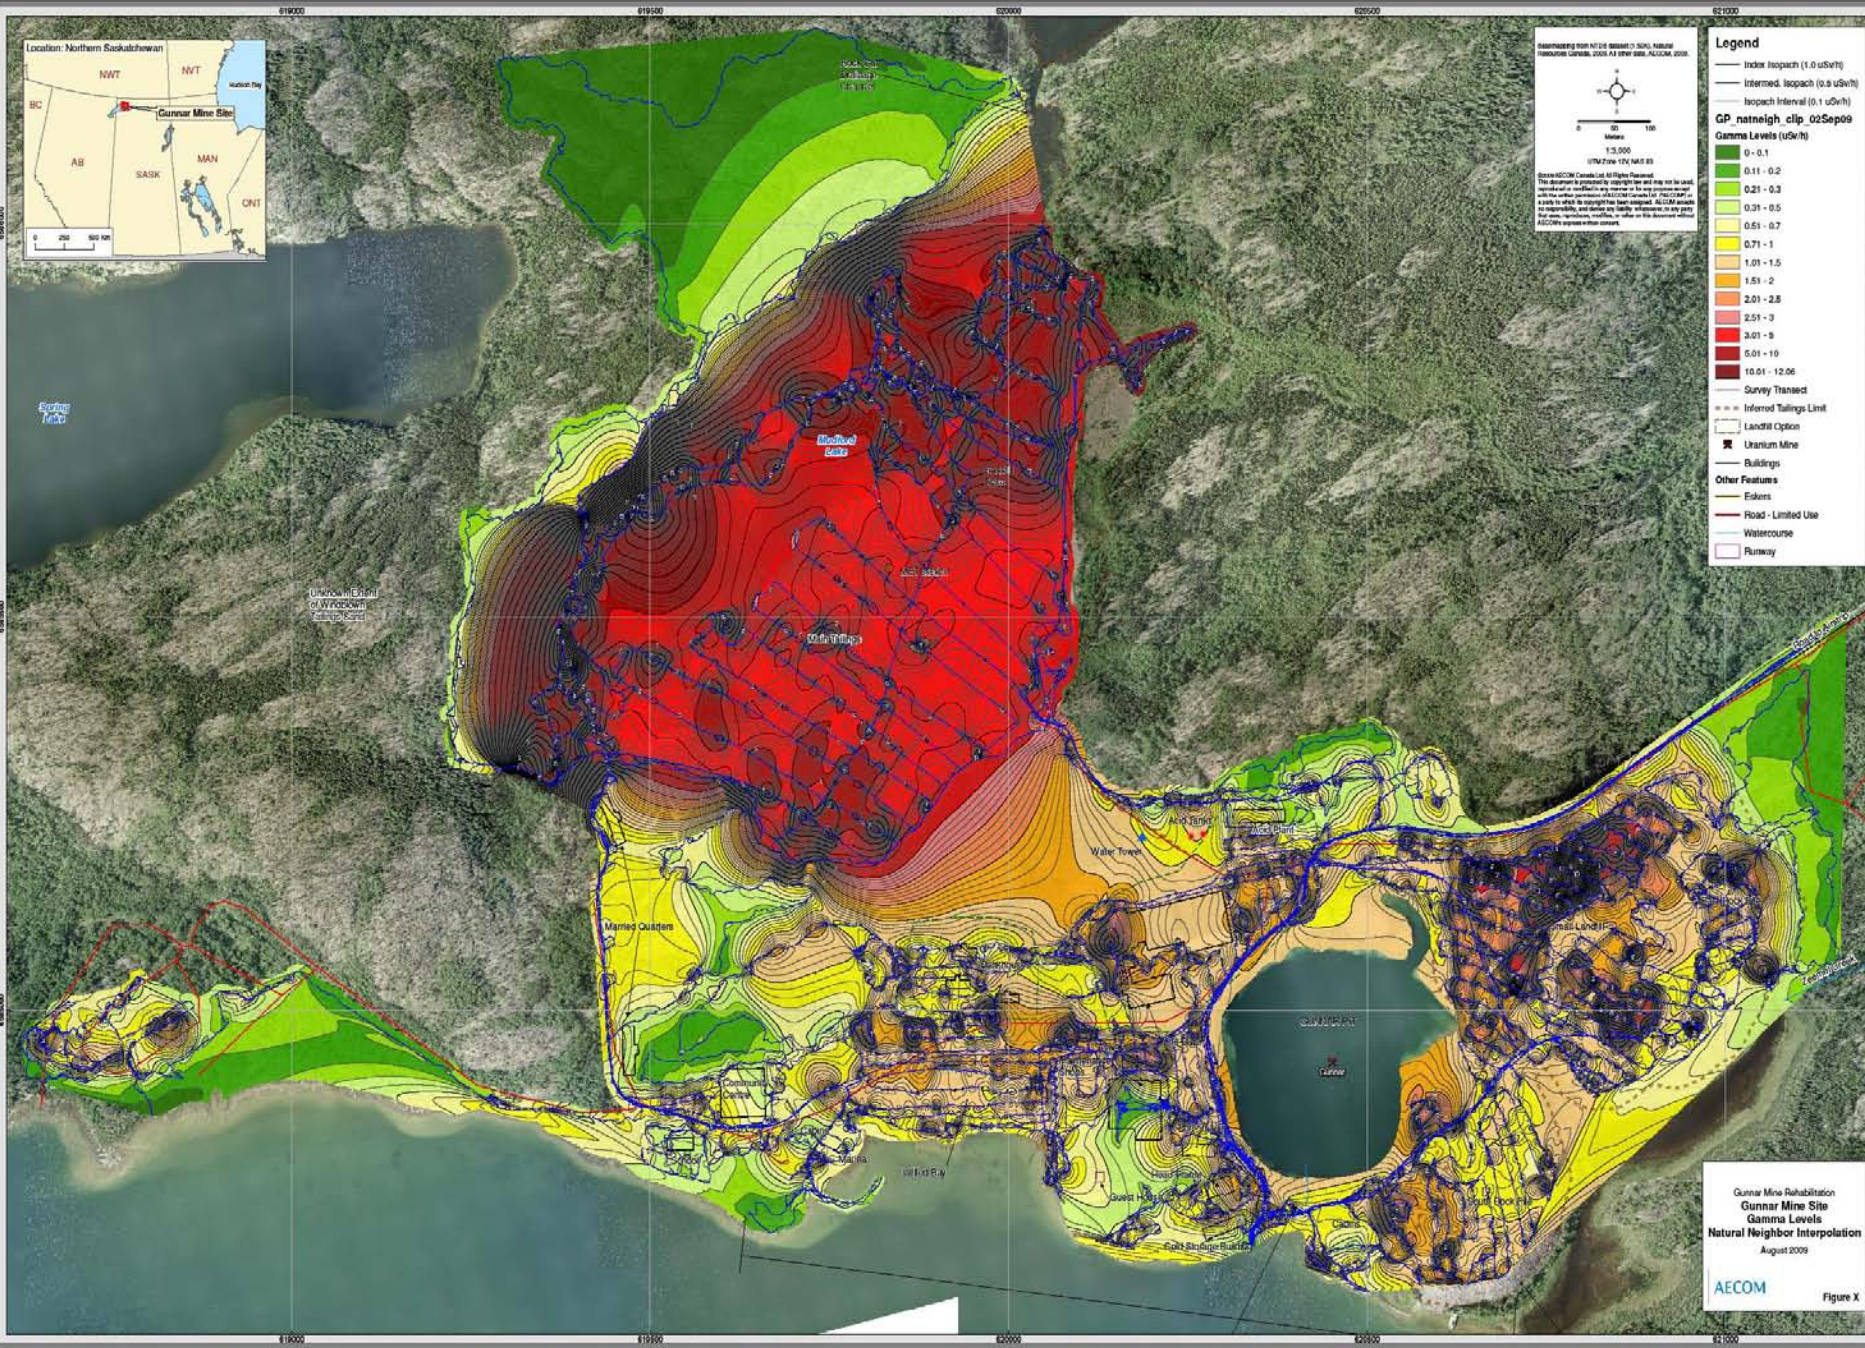
Gunnar Mine Rehabilitation
 Gunnar Mine Site
 Gamma Levels
 Natural Neighbor Interpolation
 August 2009
 AECOM
 Figure X

(reading taken every 2 seconds, over 40,000 gamma measurements collected)

- **Do nothing**
- **Relocate tailings to pit and bury (requires treating displaced pit water)**
- **Bury in place with sand and gravel**
- **Bury in place with waste rock**

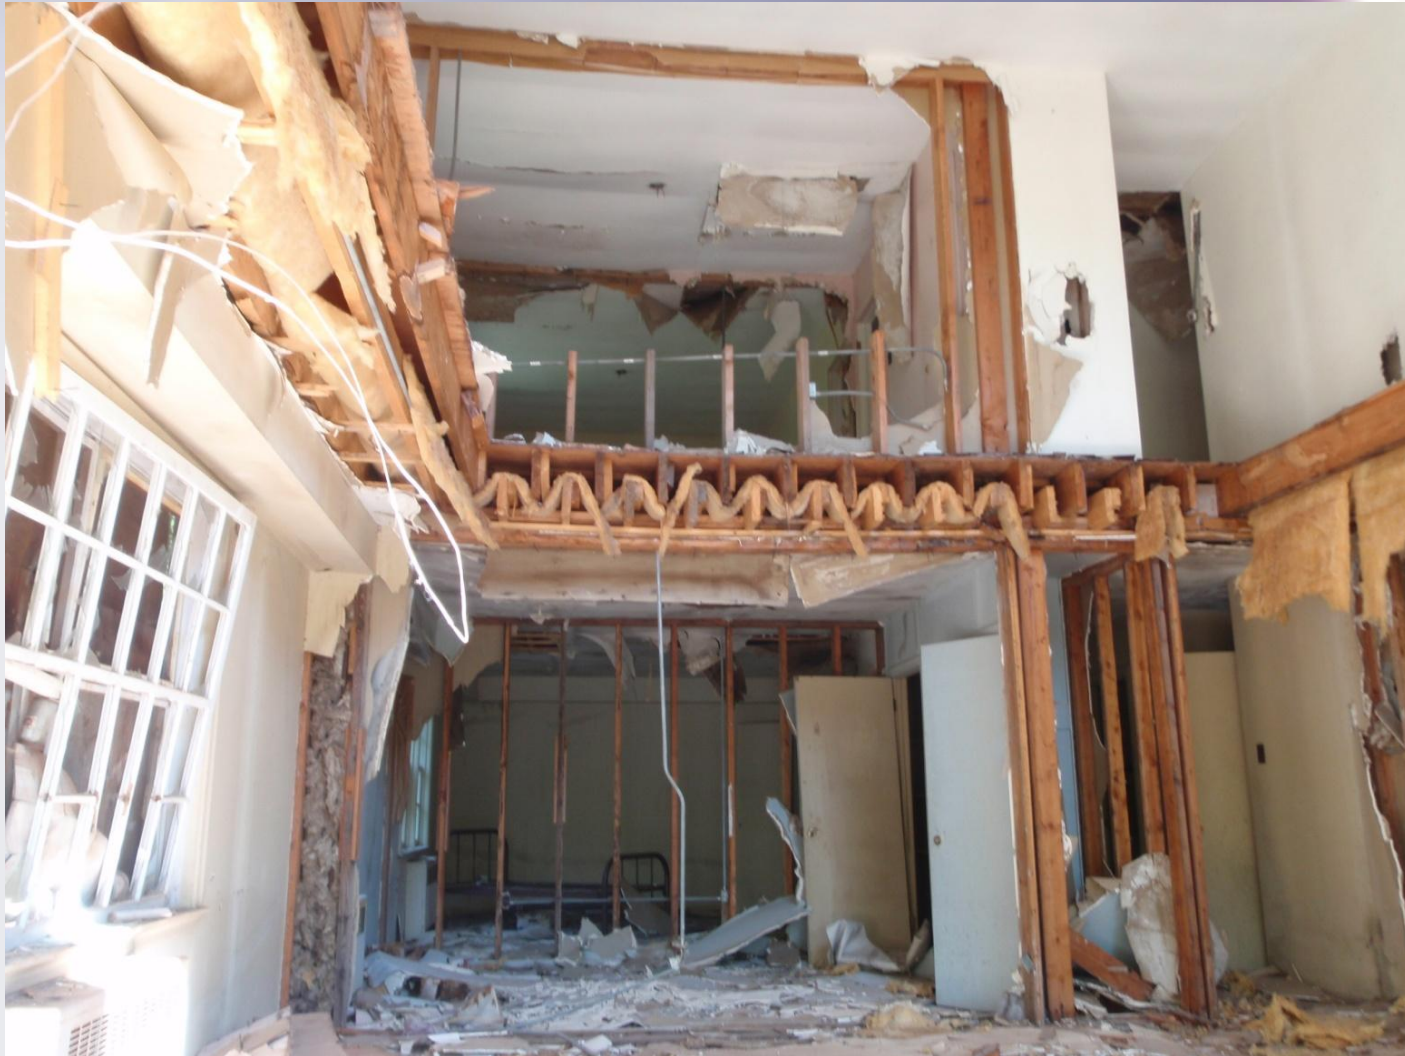
Unauthorized salvage

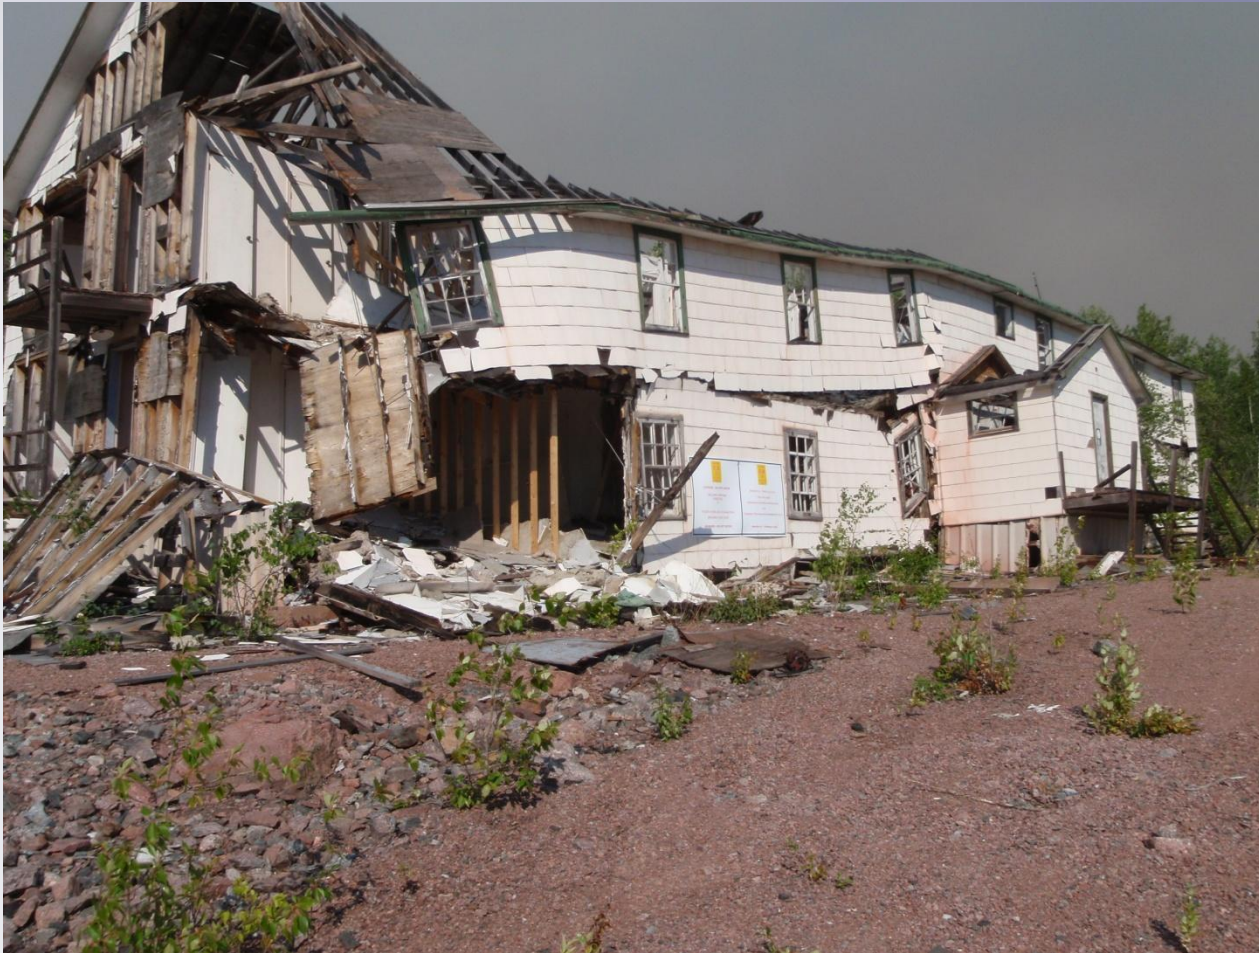
Buildings structurally unsound

Many of the residence buildings are in very poor condition

- **Underwater Disposal**
 - Gunnar Pit**
 - Lake Athabasca (unlikely)**
- **Single Landfill**
- **Multiple Landfills (three)**
- **Hauling metal off-site**
- **Mine monument?**
- **Others?**

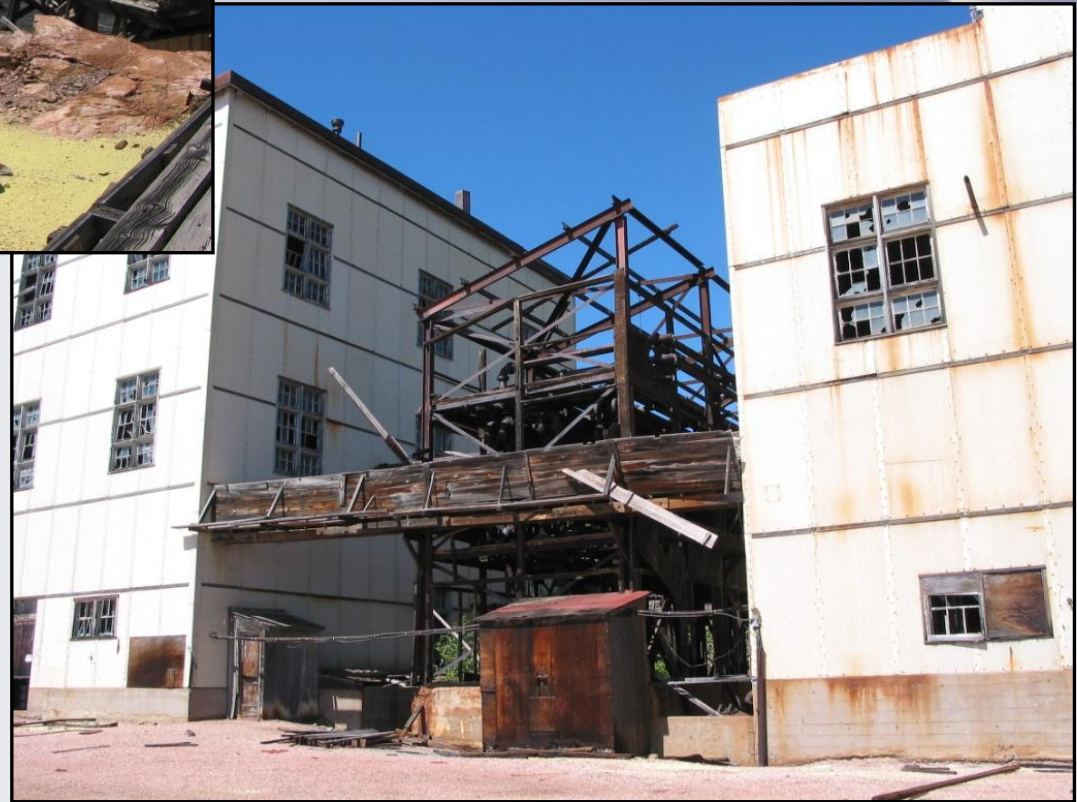
**Acid Plant
corroded and
structurally unsound**

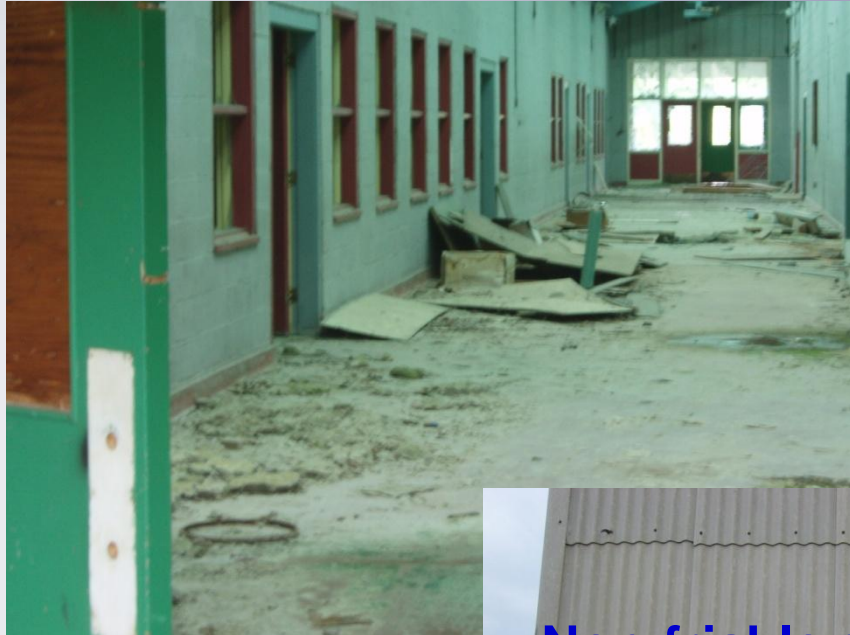
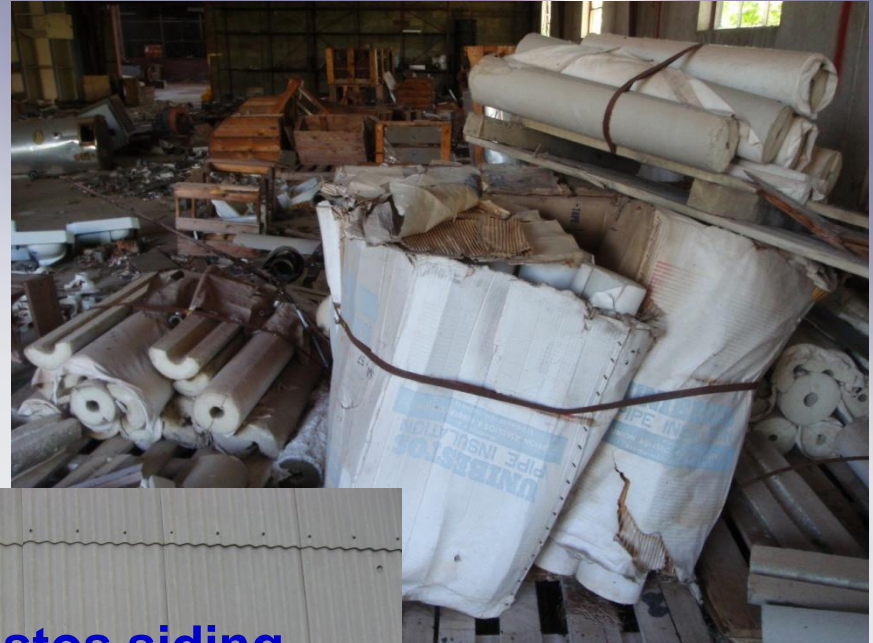
Friable -spray on asbestos insulation & pipe insulation

**Asbestos requires
specialized
handling and
disposal
techniques**

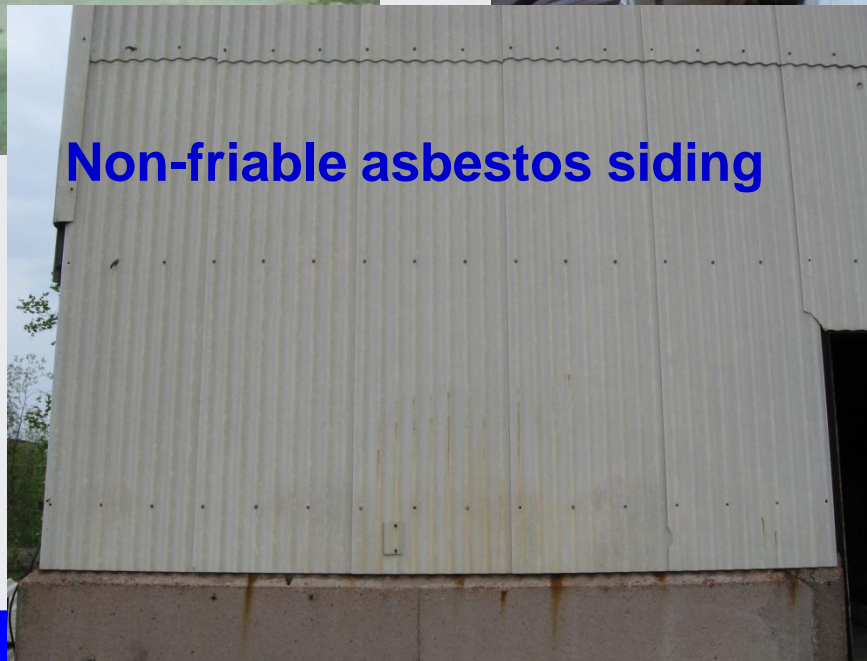
Non-friable asbestos siding

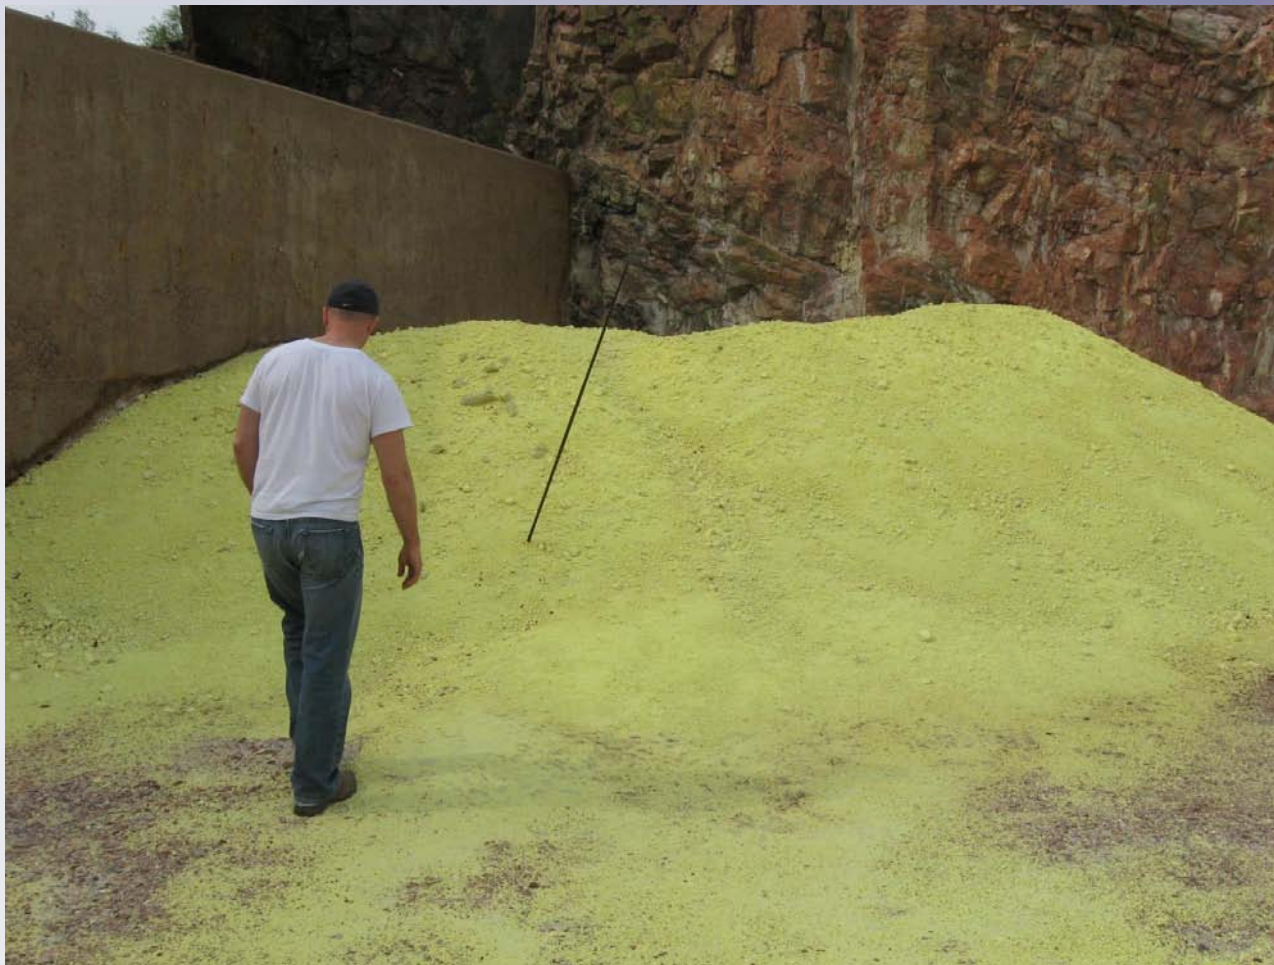
Sulphur, barged in from Alberta, was used to make sulphuric acid required in the refining process. Several cubic metres of sulphur still remain on site

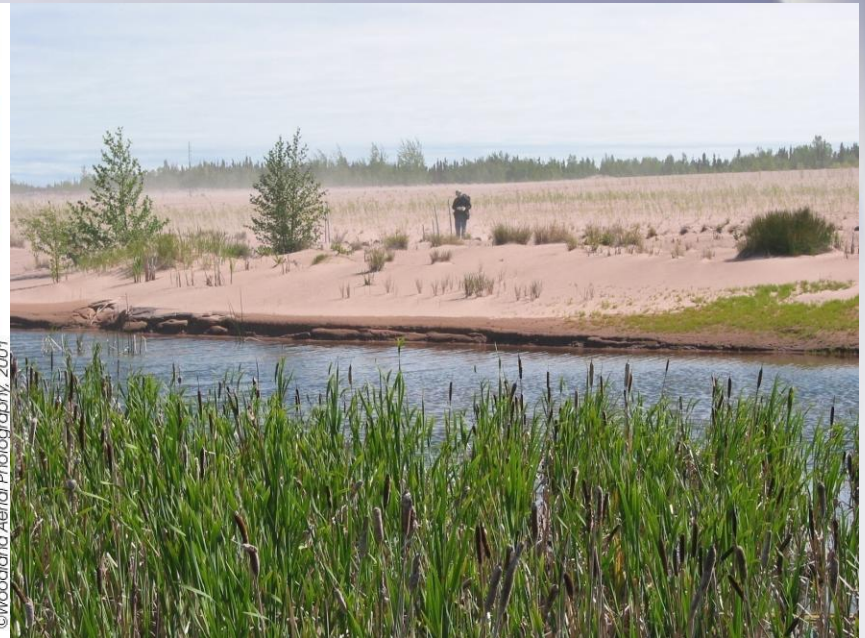
**Water pond on Gunnar Main
(note wind blown dust)**

- Do nothing
- Natural Controls and Re-vegetation
- Water/Rock Cover/Borrow Material cover
- Impermeable Engineered Cover
- Use of constructed wetlands – next slide
- Combinations of above
- Others?

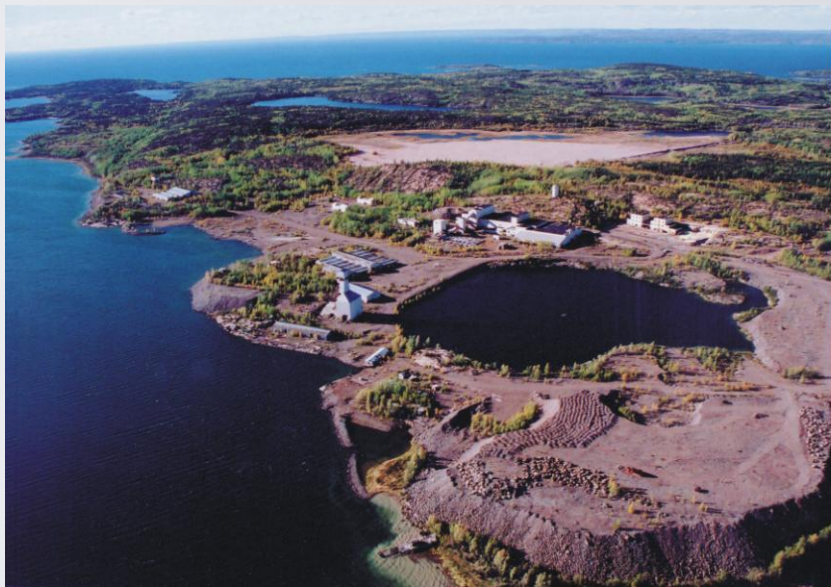
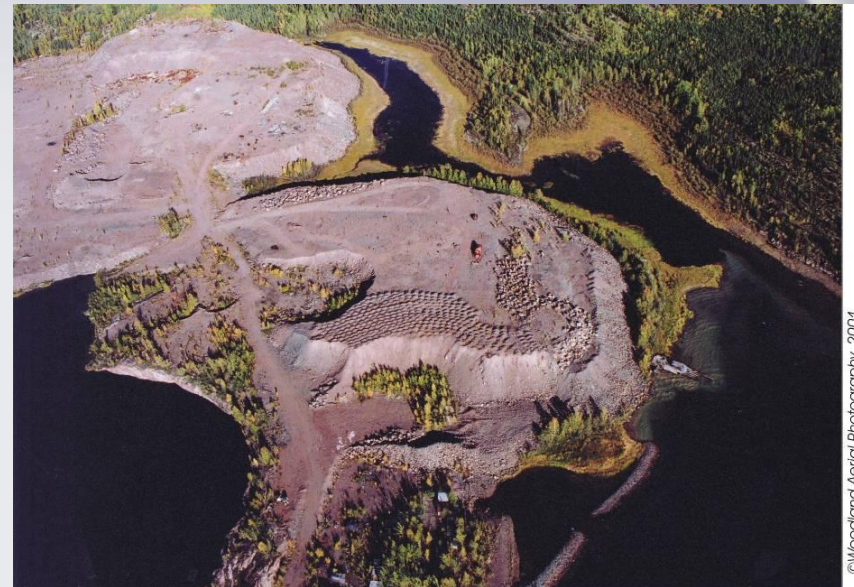
2.7 million m³ of waste rock located adjacent to the shore of Zeemel Creek and Lake Athabasca

- **Do nothing**
- **Contouring**
- **Engineered Cover**
- **Move part of the piles away from Lake Athabasca**
- **Reroute Zeemel Creek**
- **Others?**

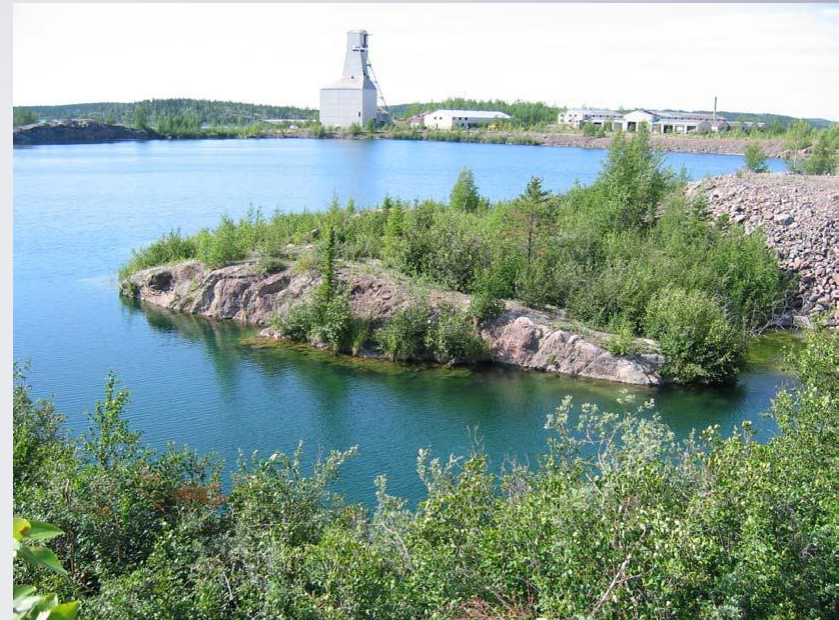
Gunnar Pit today

Flooded and supporting
a population of northern
pike

- **Do nothing**
- **Stabilize the sides of the pit**
- **In-filling of pit with mine buildings**
- **In-filling of pit with tailings**
- **Treatment of displaced pit water if pit in-filled**
- **Addressing the water seepage issue**
- **Other?**
