APPENDIX 1

GUNNAR AND LORADO DETAILED INFORMATION

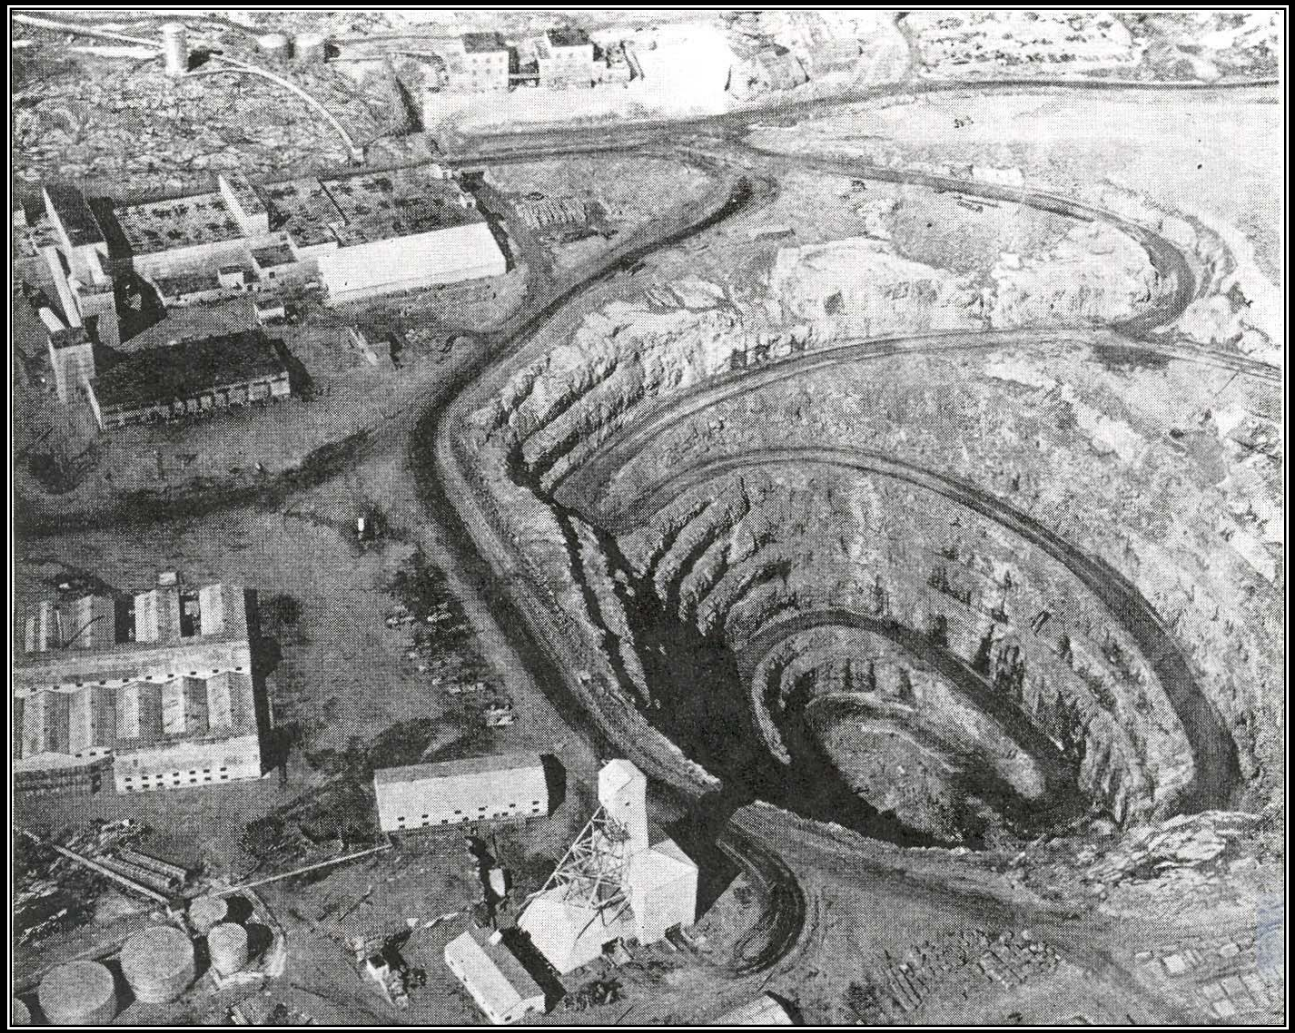
Figure 4 Gunnar Mining Ltd. Open Pit (Circa 1962)

The open pit was 1000 feet (304 m) long, north to south, and 800 feet (244 m) wide. The final depth was 380 feet (116 m), which was 360 feet (110 m) below Lake Athabasca surface levels (see Figure 4). The upper walls of the pit were generally mined in granite gneiss.

The north wall of the pit followed closely the footwall of the ore body resulting in the bulk of waste rock being produced from a large crescent-shaped mass in the south end of the pit decreasing in size with depth. The rock was mined in 30-foot vertical benches with a 21-foot berm on each bench. As a result, the wall angle was approximately 55° except where modified by haulage roads.

This pit design required that a substantial tonnage of ore in the south wall of the pit be lost to pit mining and left for recovery from underground. When experience proved the walls to be very competent, particularly on the south side of the pit, the design was modified to permit removal of the berms on this side on the lowest five benches of the pit. As a consequence, the south wall of the pit was left as a vertical face for a height of approximately 150 feet. This modification, plus the removal of a bottom bench below original design specifications, improved the overall waste:ore ratio from 2.48:1 to 1.83:1.

The open pit was located very close to the shores of Lake Athabasca. The rim of the pit was separated from Lake Athabasca by a bedrock ridge approximately 2 m wide and 6 m long. In spite of this close proximity to the lake and the fact that the pit extended to a depth of approximately 116 m, there was little subsurface flow from the lake to the pit or to the underground workings of the mine. During 1963, when underground development below the pit bottom essentially reached the maximum depth, pumping from underground averaged only 75 gallons per minute, which included the ingress of water from backfilling with tailings (Botsford, 1963).

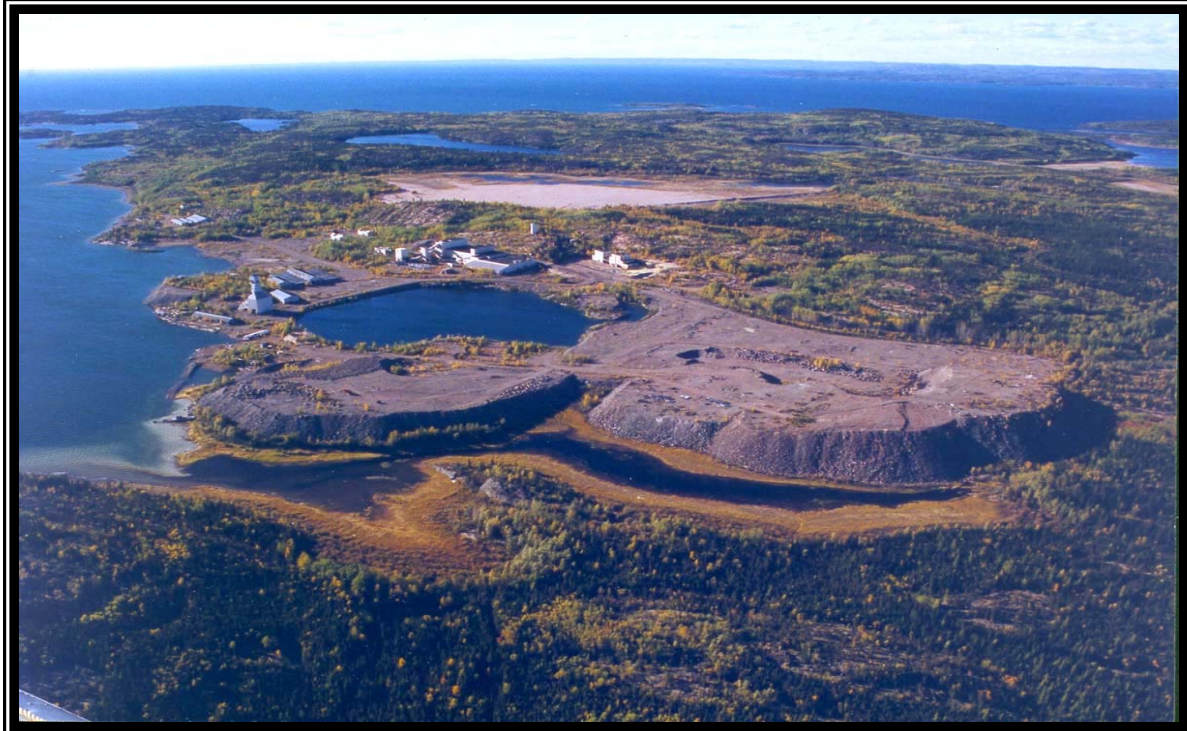
Figure 5 Gunnar Site (circa 2004)

Shortly thereafter, the blasting of a narrow, relatively shallow trench between the pit and the lake itself breached the narrow bedrock ridge that separated the open pit from Lake Athabasca. As a result, water from Lake Athabasca was allowed to flow directly into the open pit, eventually flooding the underground workings as well as the pit itself. The channel to the lake allowed the free movement of water (and presumably aquatic organisms) between the lake and the flooded pit until 1966 when the channel was blocked by filling it with waste rock.

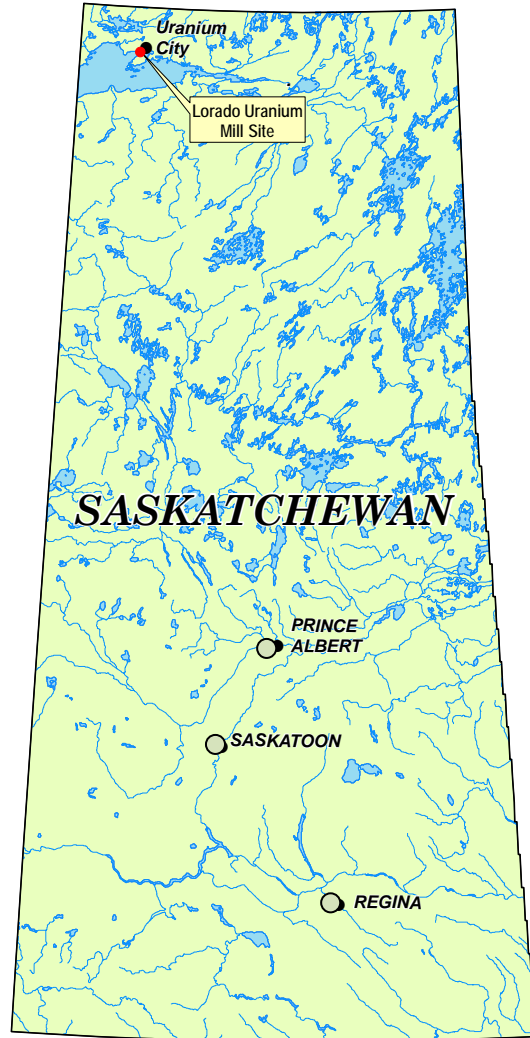
Figure 7 Location of Lorado uranium mill site

Figure 7 indicates the location of communities, First Nations lands, and parks in the region. Communities within 100 kilometres of the Lorado mill site include: Northern Settlement of Uranium City, Northern Settlement of Camsell Portage, and Fond du Lac Denesuline First Nation. First Nations lands located within the 100 kilometres radius include Fond du Lac in Saskatchewan and Collin Lake in Alberta.

The Lorado mill site is located just north of Lake Athabasca in the northwest part of Saskatchewan, (59°31'10"N, 108°41'40"W), approximately 830 kilometres north of Saskatoon (Figure 6).

There is a small refuse area associated with the construction, operation, and decommissioning of the Lorado mill facility located approximately 1.5 kilometres beyond the mill site that may require remediation pending an inventory of refuse contained at the site (see Figure 7).

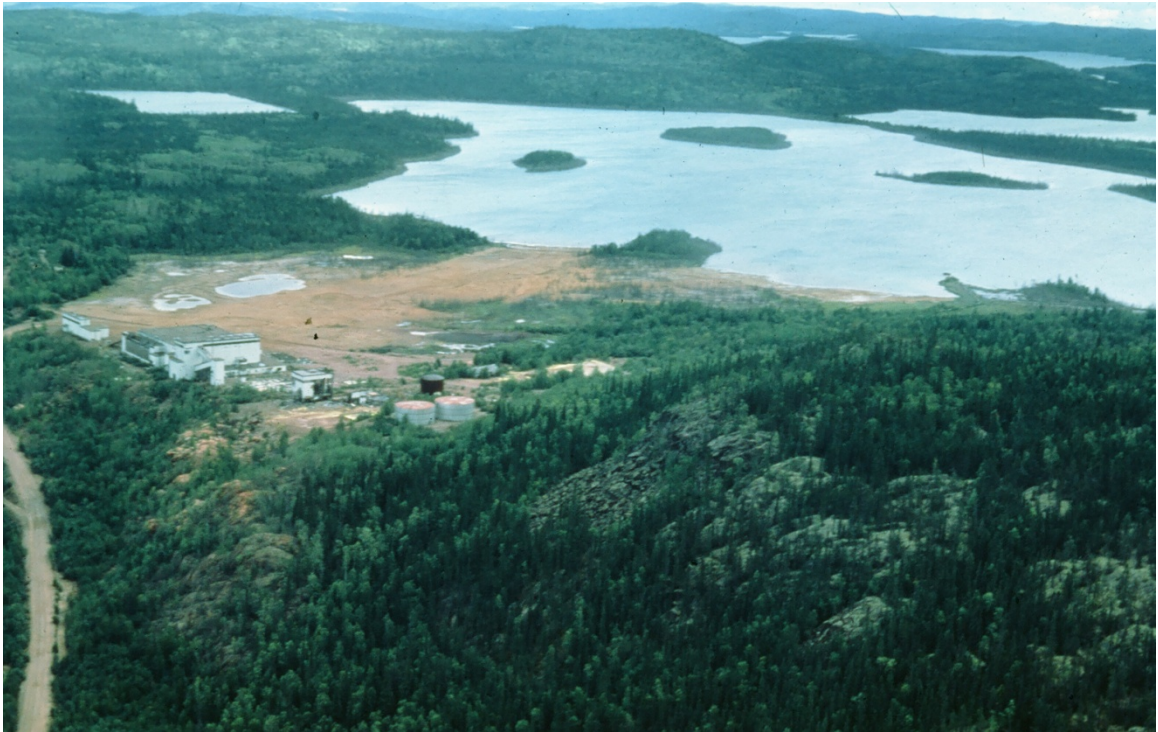
Photo 1: Lorado mill and tailings looking east towards Nero Lake (circa 1978 - prior to mill dismantling)

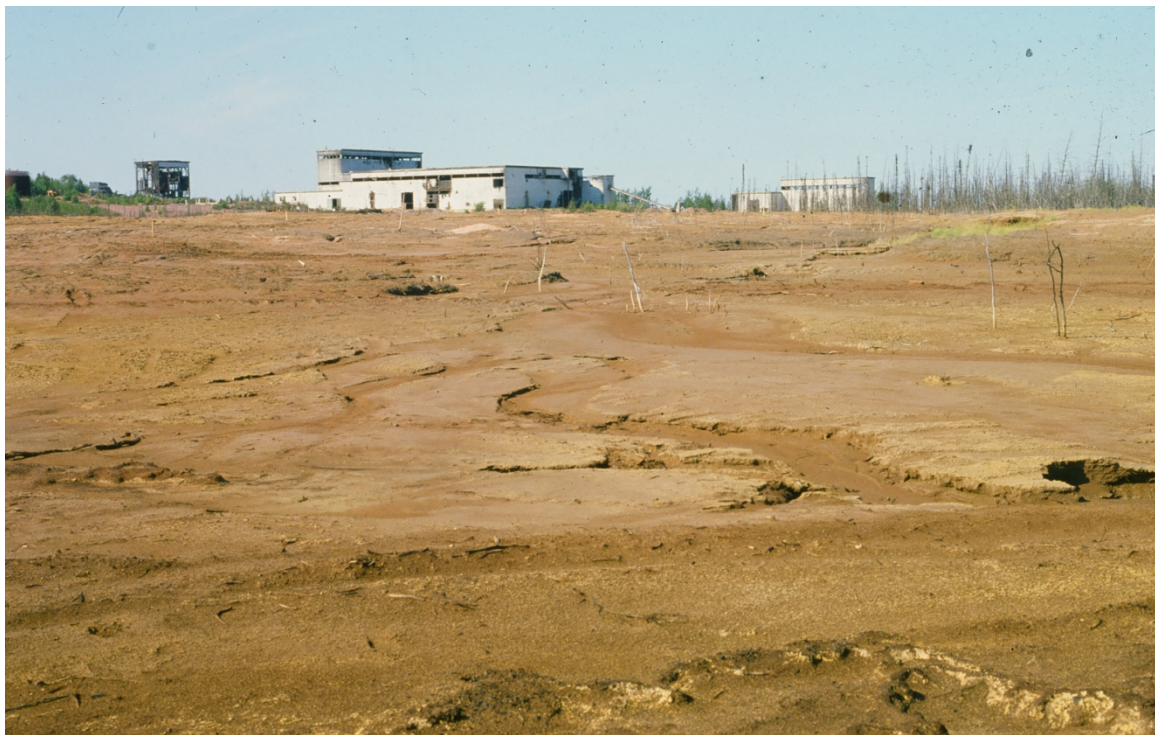
Photo 2: Lorado mill and tailings looking west (circa 1978 - prior to mill dismantling)

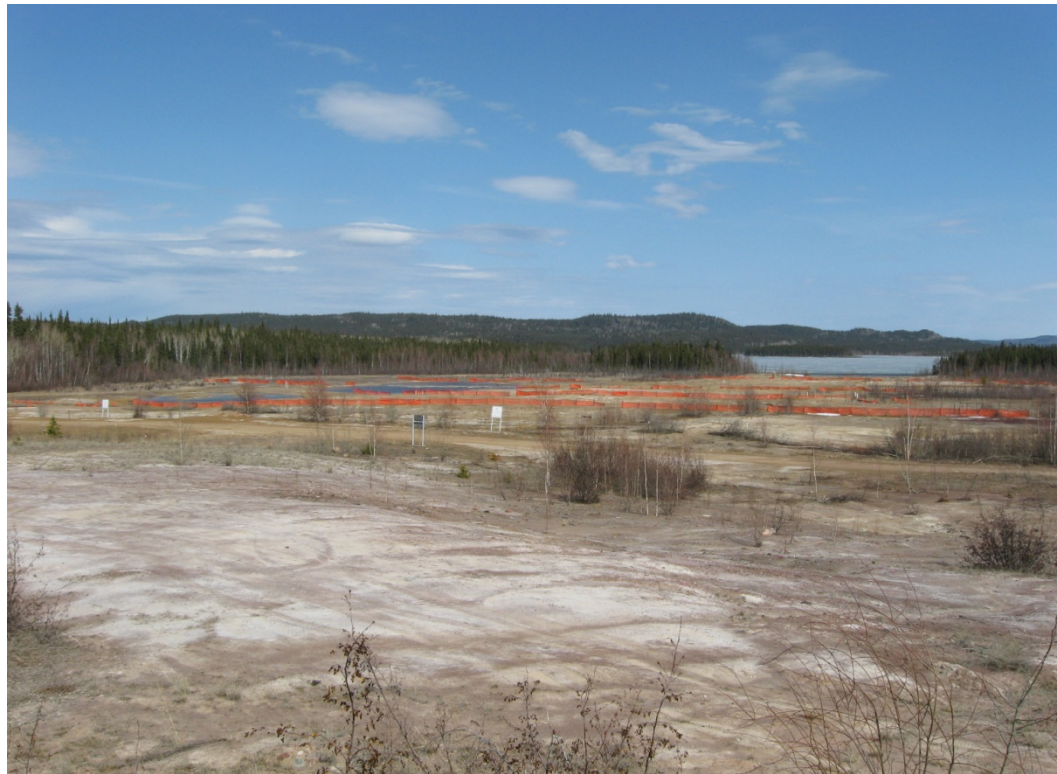
Photo 4: View of exposed tailings from former mill site towards Nero Lake (2007)

The Lorado tailings, for the most part, are not covered with vegetation, making them susceptible to wind erosion. In an attempt to reduce windblown tailings, an array of dust control fencing was placed on the exposed portion of the tailings area during the summer of 2004. These measures were reported to be effective in the reduction of blowing tailings. In 2008, SRC took action to repair several sections of the dust control fencing which had become dilapidated.

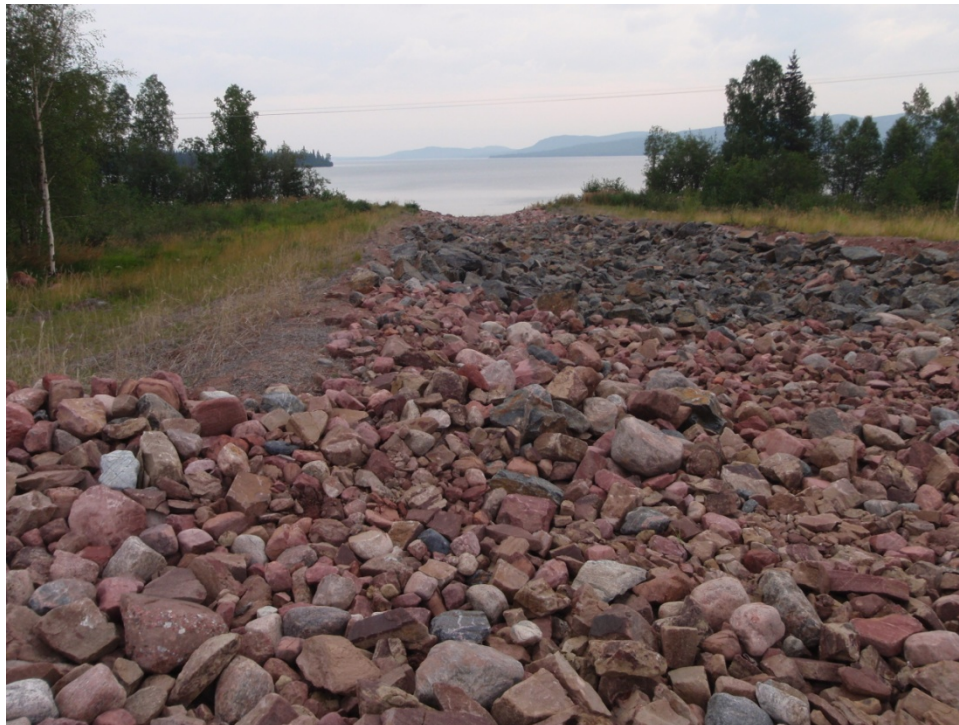
**Photo 6: Photo of armored spillway constructed to improve land bridge stability
(looking towards Beaverlodge Lake)**

There are a number of ways that water from Nero Lake can enter Beaverlodge Lake. Migration can occur through a partially collapsed culvert that exists underneath the road on the top of the bridge, or by water splashing over the bridge during high water levels, or as groundwater seepage through the upper till fill and the lower pink till. An investigation of the bridge of land roadway between the lakes was undertaken by a consultant working for Saskatchewan Environment in 2001. The investigation concluded that the culvert did not ensure peak flood events can be readily and safely passed from Nero Lake to Beaverlodge Lake. As a result, rehabilitation of the berm was undertaken in 2005/06 (see Photo 6).
