Project CLEANs Public Meeting Ben McIntyre School, Uranium City April 29, 2010 1:00 pm

PROJECT CLEANS:
*Satellite Remediation Completed in
2009*

Project CLEANS Group 3 Satellite site Remediation Proposed for 2010

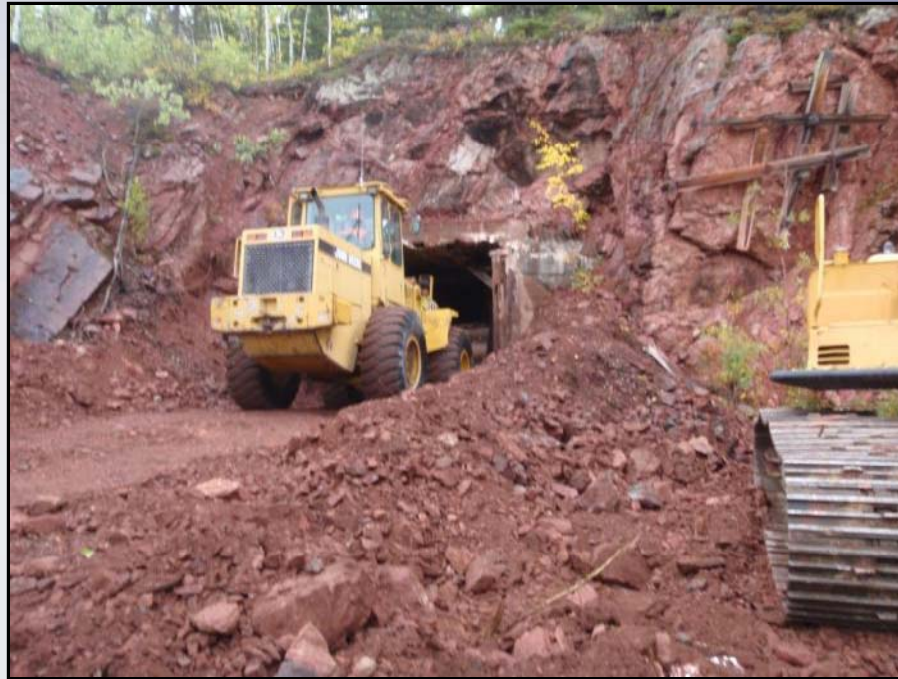
(left) Backfilling of the 1st adit

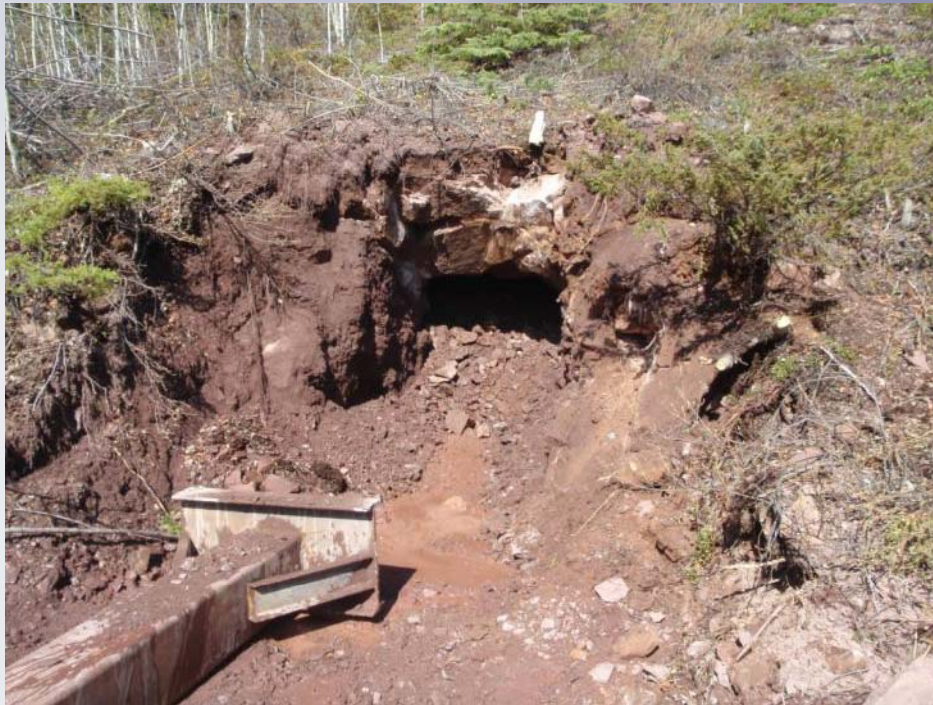
(left) backfilling of adit #1.

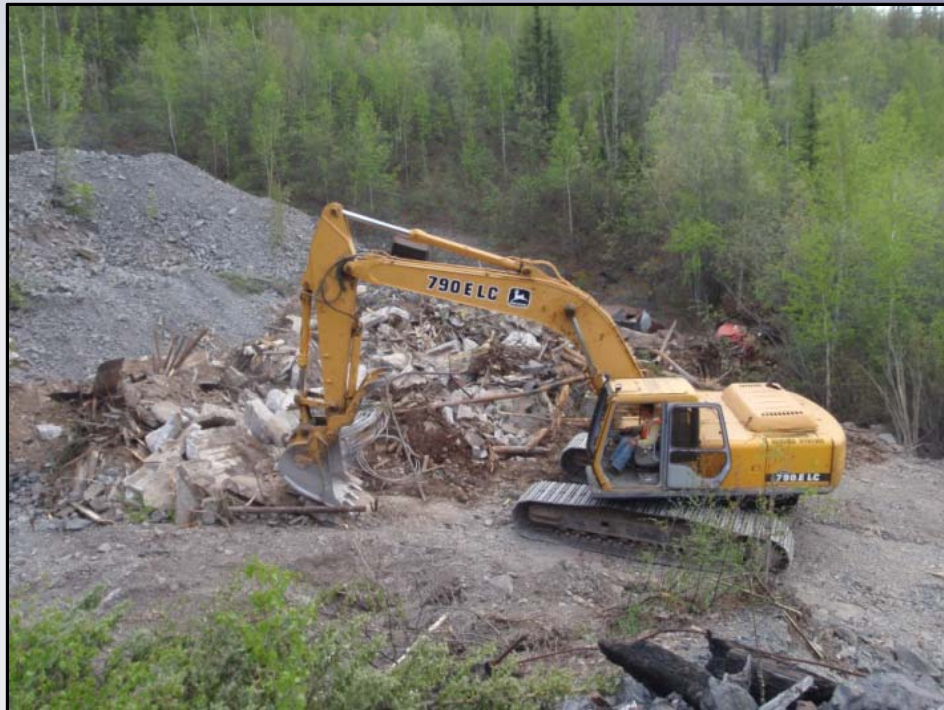
(left) debris disposal area

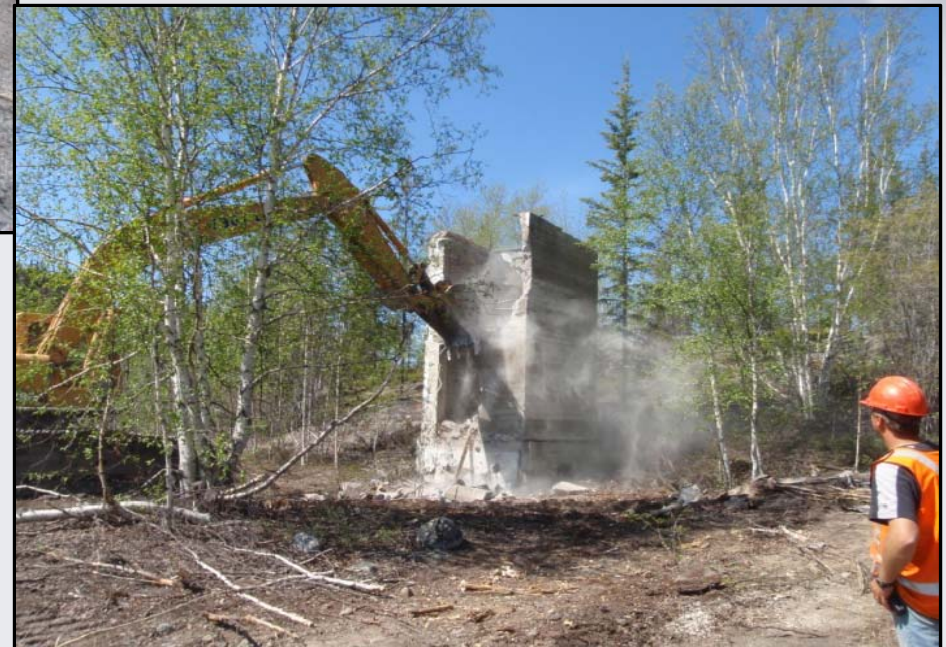
(right) demolition of 2 storey concrete structure

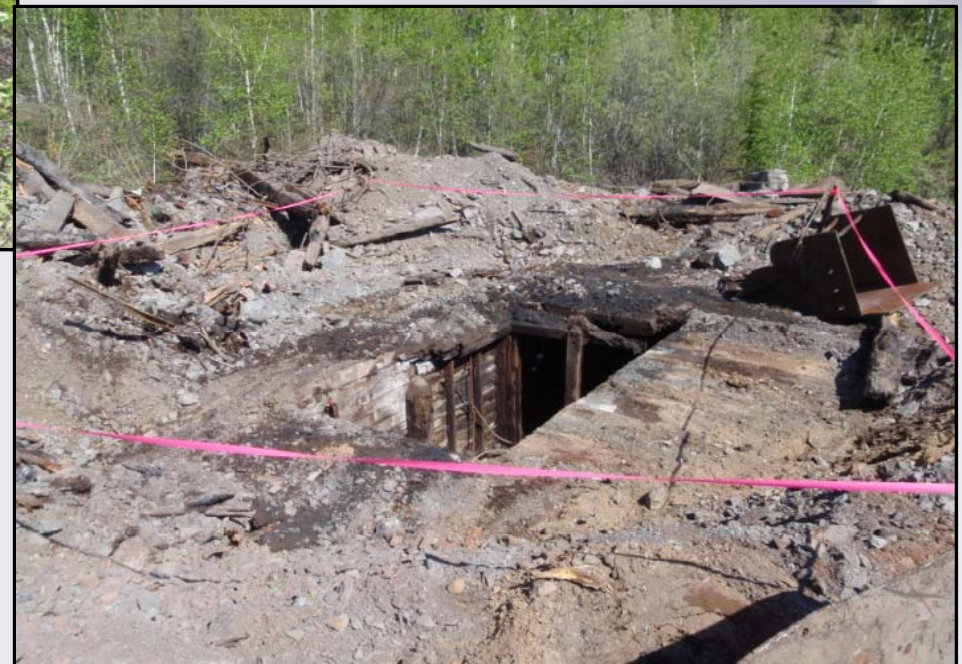
(right) debris removed from
shaft opening.

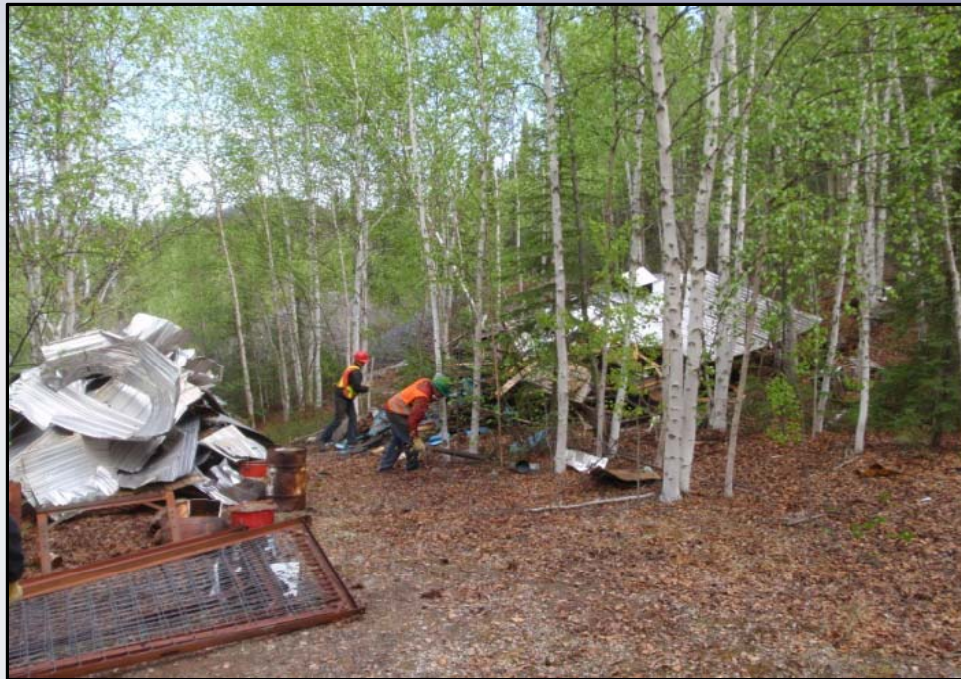
(left) dismantling of the tin shed

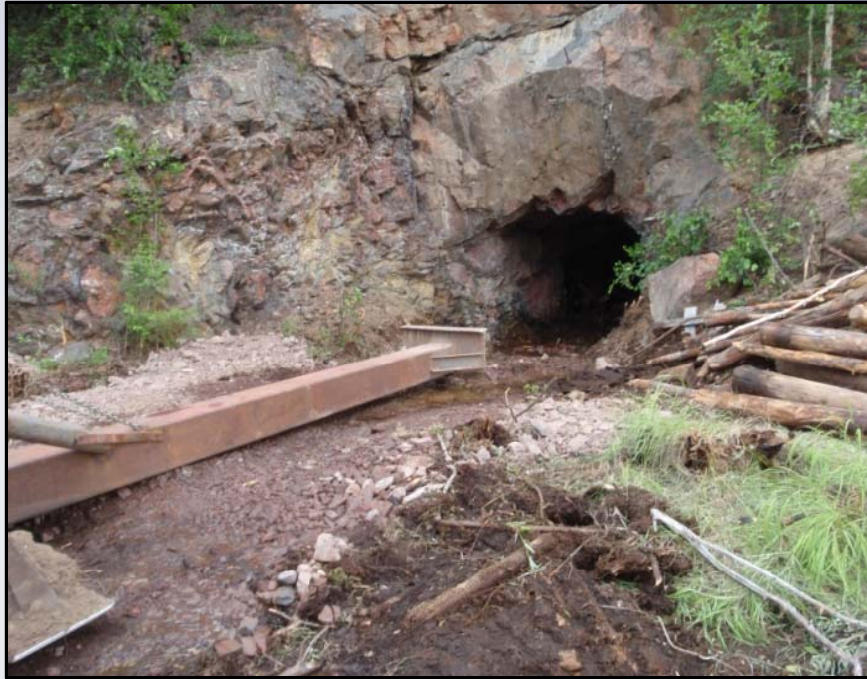
(left) adit opening prior to backfilling

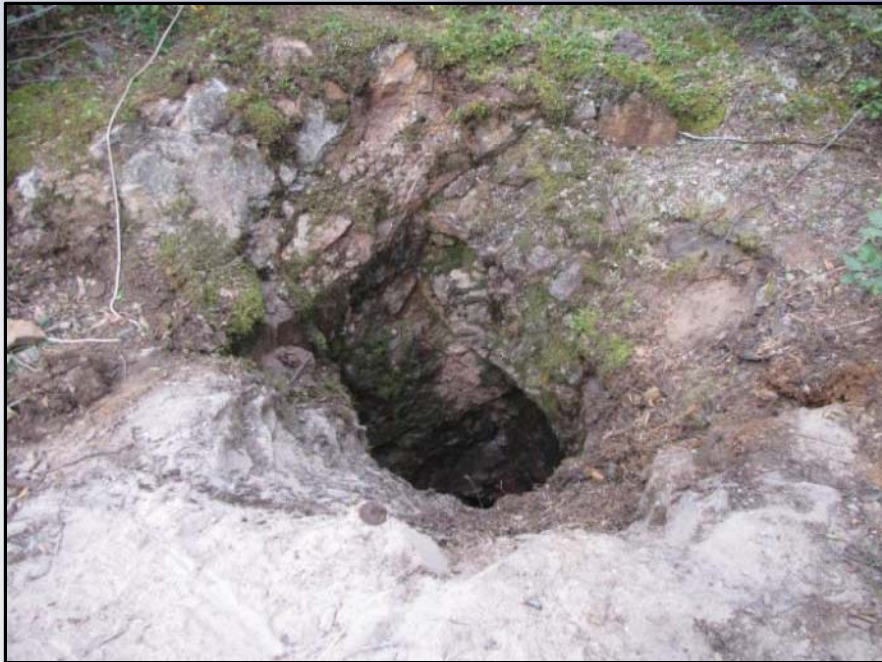
(left) Exposed opening of raise
