Gunnar Uranium Mine Remediation – Northern Saskatchewan

**Environmental Quality
Committee (EQC)**

Project **CLEANS**

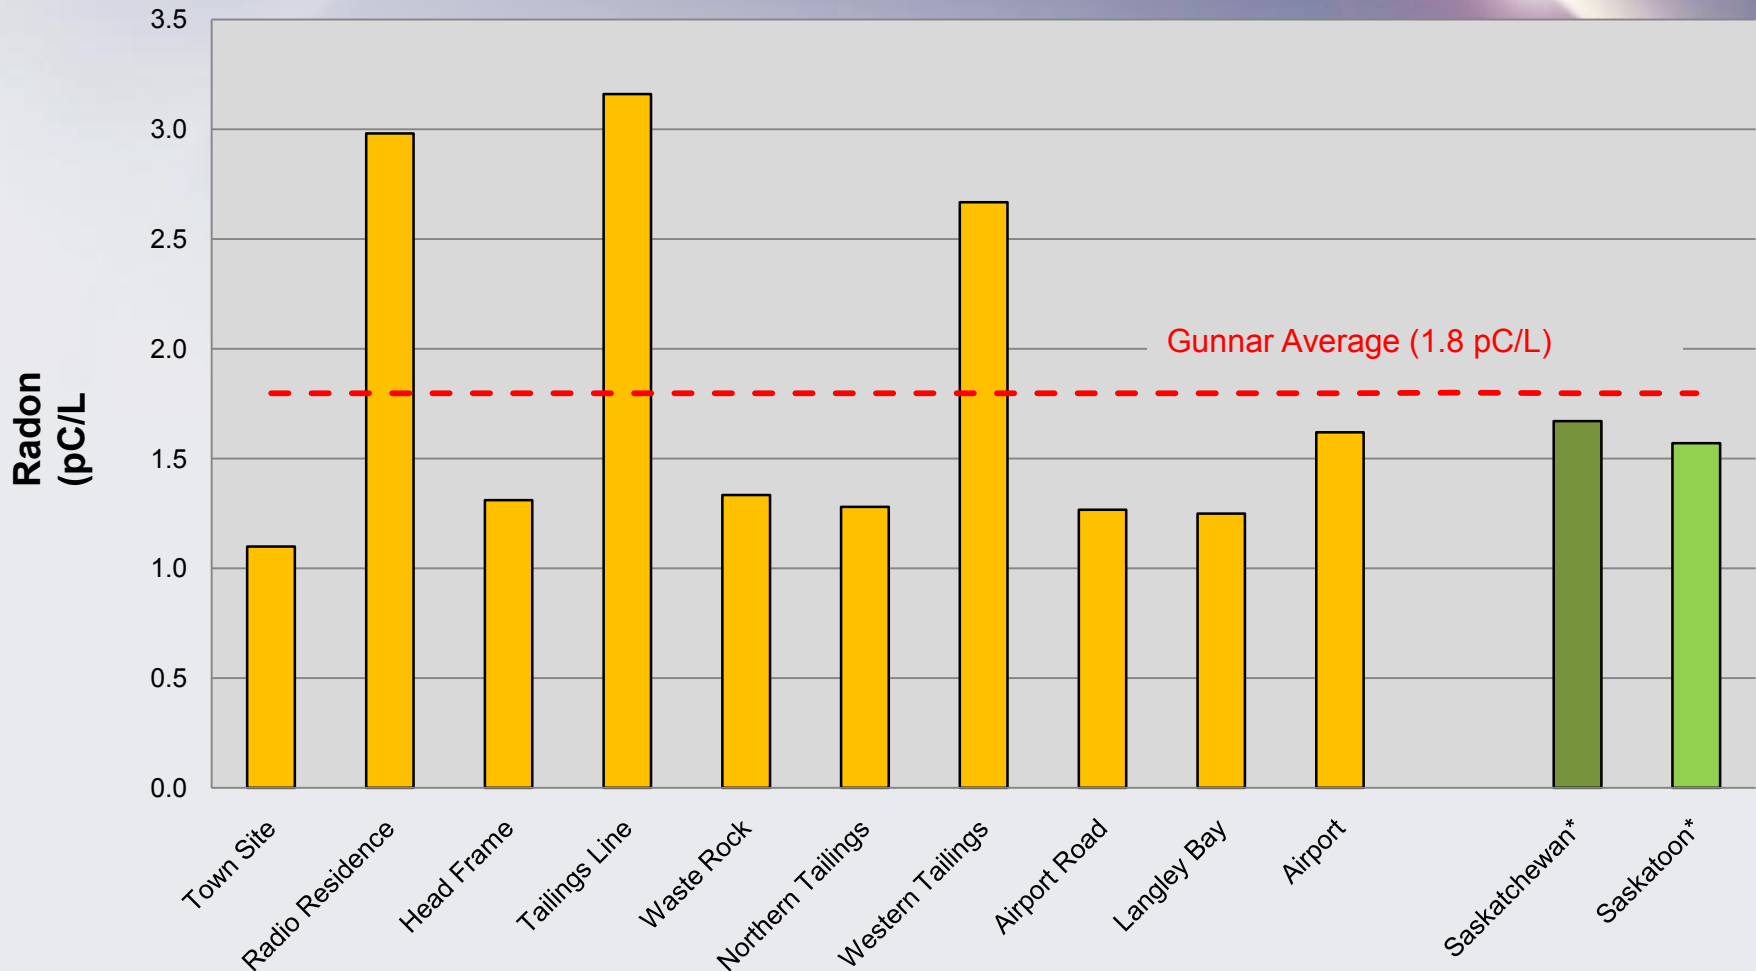
Average Radon levels Gunnar site 2004-2009

10 radon gas stations are located on the Gunnar site. Detectors are collected and analyzed twice a year.

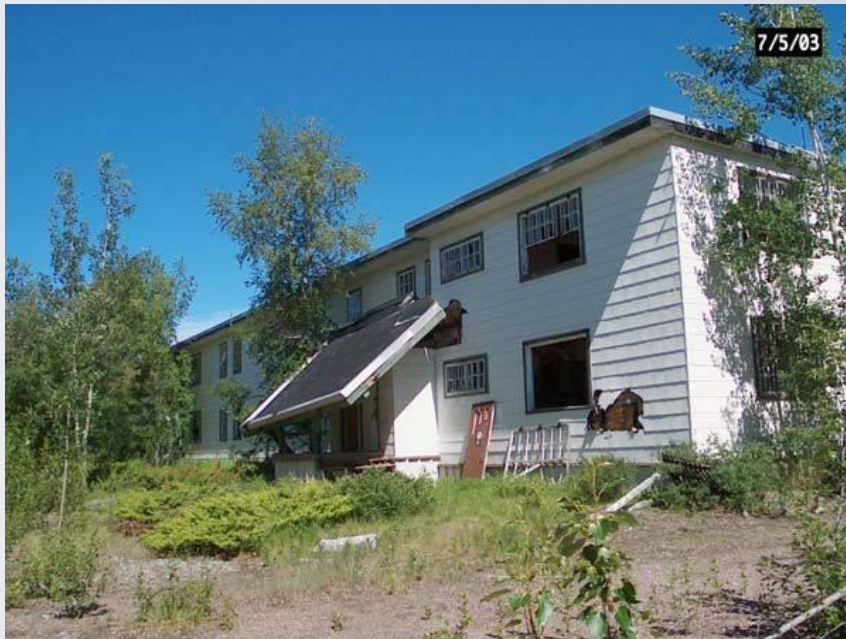
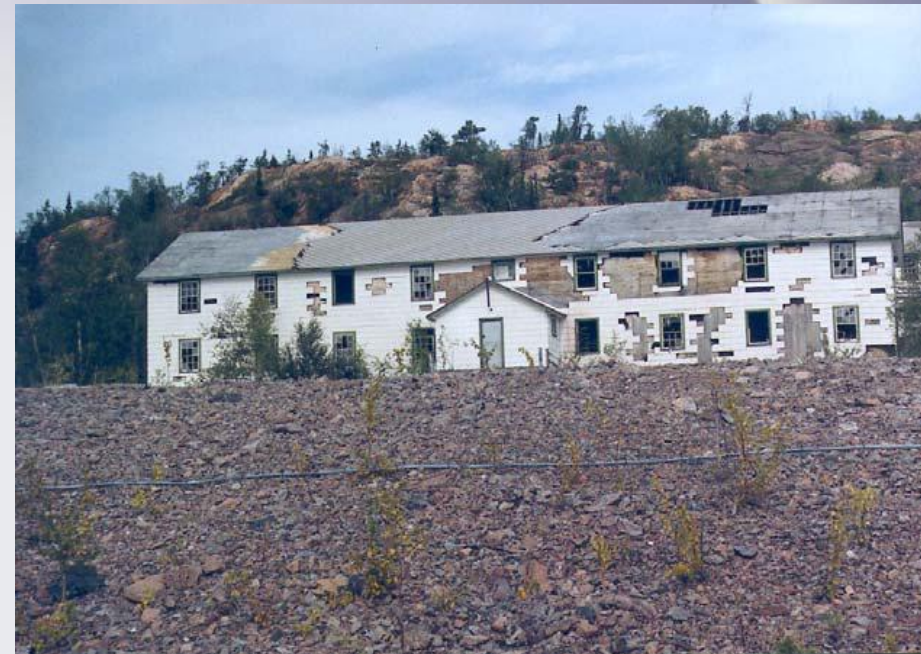
Married Persons Quarters

Single Workers Residence

Many of the residence buildings are in very poor condition

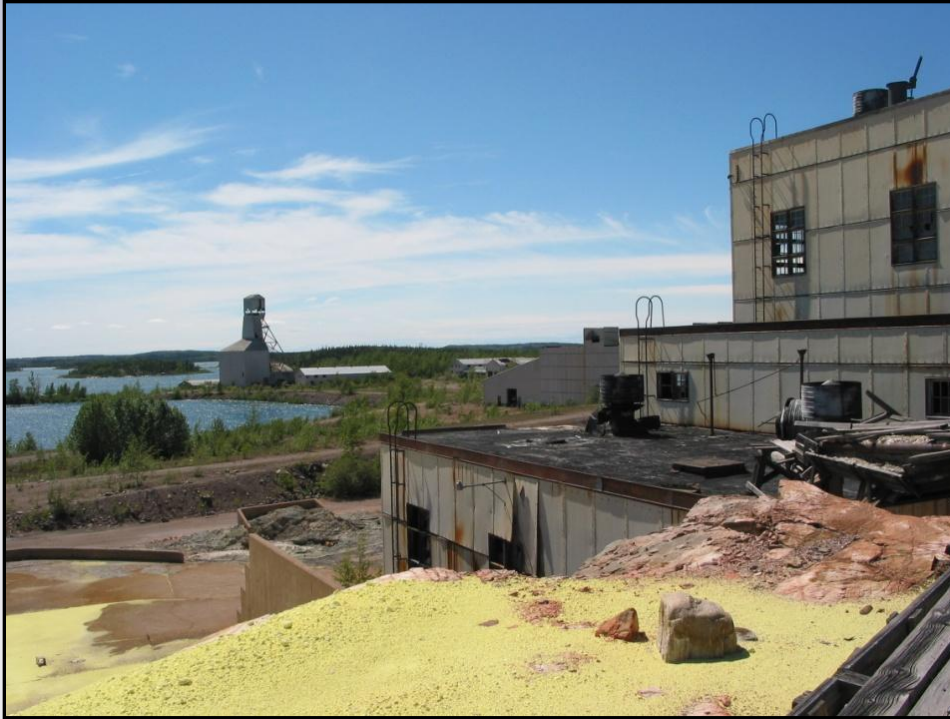
**Acid Plant
corroded and
structurally unsound**

- **Underwater Disposal**
 - Gunnar Pit**
 - Lake Athabasca (unlikely)**
- **Single Landfill**
- **Multiple Landfills (three)**
- **Hauling metal off-site**
- **Mine monument?**
- **Others?**

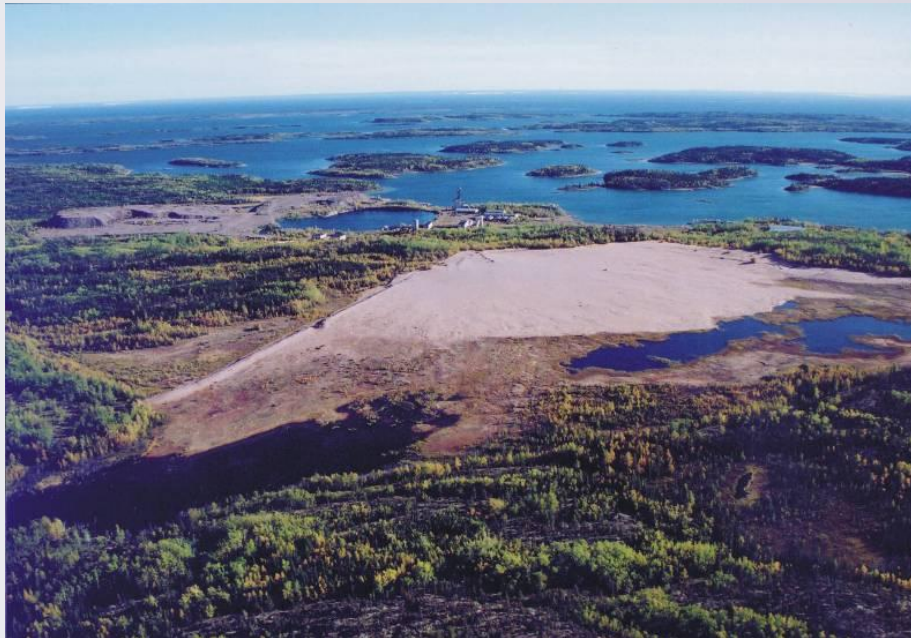
**Gunnar Main looking south
towards Lake Athabasca**

- Do nothing
- Natural Controls and Re-vegetation
- Water/Rock Cover/Borrow Material cover
- Impermeable Engineered Cover
- Use of constructed wetlands – next slide
- Combinations of above
- Others?

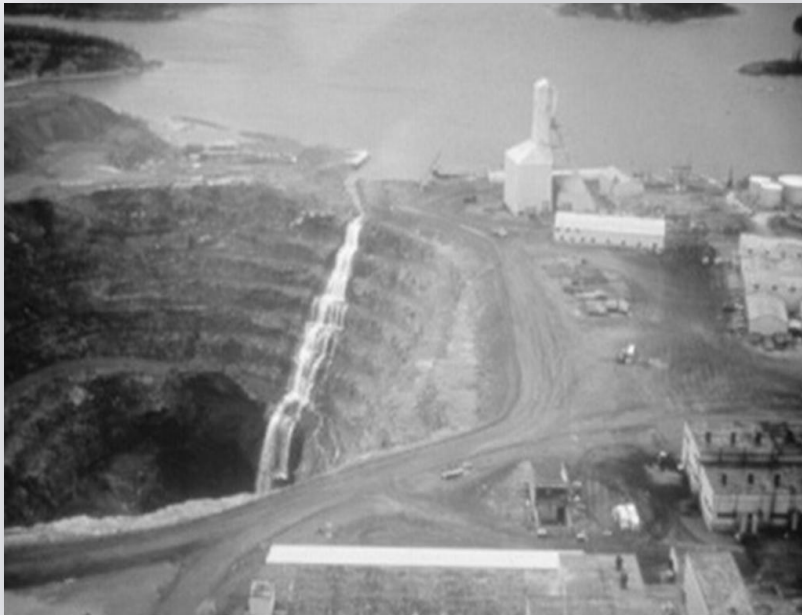
Gunnar Pit - 1964

116m deep, and
approx. 300m dia.

50 m from shore of
Lake Athabasca

- **Do nothing**
- **Stabilize the sides of the pit**
- **In-filling of pit with mine buildings**
- **In-filling of pit with tailings**
- **Treatment of displaced pit water if pit in-filled**
- **Addressing the water seepage issue**
- **Other?**
