MEMORANDUM

Re: **SRC Gunnar Tailings Remediation Plan – Borrow Material Balance and Suitability (963-1-MEM-0003)**

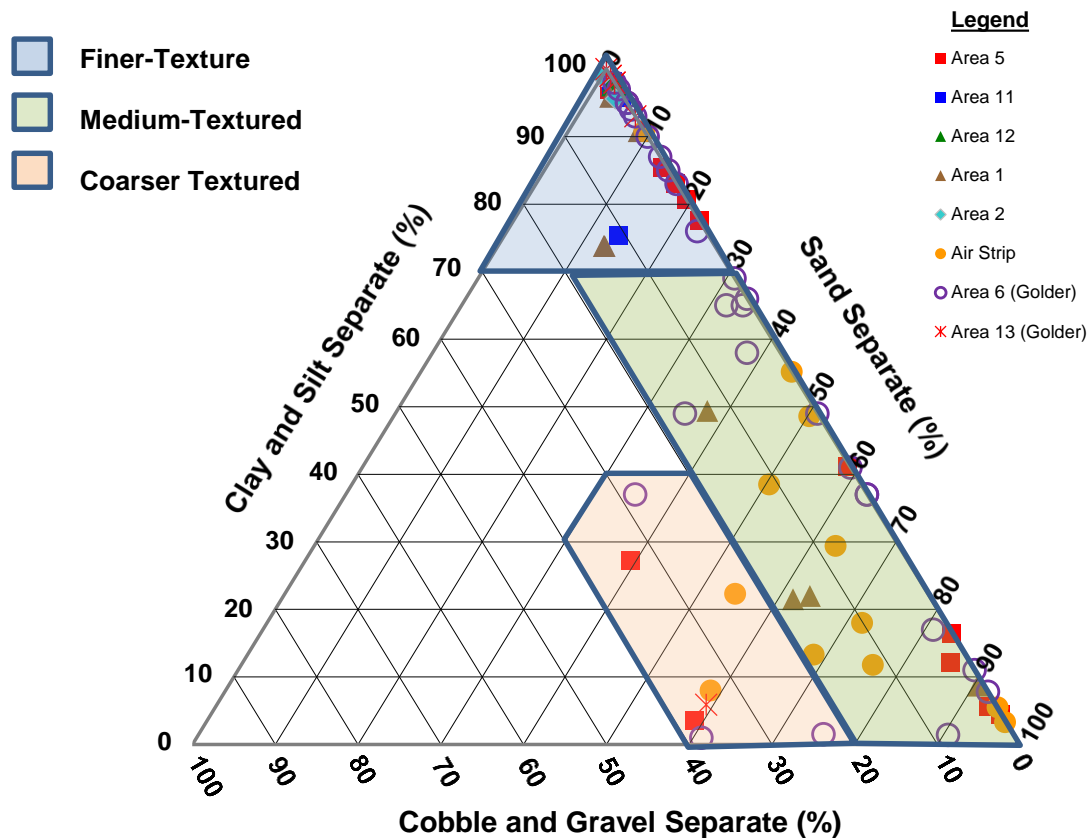
The majority of materials encountered in Areas 1, 2, 11, 12, and 13 were clay- and silt-size particles. Areas 5 and 6 have varying quantities of clay and silt to sand and gravel size particles. Based on PSD analyses, materials were partitioned into three texturally based categories: finer-textured (clay and silt), medium-textured (fine sand to coarse sand) and coarser-textured (sand and gravel or coarser).

Figure 1. Textural triangle showing PSDs measured for borrow materials from previous and current investigations.

Previous studies included detailed test pit and laboratory testing programs that targeted Investigation Areas 6 and 13¹ as well as the airstrip². The current field investigation targeted Investigation Areas 1, 2, 5, 11, and 12. Several bulk samples were collected from each target borrow area and submitted for particle size distribution (PSD) analysis. Figure 1 provides a summary of PSDs for the current and previous studies.
