Project CLEANs Public Meeting Ben McIntyre School, Uranium City April 29, 2010 1:00 pm

PROJECT CLEANS:
*Satellite Remediation Completed in
2009*

Project CLEANS Group 3 Satellite site Remediation Proposed for 2010

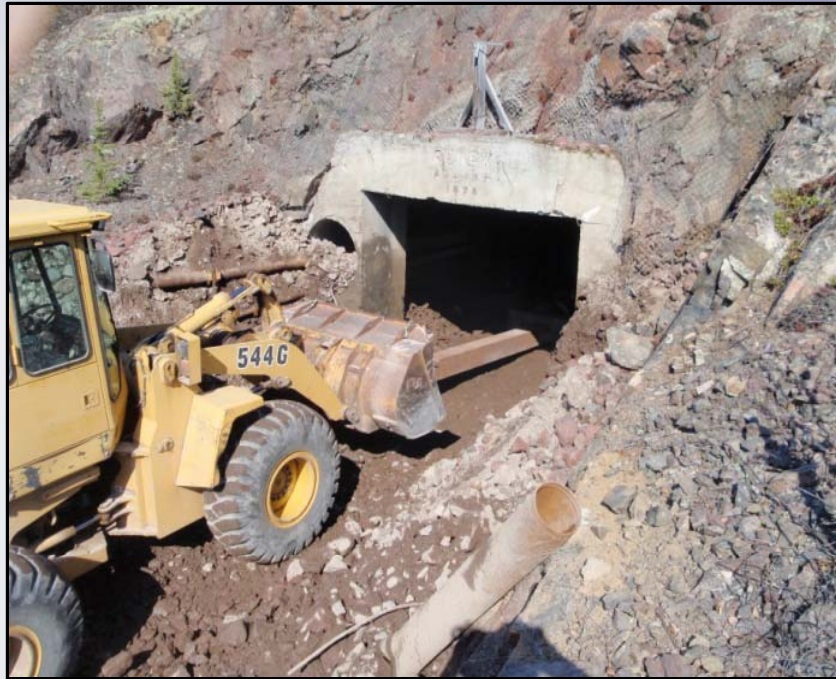
(Left) Backfilling of the adit

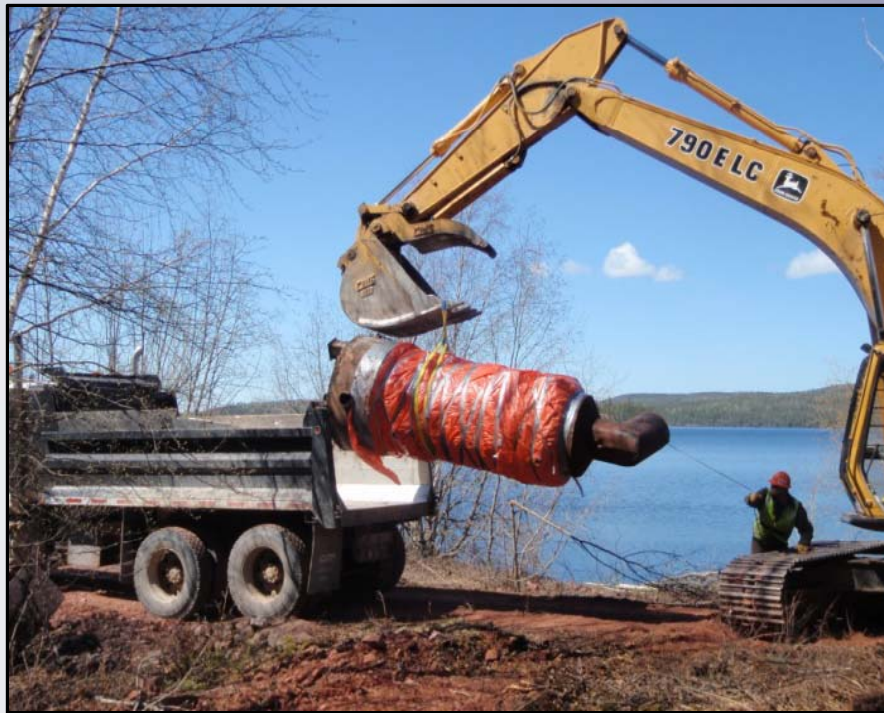
(left) Removal of the boiler with asbestos insulation

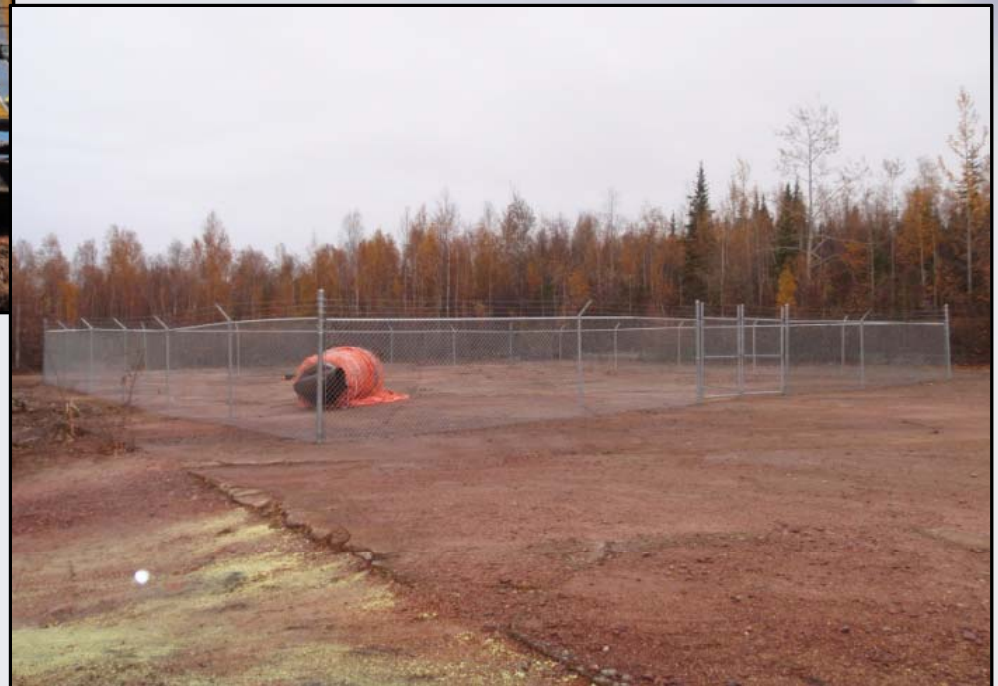
(right) Temporary special disposal area at the Lorado mill site.

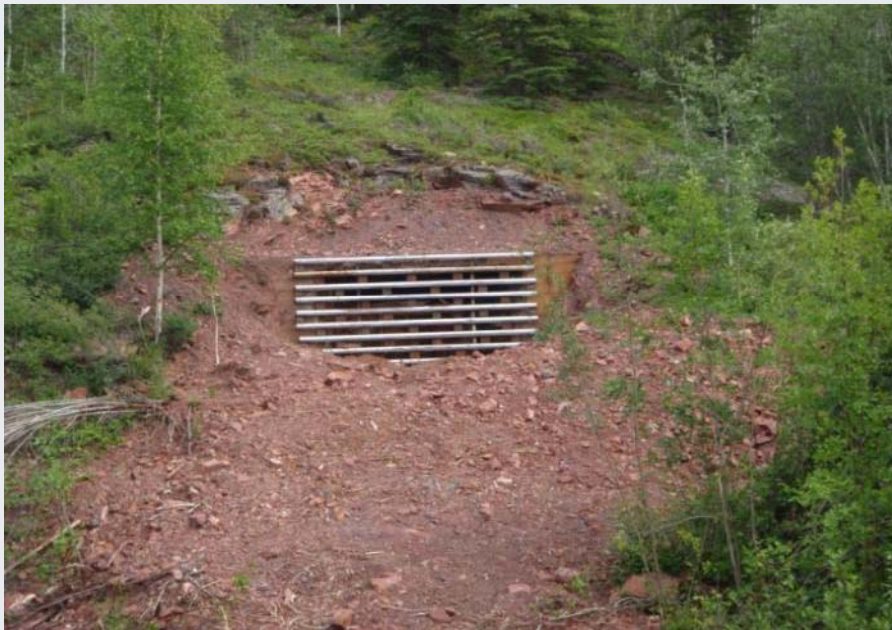
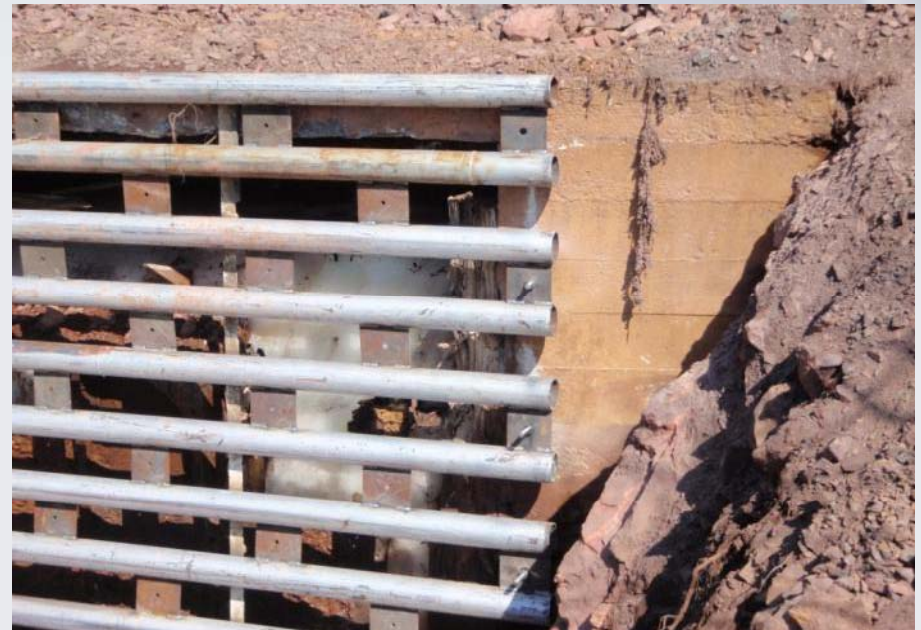
- A build up of ice in the second adit prevented a proper backfill from being completed in 2009
- A temporary jail cage was installed and the adit will be further assessed early in the 2010 field season

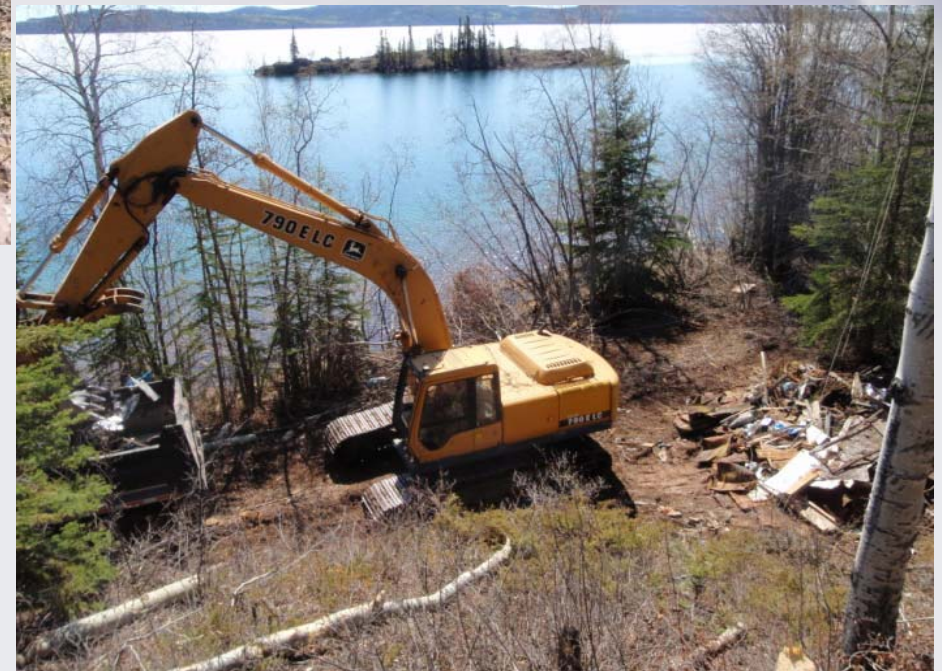
(right) debris cleanup at the hunting/fishing camp

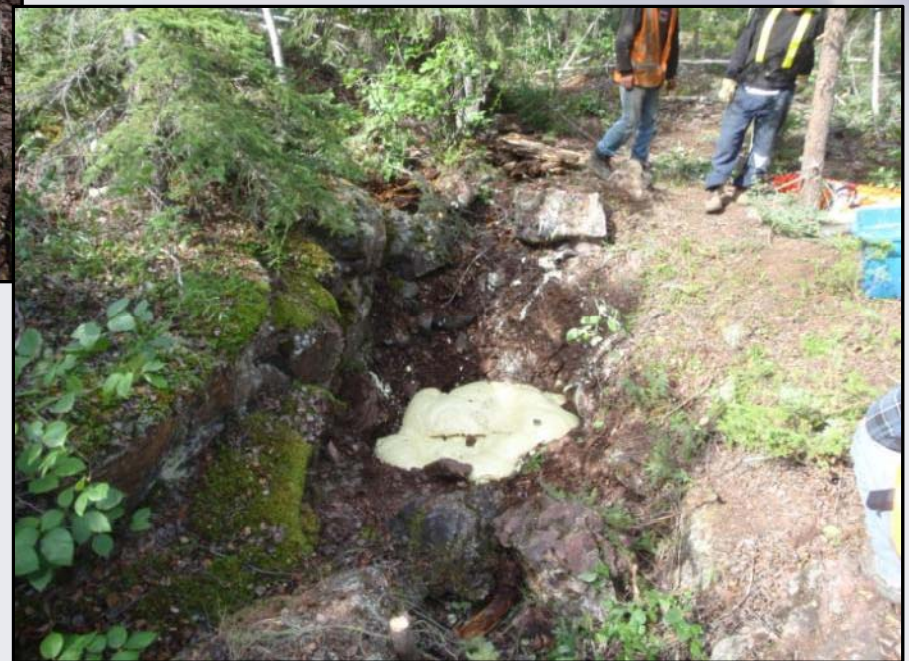
(right) PUF plug at raise #2

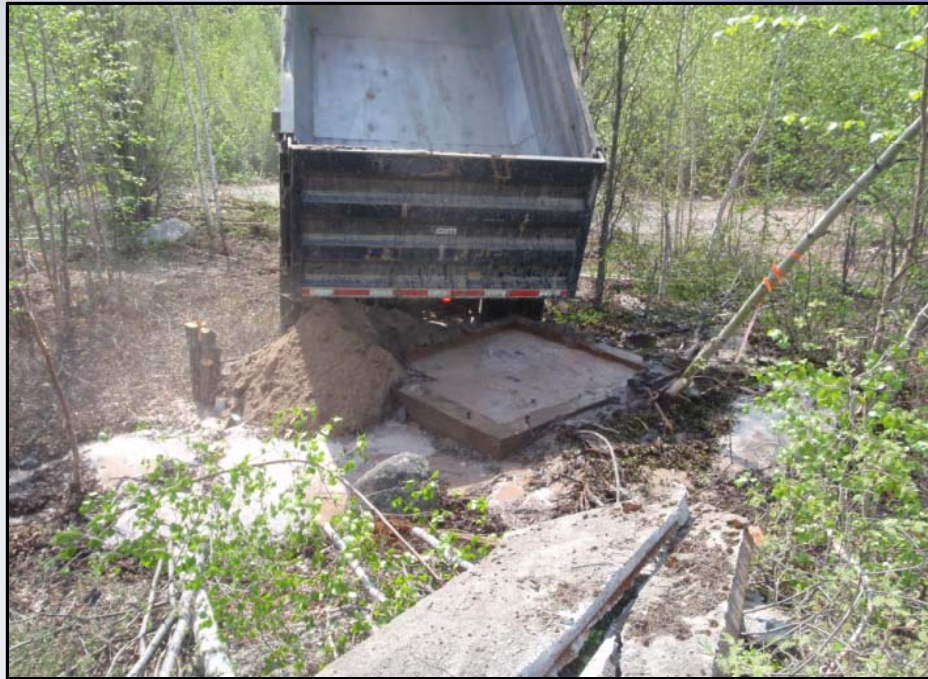
(left) Backfilling of raise #1.
Raise #2 was also backfilled.

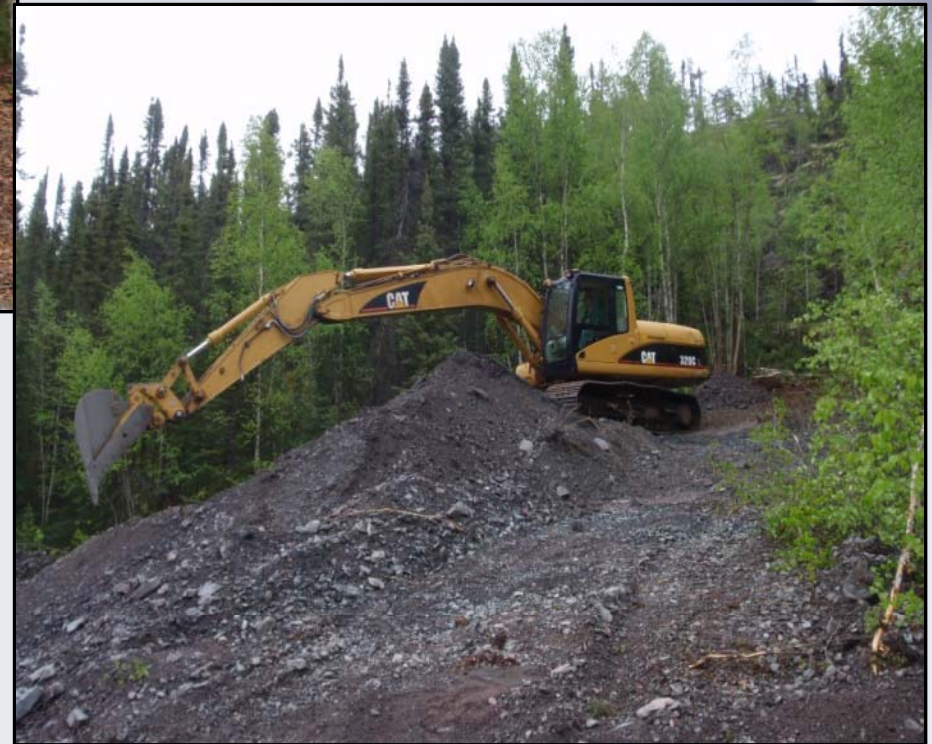
(right) contouring of the remaining waste rock

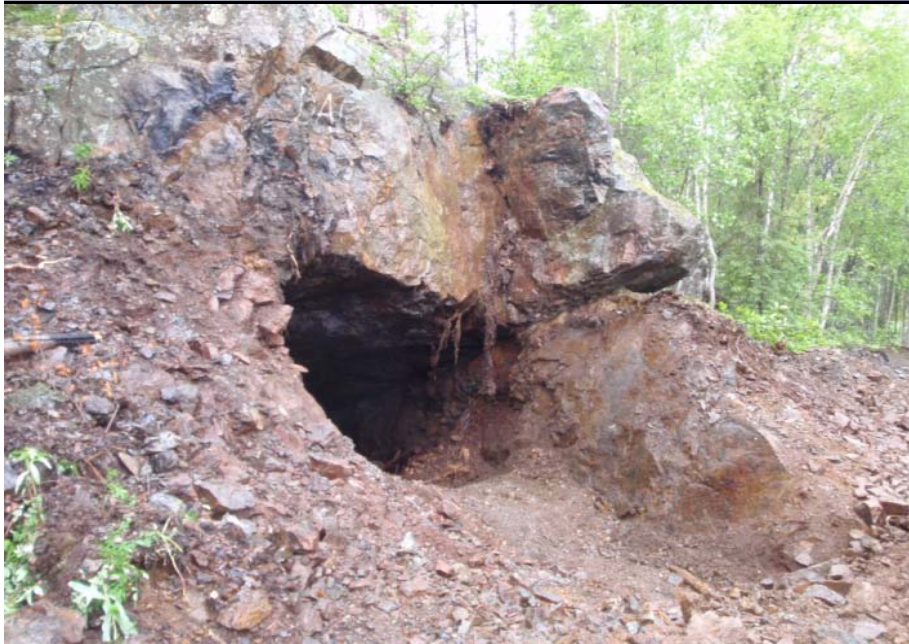
(left) Exposed inclined adit after blast debris was removed

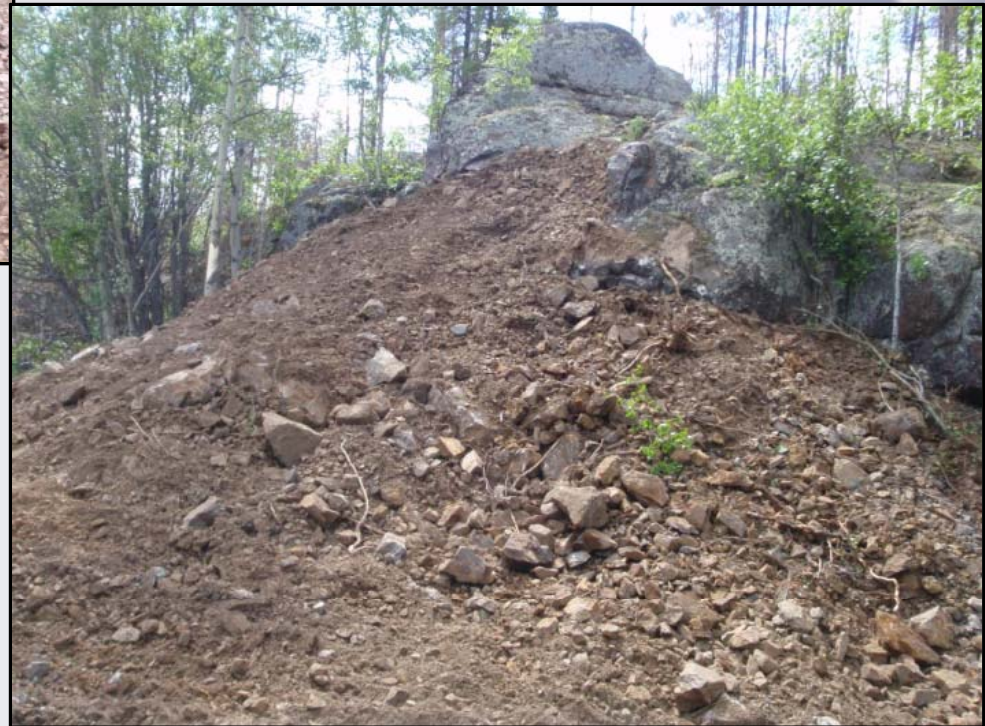
(right) Inclined adit once backfill was completed

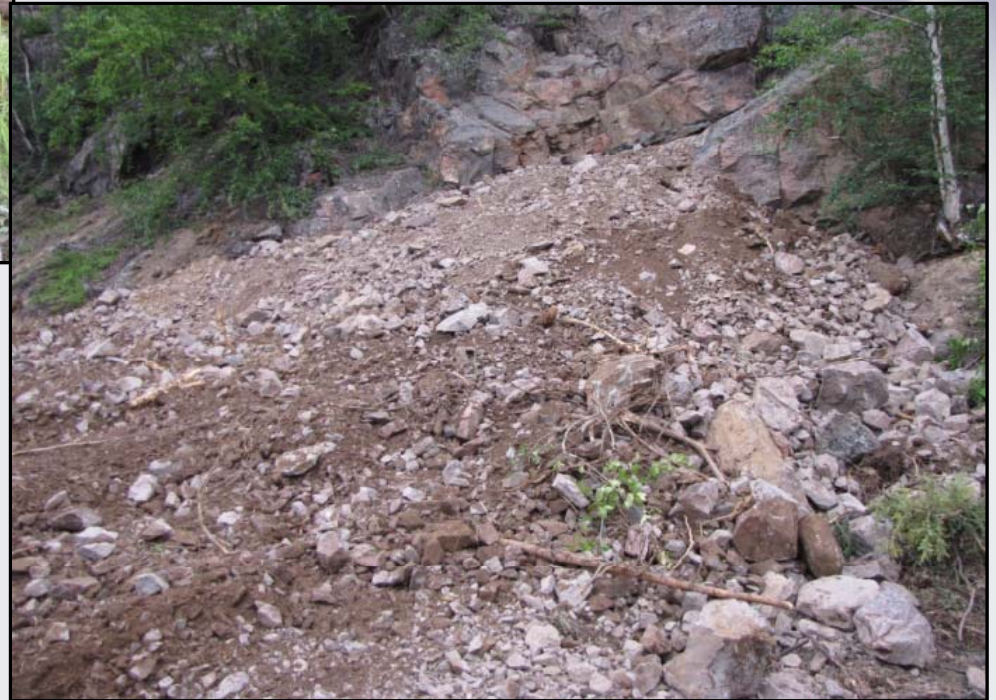
(right) completed backfill of adit

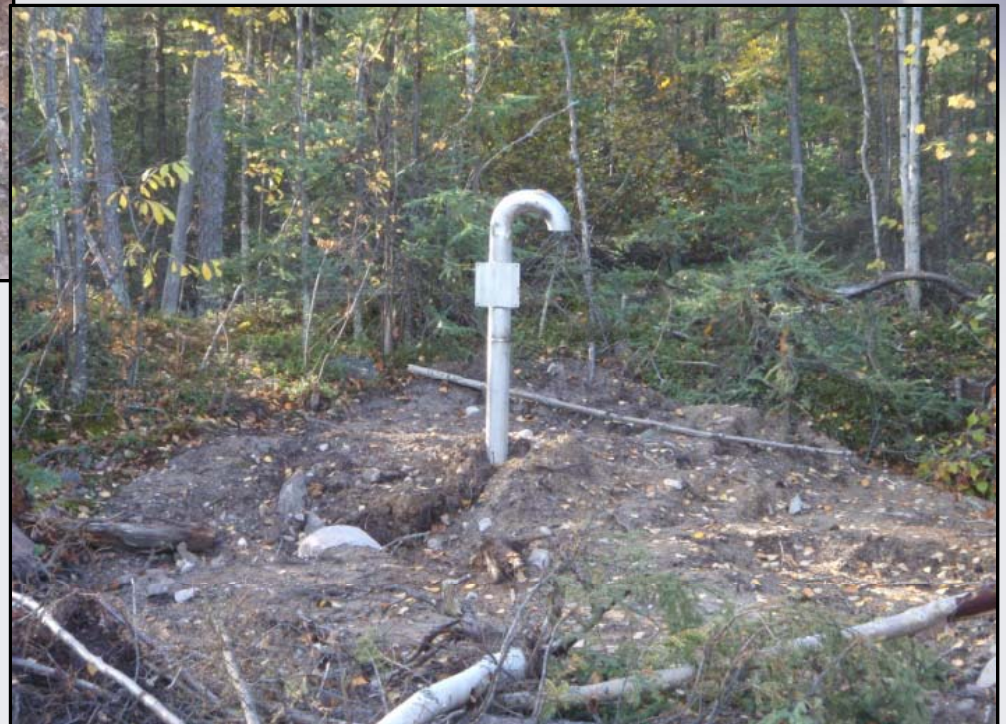
(right) Vented raise sealed with PUF.

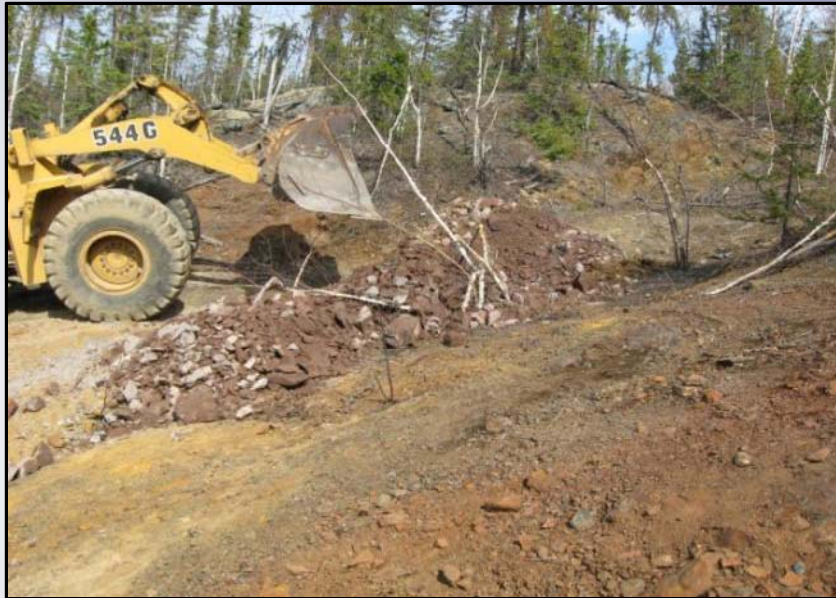
(left) A berm was constructed to direct surface runoff away from the backfill area.

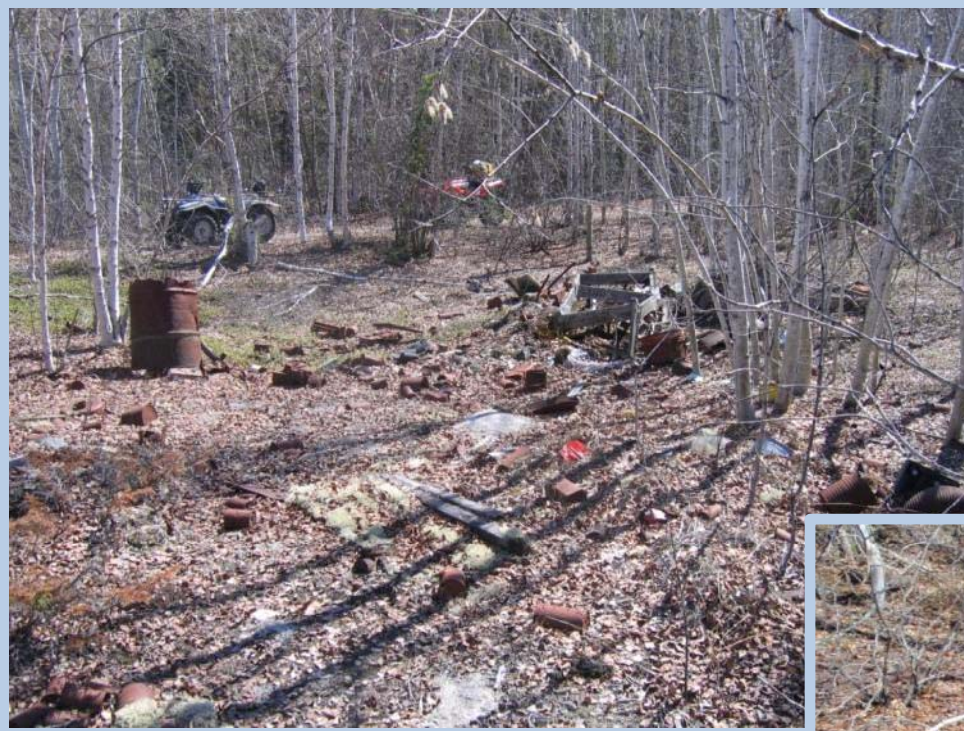
Steel debris, tires, 45 gal. drums, lead from batteries, bury steel in Cayzor waste rock
Remove batteries to waste storage site at Lorado
Gamma survey of site

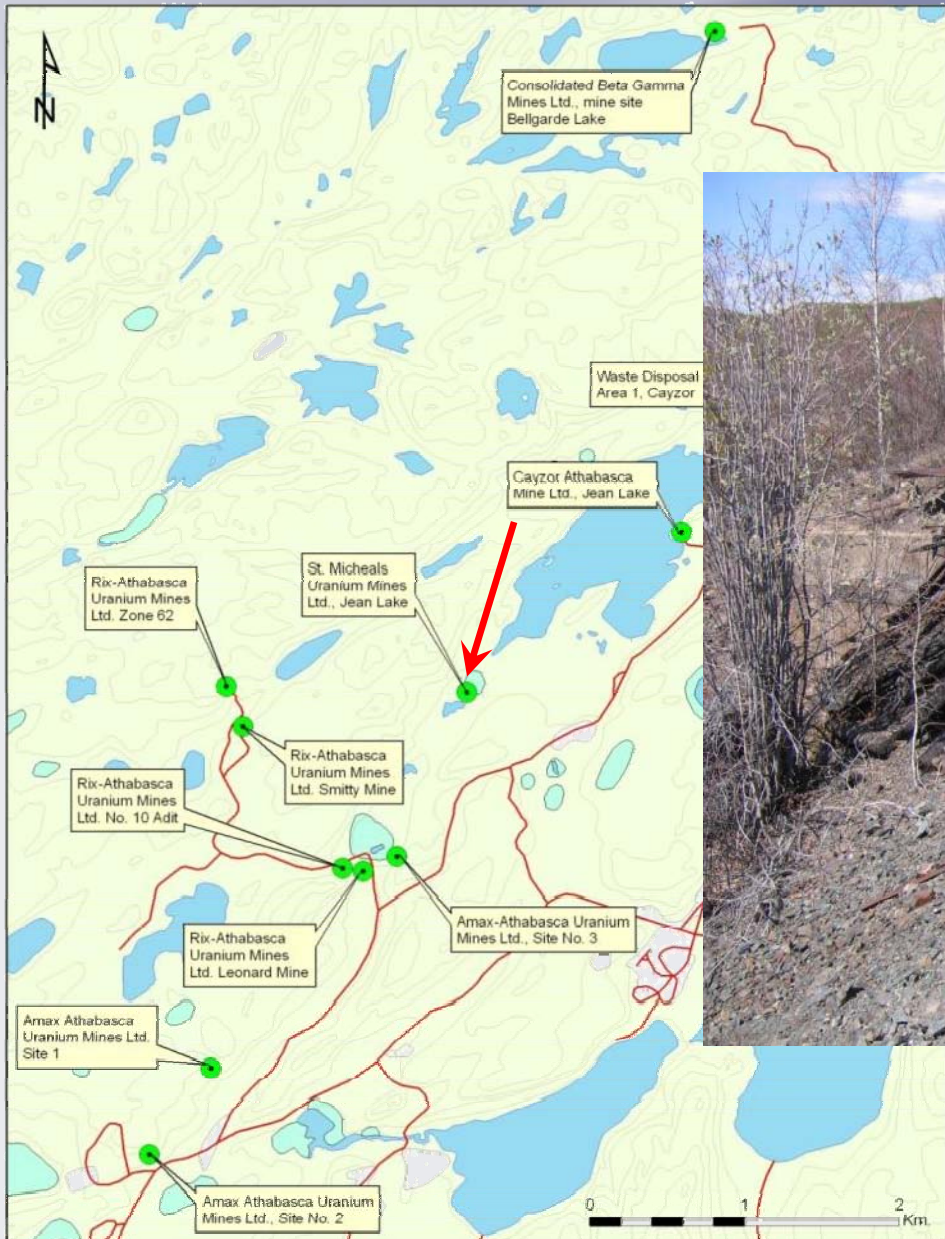
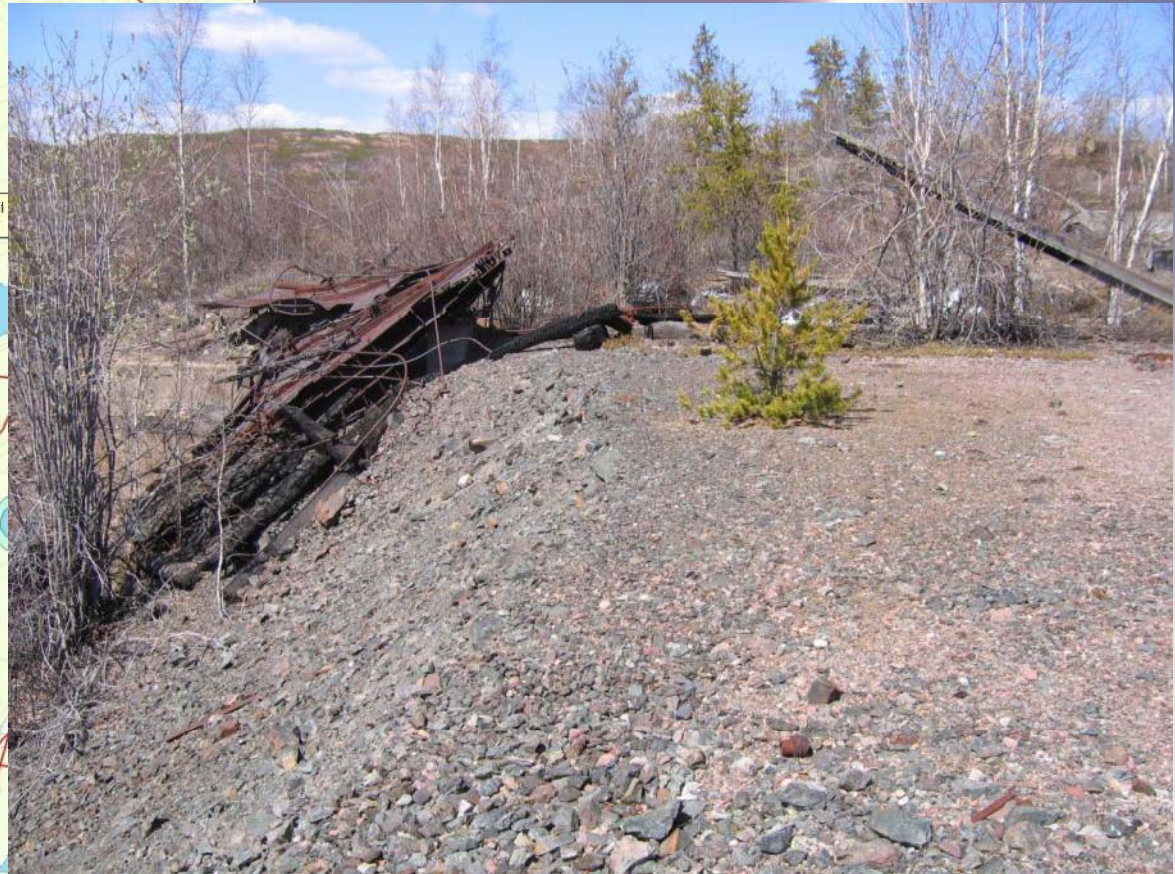
St. Michaels mine, Jean Lake

Some steel waste to be collected and buried in waste rock on site

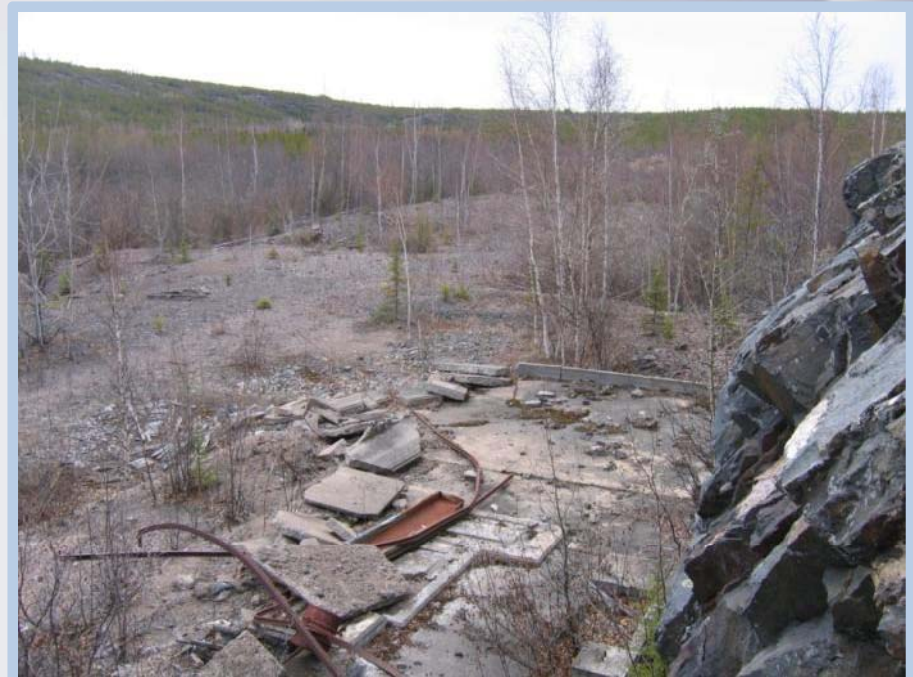
Adit showing signs of slumping, reopen and place backfill into adit as well as in front

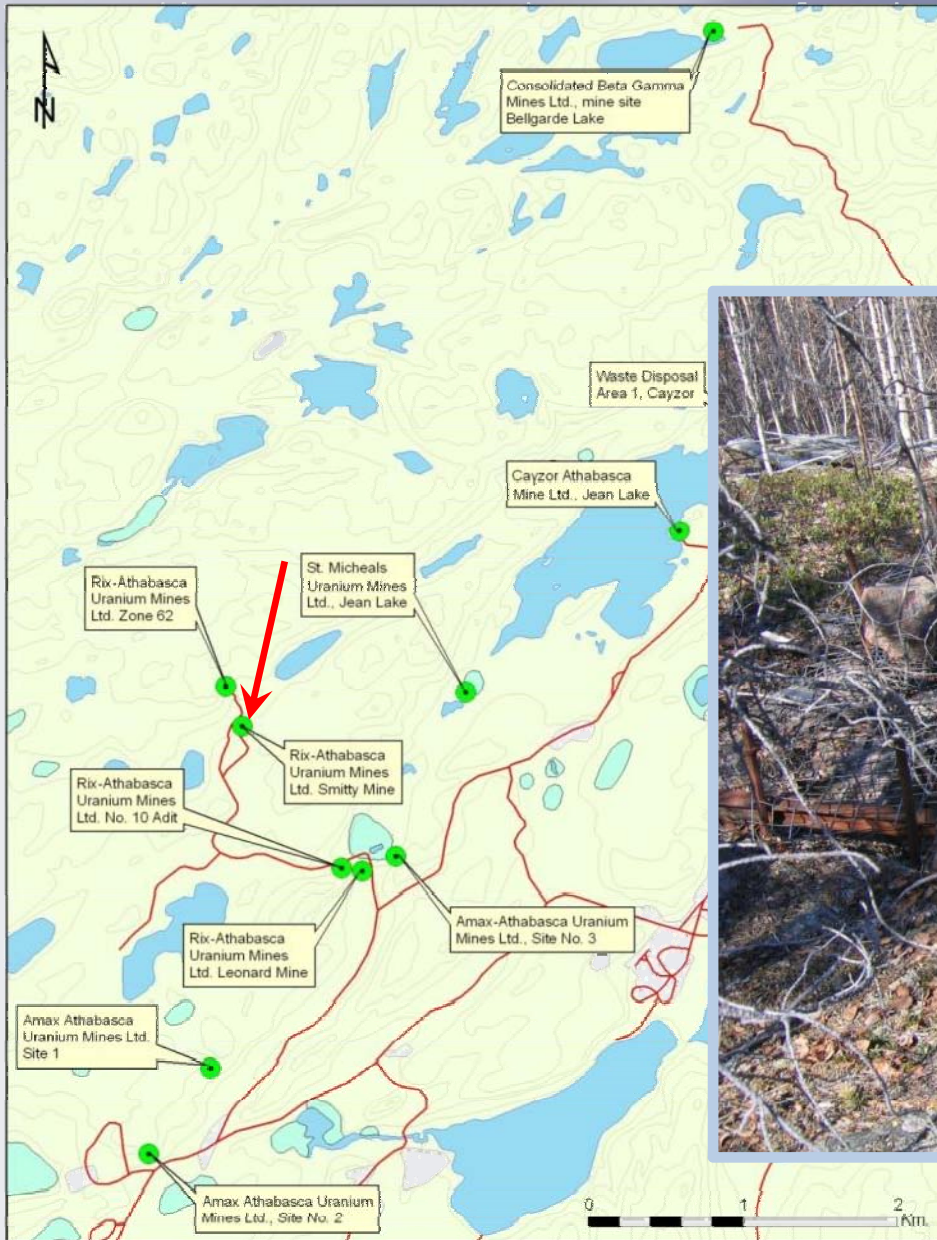
One of several openings in need of closure at Smitty mine

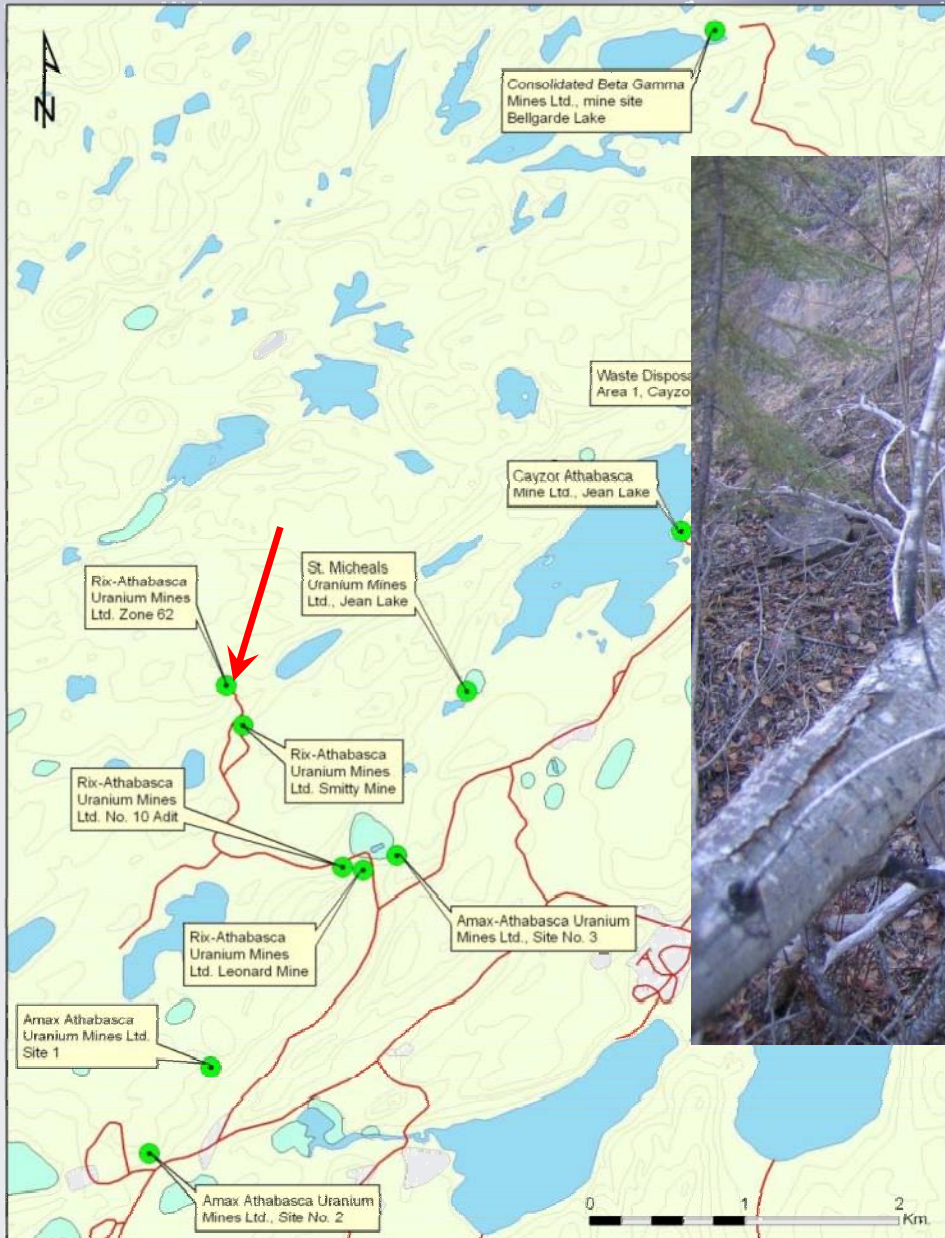
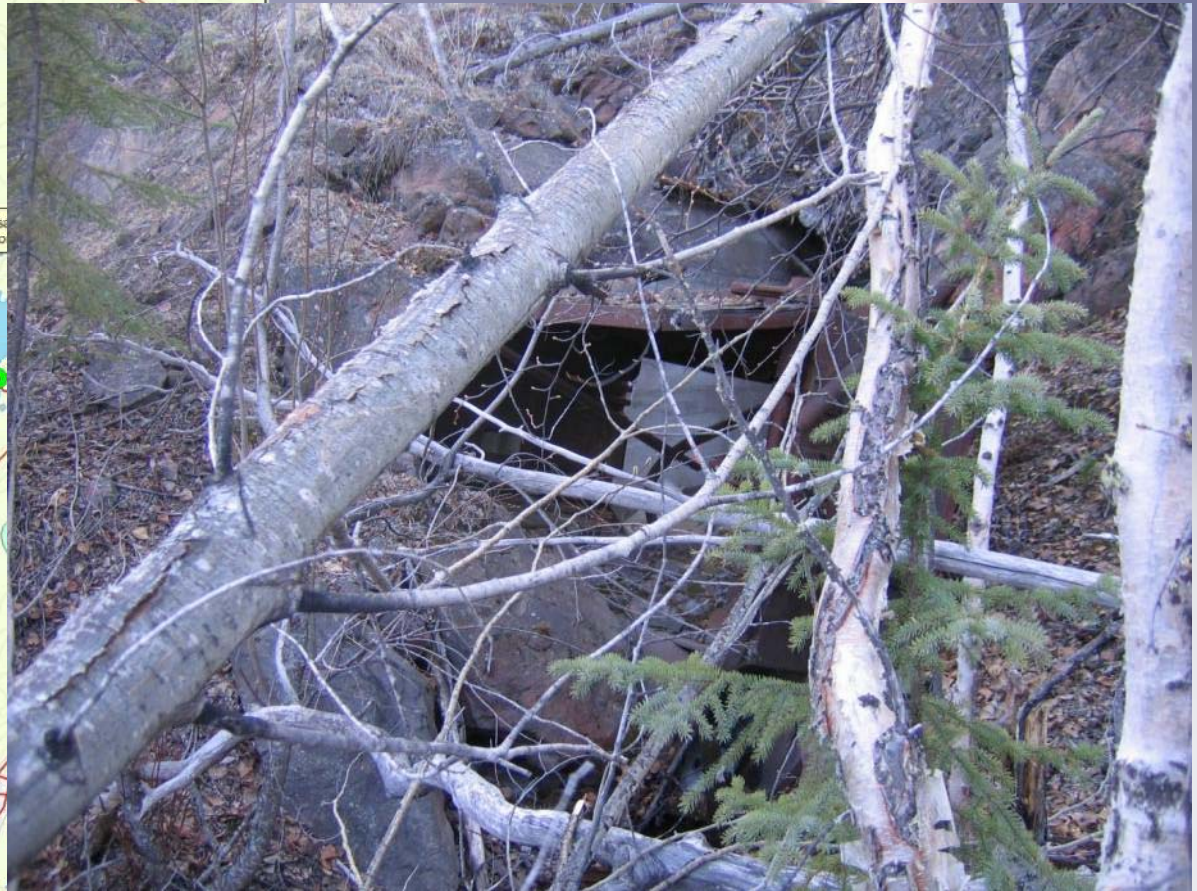
Rix-Athabasca Zone 62

Some steel waste to be collected and buried, ore cart

Unstable bedrock caused
by underground mining
near surface
